Difficulties with ground anchorages in hard rock in Dublin, Ireland

Michael Long, Department of Civil Engineering, University College Dublin, Ireland*

Bernard Murphy, BMA GeoEngineering, Carlow, Ireland

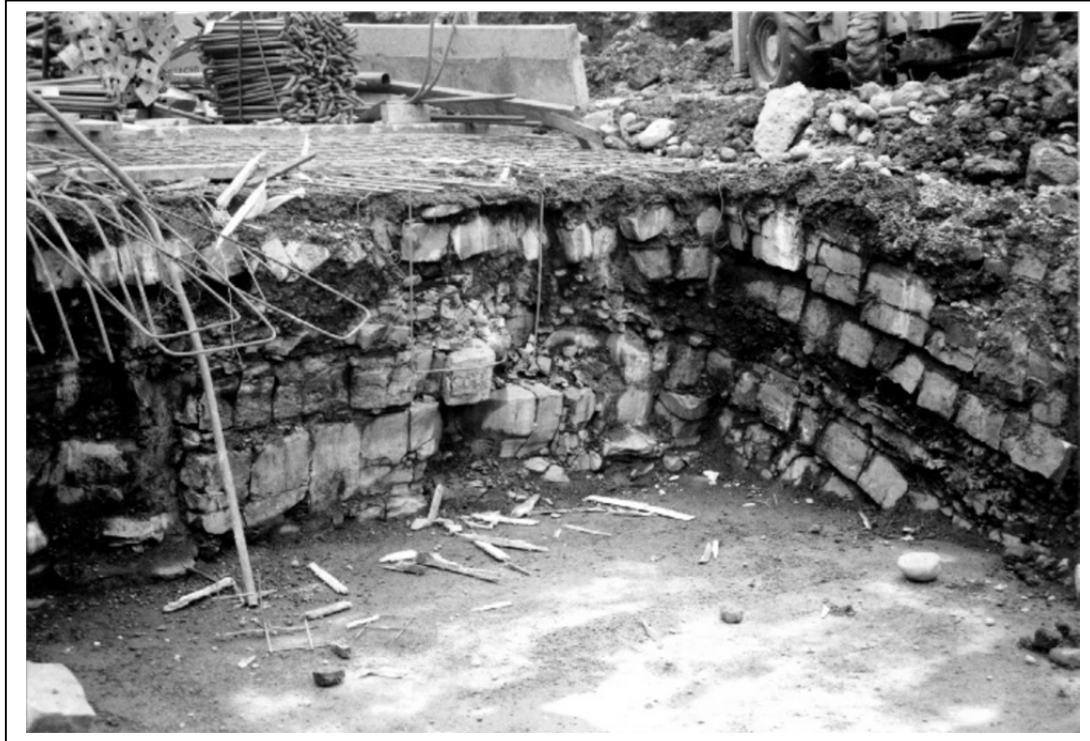
FIG. 5. *Photograph of weathered rock*

The discontinuities are described as being roughly horizontal and the fractures are often closely spaced. The percentage of “severely weathered and fractured limestone” to intact limestone varies between 0% in BH1 to 27% in BH5, with an average of about 10%. This weathered rock generally had the appearance either of blocks of limestone surrounded both vertically and horizontally with bands of black silty clay or of cobbles and boulders of limestone in a matrix of silty clay. A photograph of a cutting (for a pad footing) in the weathered rock is shown on Figure 4.

when required. The upper 0.5 m to 1.0 m of the bedrock was confirmed to be weathered and fractured, see Figure 4.

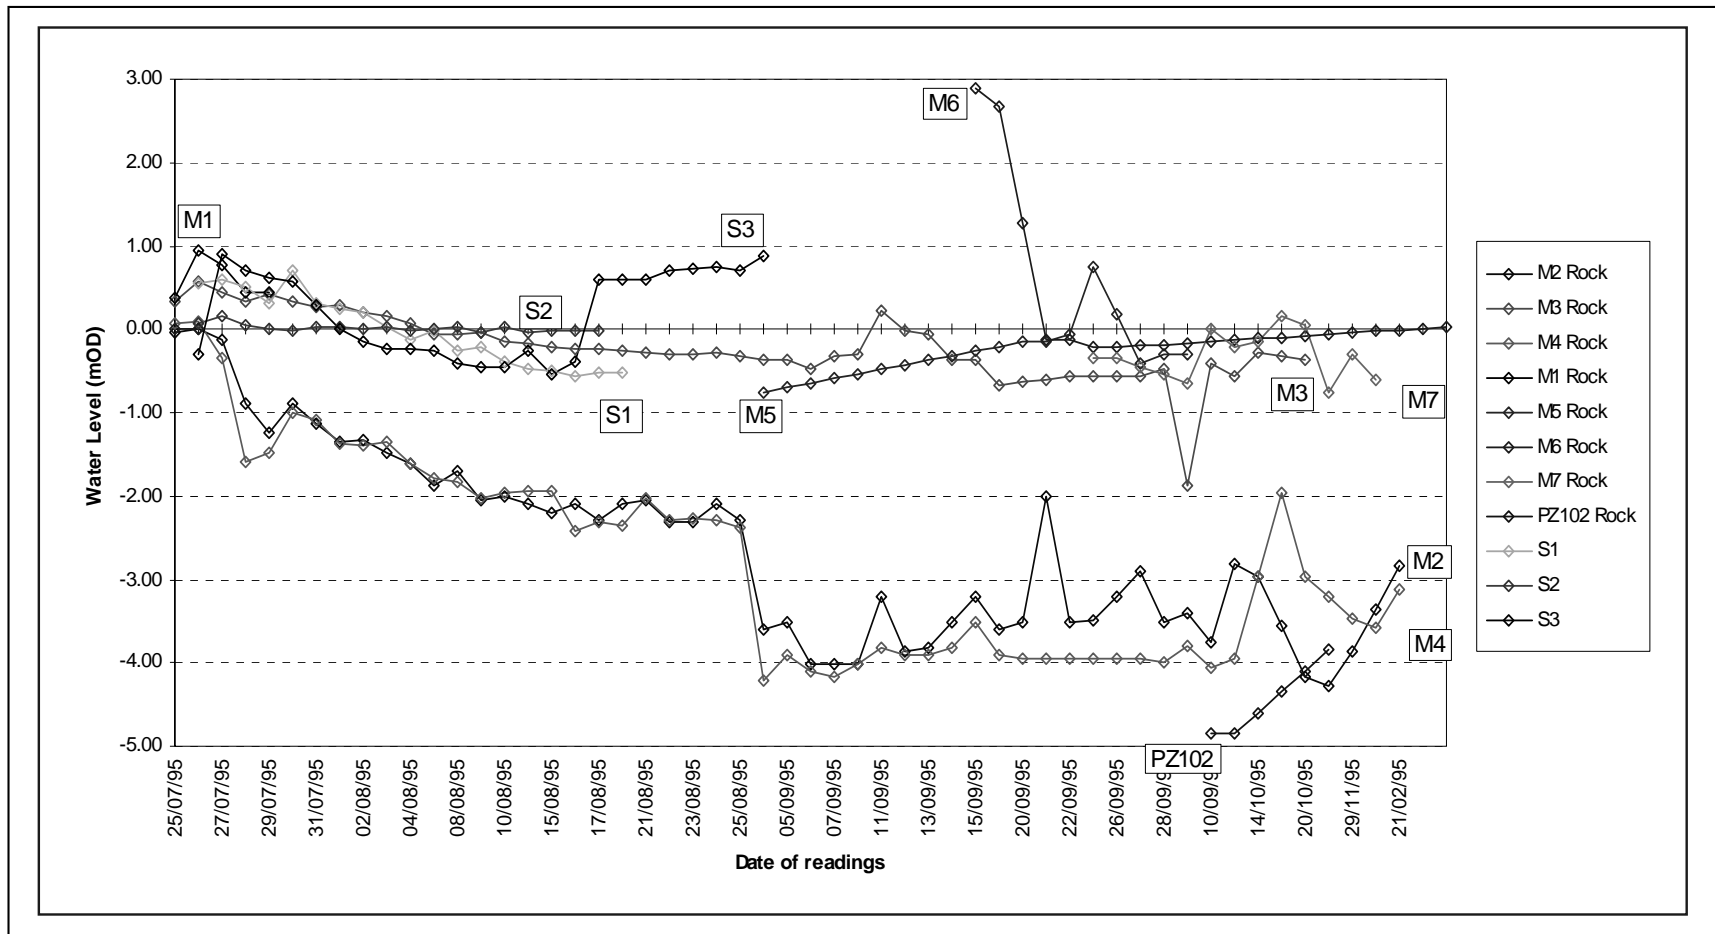
FIG 8b. Piezometer readings in bedrock

Fairly soon after pumping began, the water level in the rock was drawn down between approximately 1 m in the Jervis St. / Upper Abbey St. area and about 4 m in the Mary St. / Liffey St. area (Piezometers M2, M4 and PZ102) and remained

approximately at these levels during the monitoring period. This relatively high drop in piezometric level did not have implications for adjacent structures as all are either piled or founded at a higher level on the gravels. Regular inspections of adjacent structures revealed no effects. A general comment would be that the readings are “spiky” in nature because of the intermittent pumping effort. In general the response of the piezometers in the bedrock was in hydraulic continuity with that in the gravels. The exception is that for piezometers M2, M4 and PZ102, all of which are located at the Mary St. / Liffey St. corner of the site.

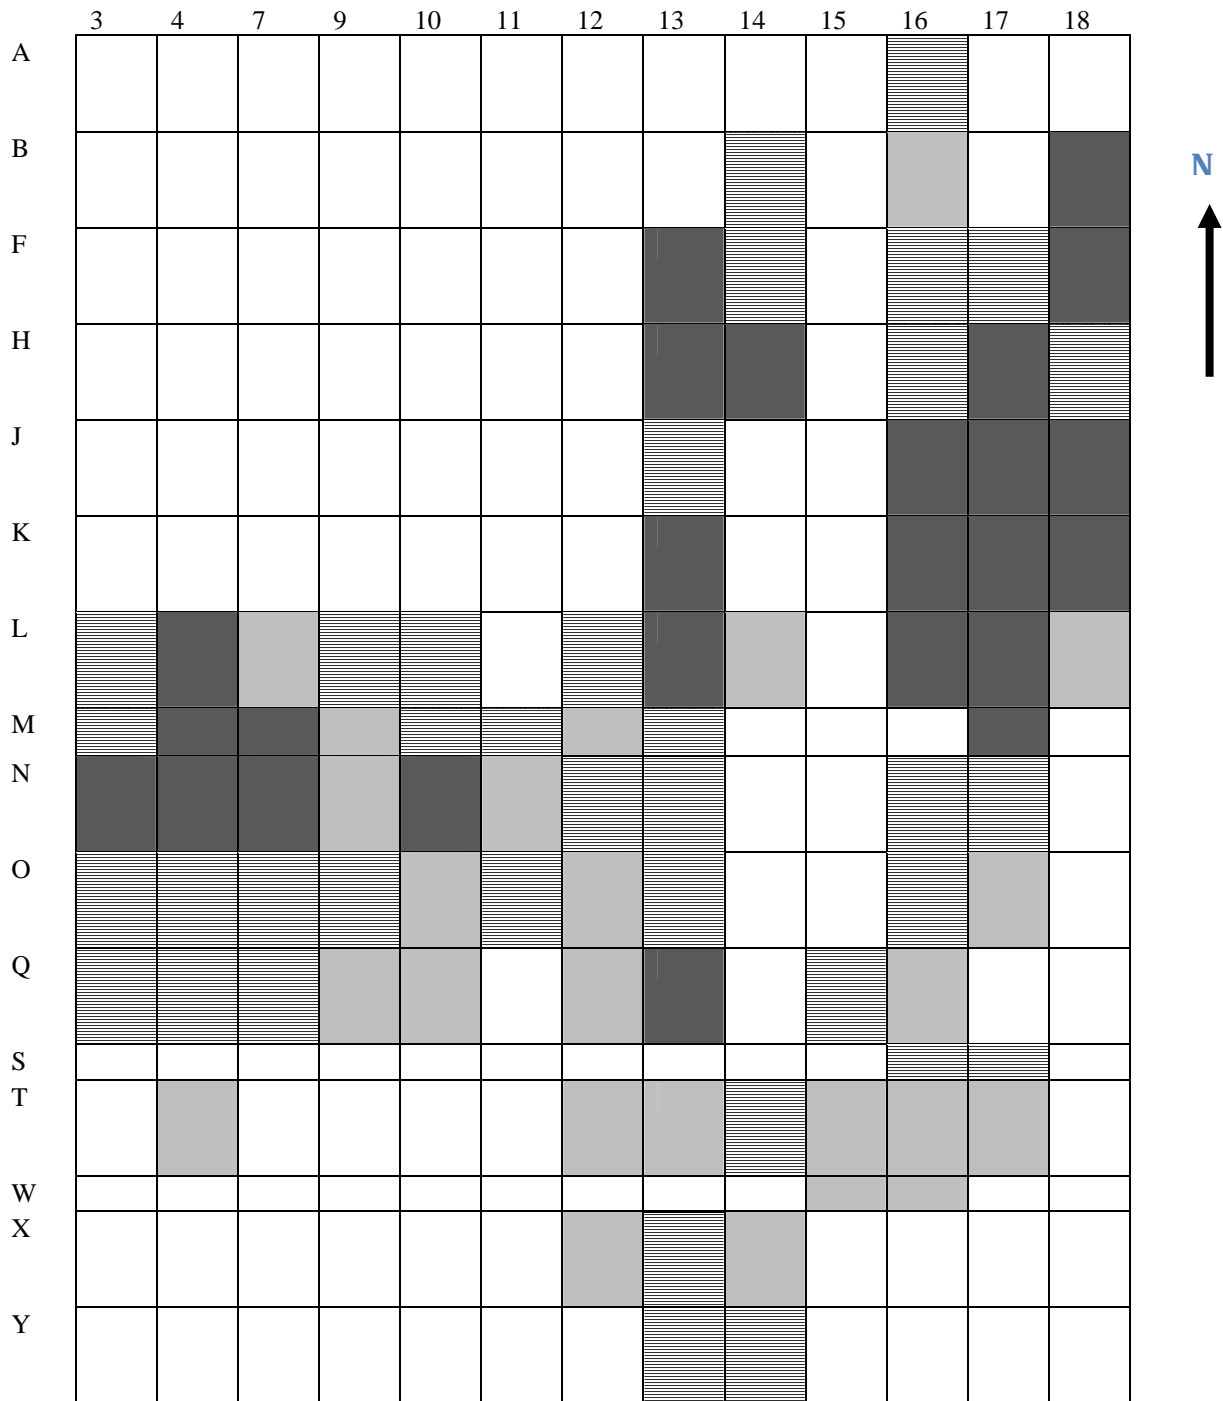
FIG 9a. Average time to drill hole

Figure 7a shows those areas of the site where the drilling time exceeded 90 minutes, was between 60 minutes and 90 minutes and was less than 60 minutes. Drilling time exceeded 1 hour (i.e. that time assumed at tender) in 228 of the holes. Lowering the air pressure did not ease the drilling difficulties. Some holes were also found to be dry. The main problem areas were in the south-west and north–east of the site.

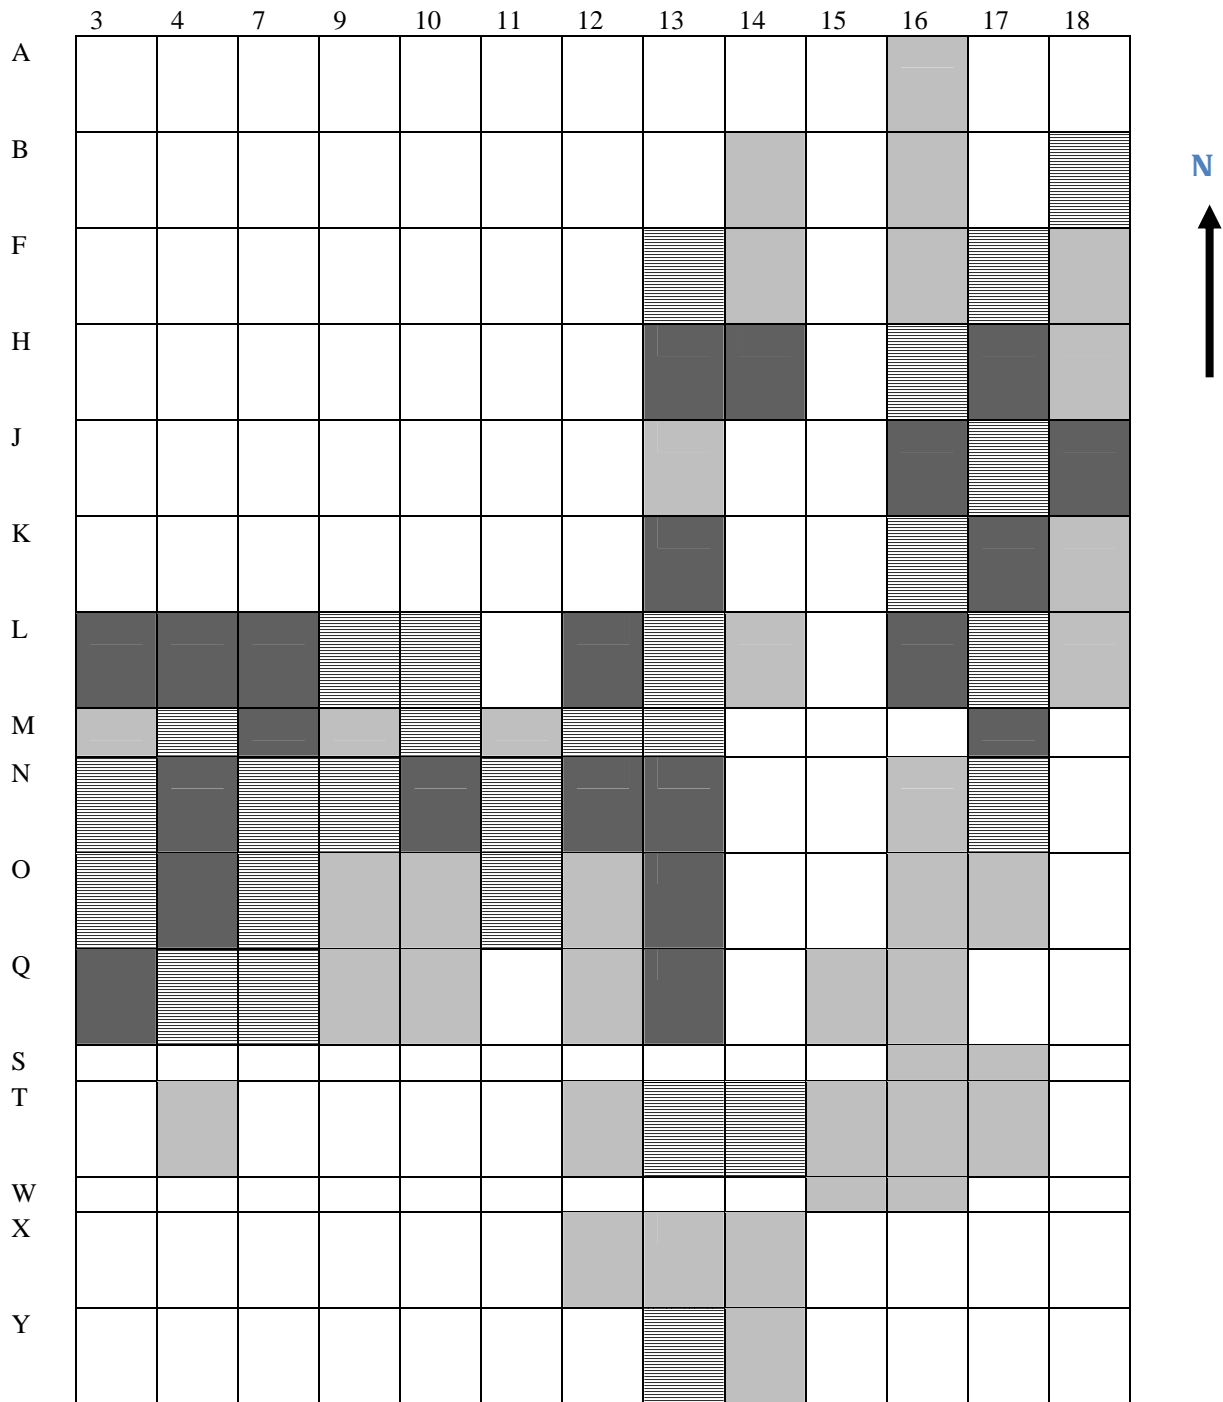
FIG 9b. Cased hole or equivalent depth of collapsed hole

Hole instability” is defined as those occasions where the collapse of the hole prevented the installation of the anchorage. This occurred in 83 of the holes, mostly “open holes.

Figure 7b illustrates areas where the number of boreholes drilled, which were either cased or collapsed, lay between 0 and 20%, 20% and 40% or exceeded 40%.

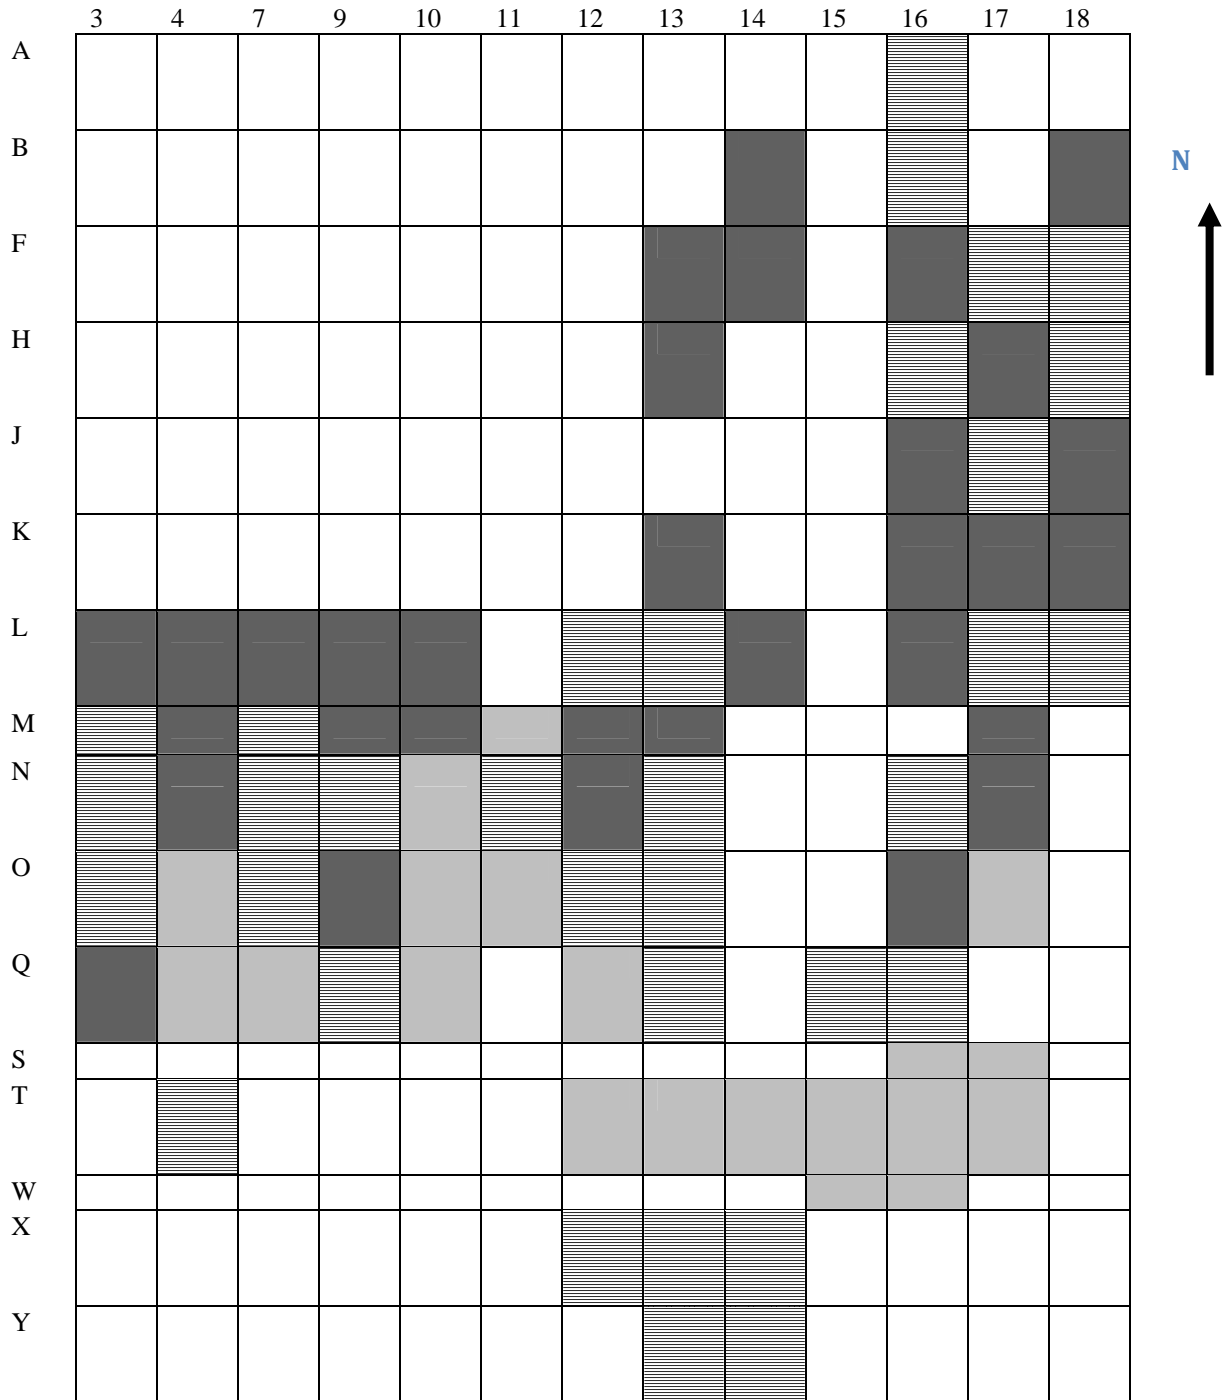
FIG 9c. Average volume of grout per hole (anchorage installation only)

A neat cement grout with a 0.4 water / cement ratio was used in the works. It had a required 28 day grout strength of 40 N/mm² and this was always achieved. The theoretical grout take per holes was made up of 2 (50 kg) bags of cement. The contractor budgeted for a take of 4.5 bags per hole. Figure 7c shows where the volume of cement, during anchorage installation only, lay between 0 and 0.19 m³, 0.19 m³ and 0.38 m³ or exceeded 0.38 m³ (0.38 m³ is equivalent to 10 bags of cement). Figure 7d show the areas of the site where the total grout take lay between 0 and 100%, 100% and 500% or exceeded 500% of he budgeted take of 4.5 bags.

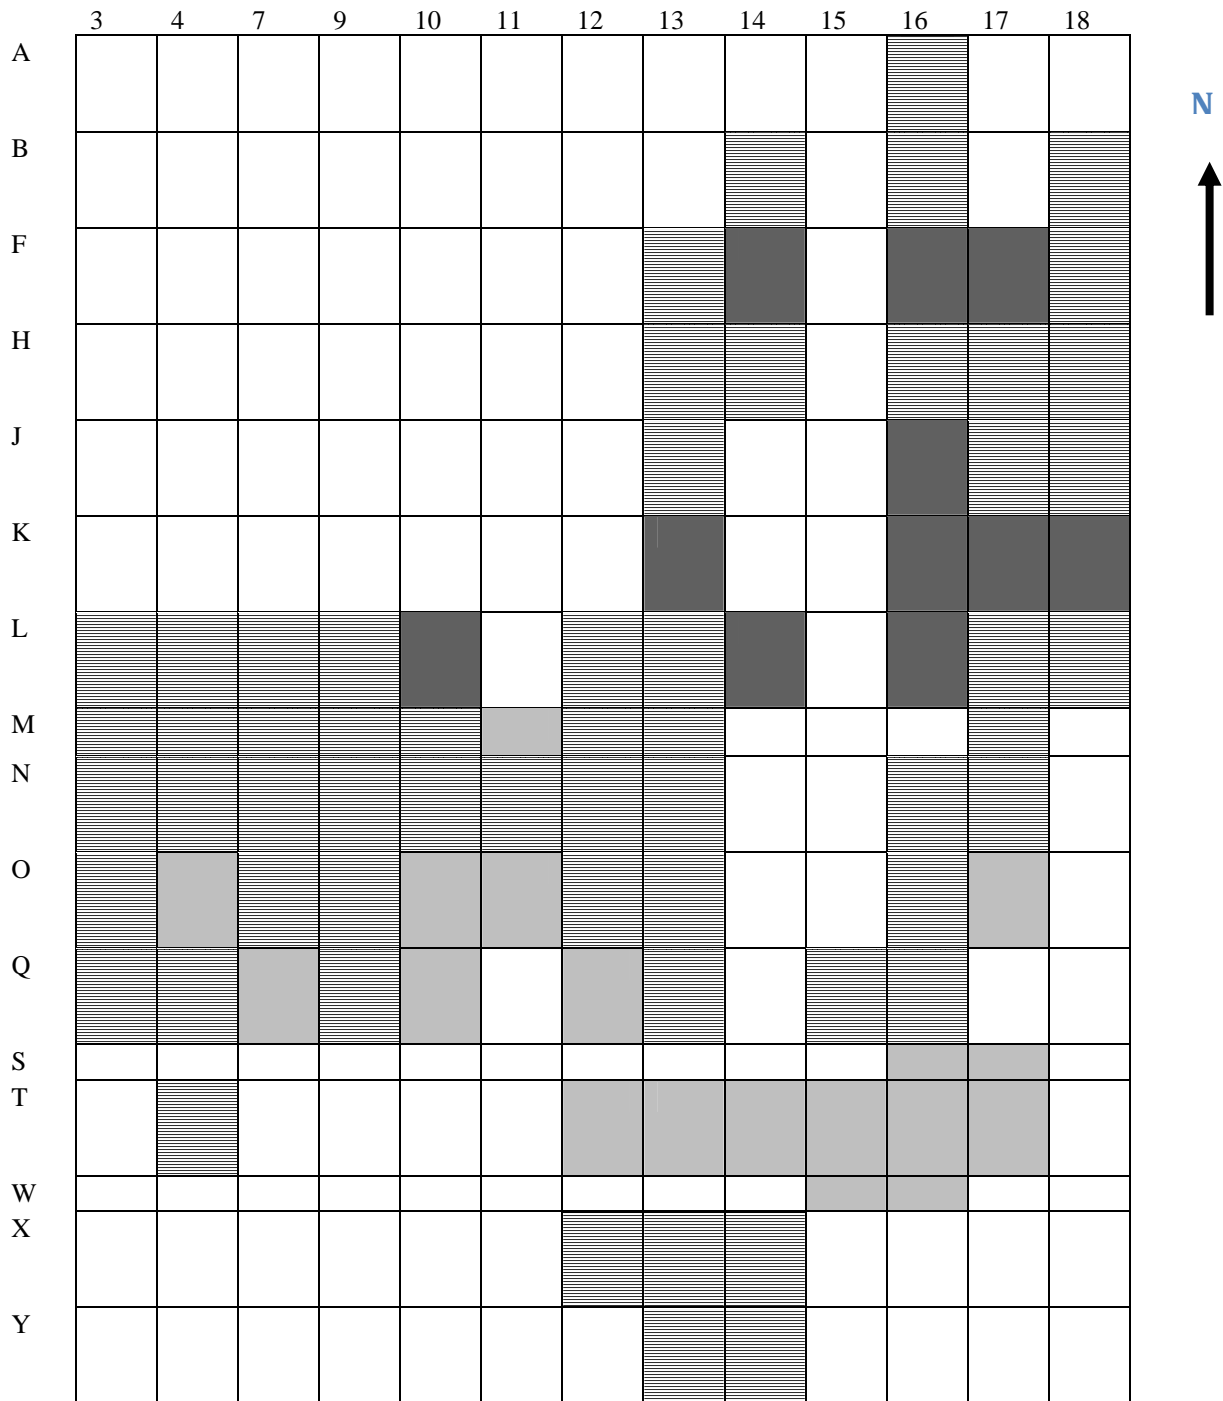
FIG 9d. Total grout takes

In all 6800 bags of cement were used (340 t), compared to the theoretical quantity of 900 bags. Cement take exceeded 10 bags in 136 holes and exceeded 200 bags in several

holes. Again most problems seem to have occurred in the south-west and north-east parts of the site.

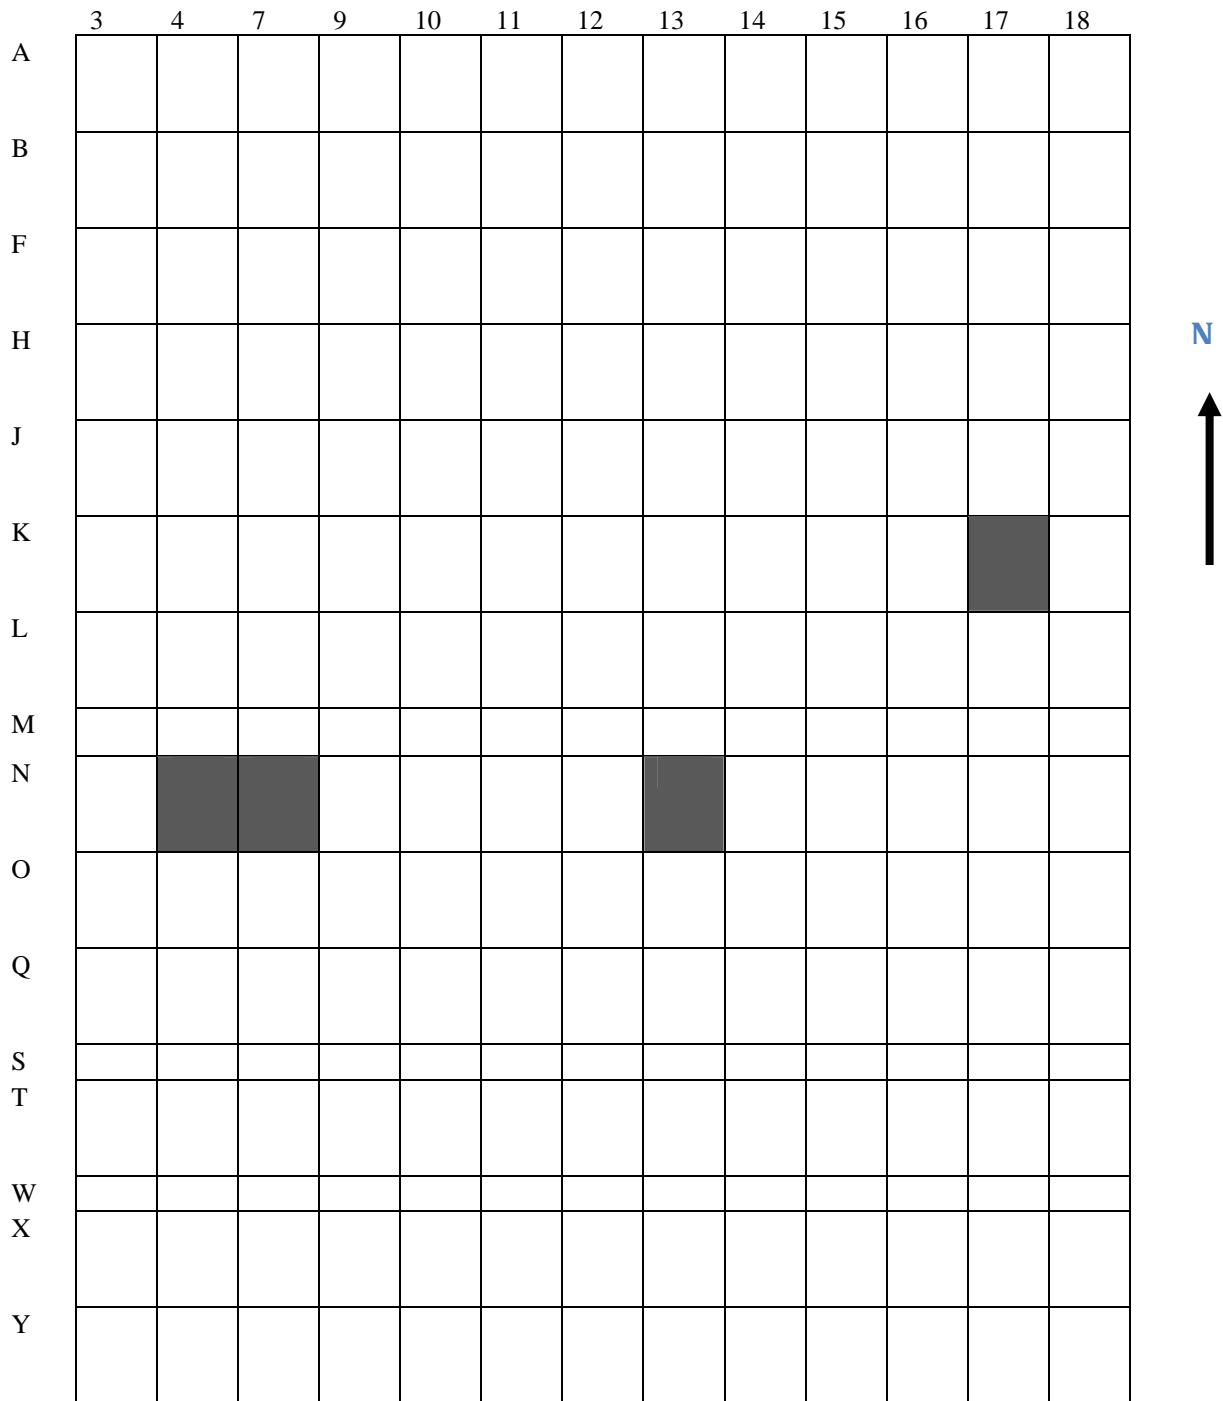
FIG 9e. Location of voids

Voids were encountered in 4 holes as shown on Figure 7e. This included two occasions where the void was encountered in the first drillhole, indicating the voids were pre-existing in the bedrock. These findings were particularly surprising as the Dublin “calp” limestone is regarded as being too argillaceous to permit the development of solution features.

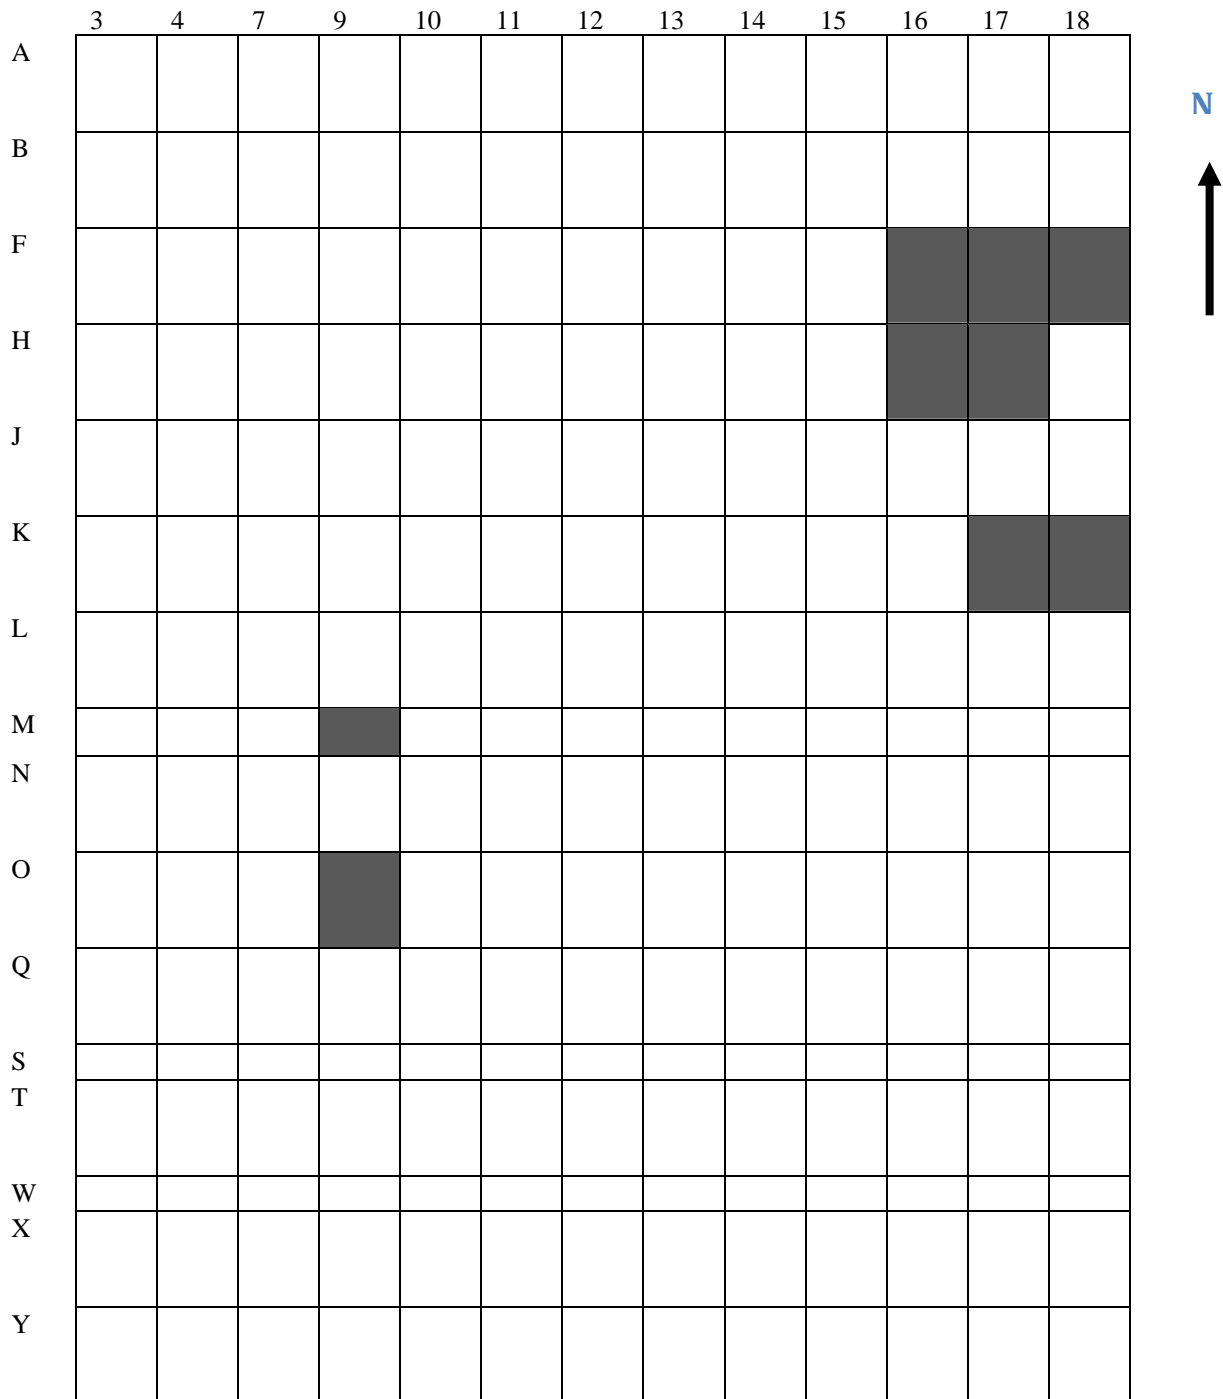
FIG 9f. Location of cobbles and gravels

Rounded gravel size fragments of limestone were encountered in 22 holes, particularly in the lower basement area, see Figure 7f. This is also an unusual occurrence for the Dublin limestone where the fragments are usually angular and platy, and may suggest flowing water conditions exist in these zones.

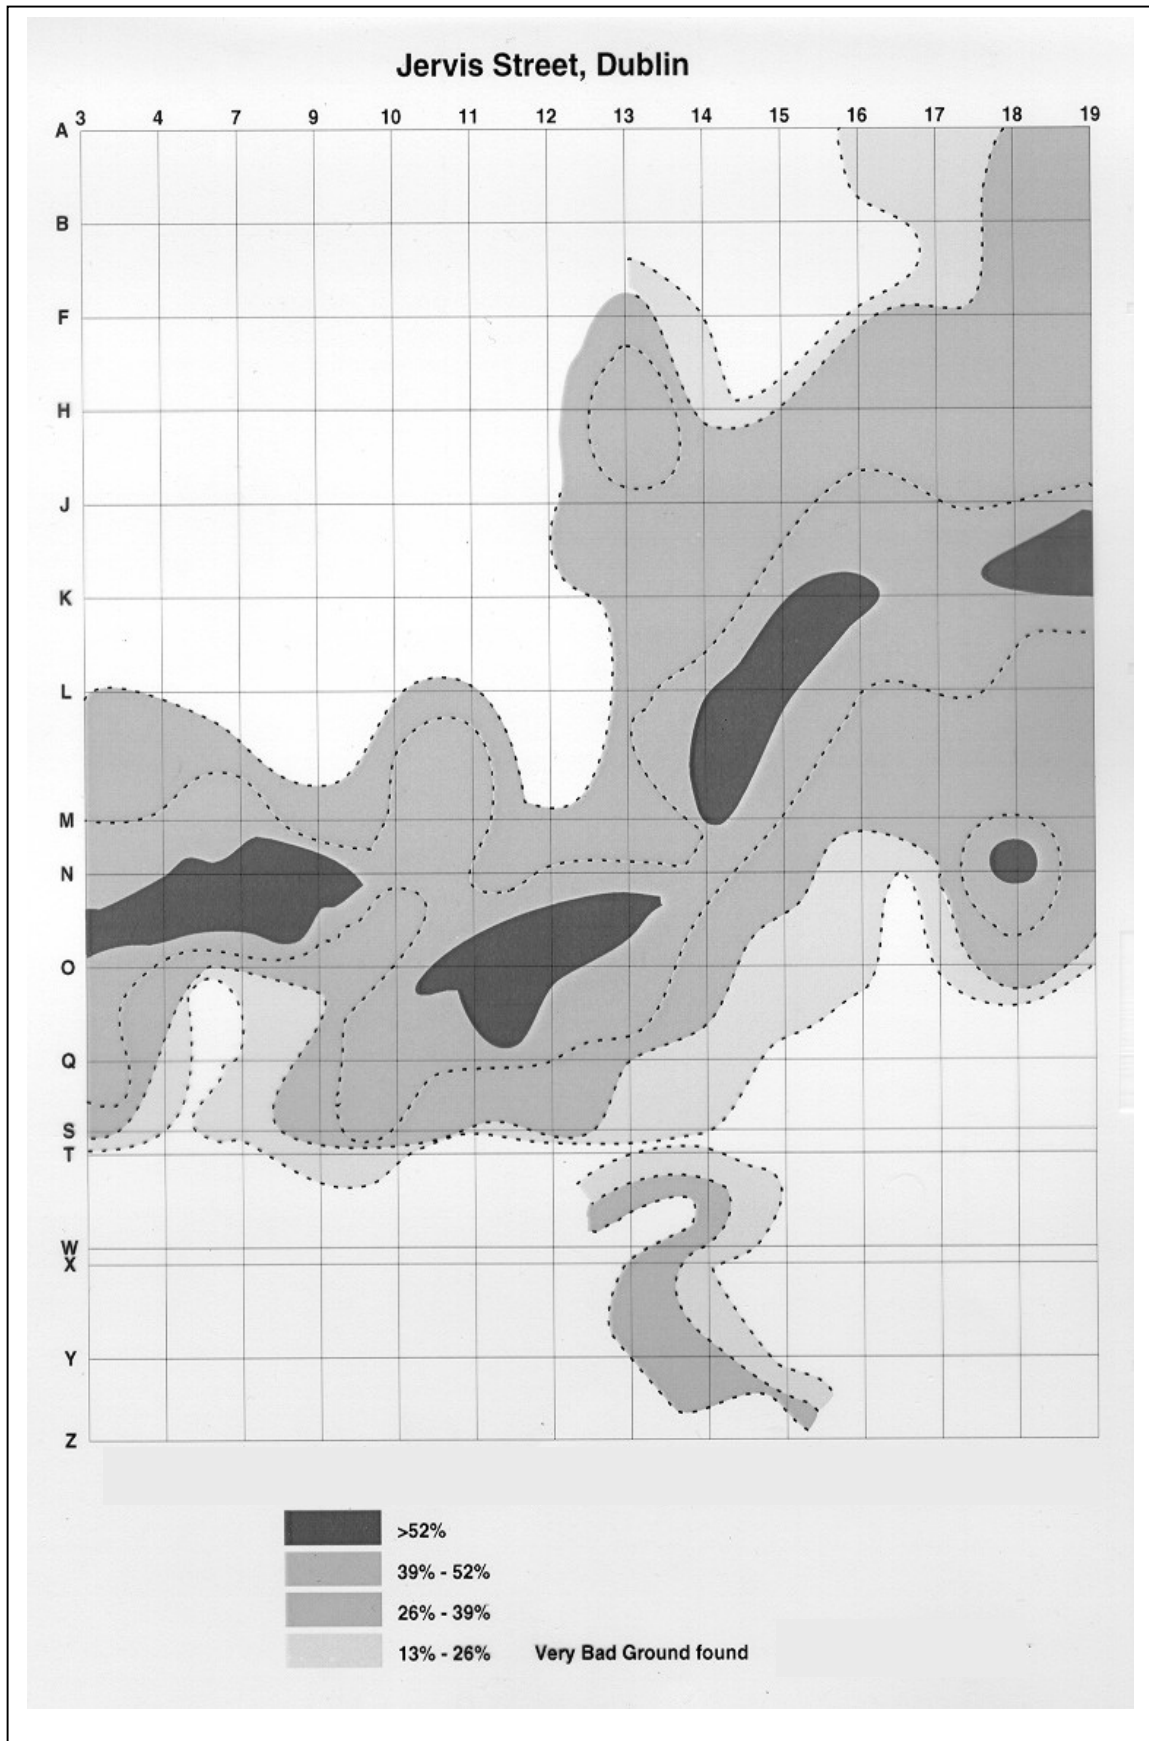
FIG 10. Percentage of very poor ground encountered during drilling

Figure 8 shows the areas of the site where very poor ground was encountered during the drilling process. This information was obtained from the driller’s logs. The figure is sub-divided into those areas where the percentage of very poor ground exceeded 52%, lay between 39% and 52%, between 26% and 39% and was less than 26%.

The orientation of the zone where most of the problems were encountered in the Jervis St. site is south-west to north-east. This is best illustrated on Figures 7a, 7f and 8. It has been previously described how the known faulting in the central Dublin areas follows the same trend. It is also interesting to note that the five sites where known problems with construction in the bedrock have occurred are all located along the River Liffey and are within the pre-glacial buried channel where structural weakness in the bedrock is suspected to exist.
