Downloaded 2026-05-02 00:27:44

The UCD community has made this article openly available. Please share how this access benefits you. Your story matters! (@ucd_oa)

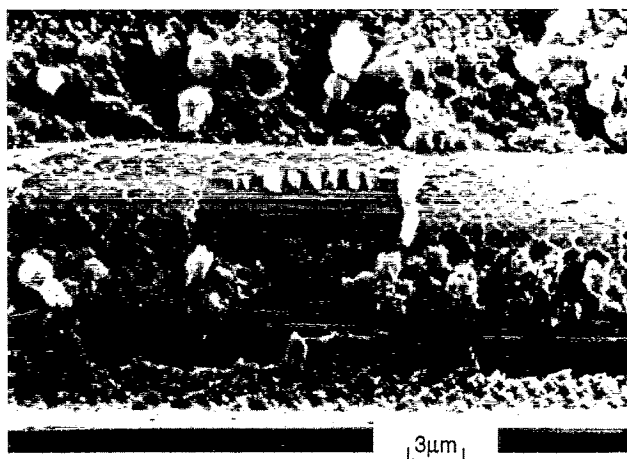
Fig. 1. Microstructure of carbon/epoxy T300/914 shows a thin coating of epoxy matrix adhering to a fibre. Small nodules ($\approx 1 \mu\text{m}$ in diameter) of poly(ether sulphone) are embedded in the bulk epoxy matrix material. (From Lowe²⁶.)

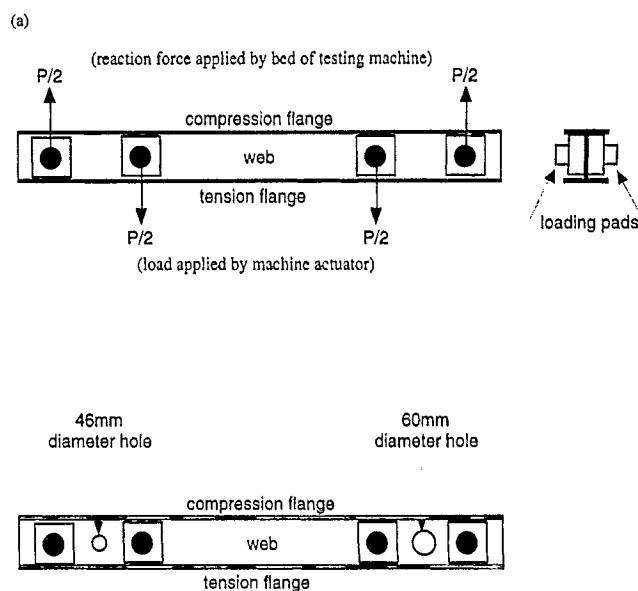
Fig. 3. Schematic representation of the four-point flexure loading arrangement used for static testing of (a) unnotched I-beams and (b) notched I-beams. Static tests have been under a displacement mode of control.

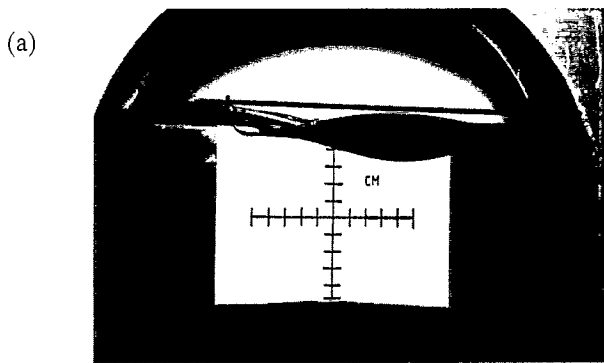
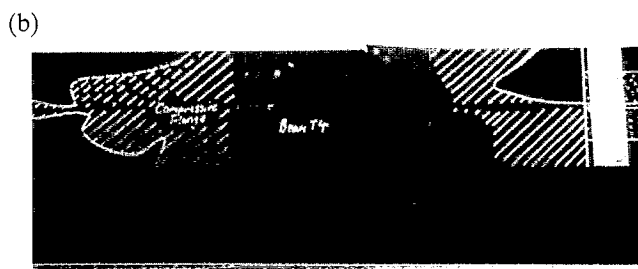
Fig. 4. Unnotched I-beam: (a) side view taken immediately before failure, and (b) plan view taken after failure.

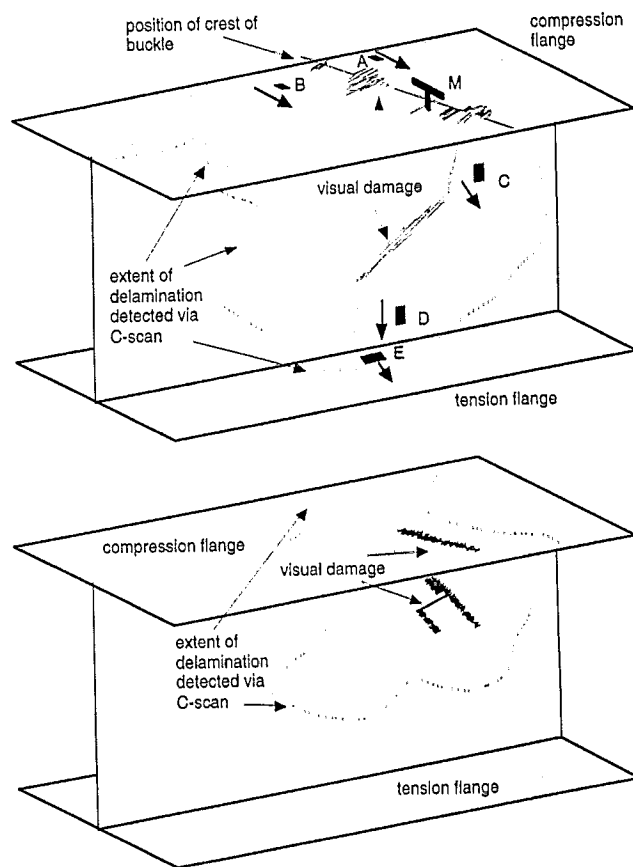
Fig. 5. Schematic representation of the damage, failure sequences, and locations of microscopy sections in (a) the unnotched carbon/epoxy I-beam and (b) the unnotched glass/epoxy I-beam. This region of I-beam is between the central pairs of loading pads; no damage exists outside this region, see Fig. 3(a). The first paper in this series²⁸ provides details of the visual appearance of the general damage. Sections A and B (see Figs 7 and 9) are from the compression flange; section M (see Fig. 10) from the compression flange/web junction; sections C and D (see Figs 12–14) from the web region; and section E (see Fig. 15) from the tension flange. (Total flange width is 75 mm; internal web depth is 119 mm.)

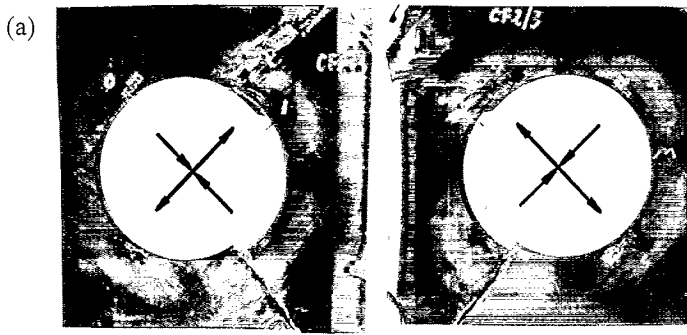
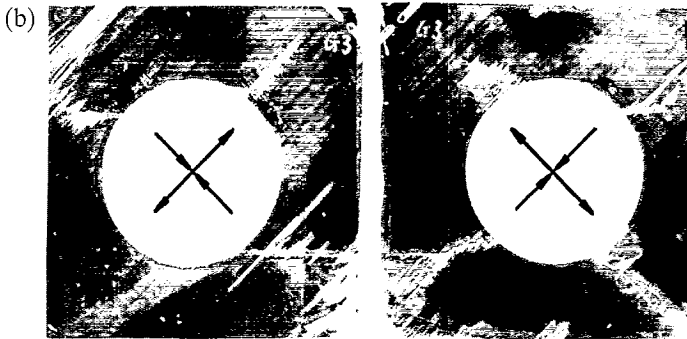
Fig. 6. Visually identified damage around the front and back of shear-loaded web cutouts (60 mm diameter) in (a) the notched carbon/epoxy I-beam and (b) the notched E-glass/epoxy I-beam. In all cases, the compression flange is along the top of the photographs and the tension flange along the bottom. The local directions of resolved tensile and compressive stresses are indicated.

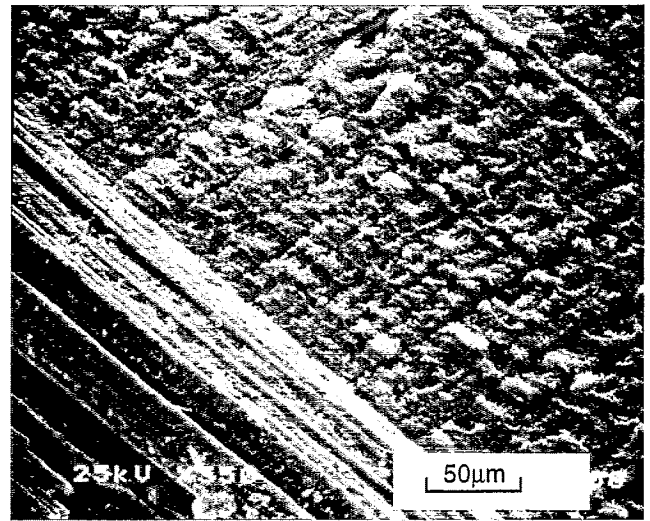
Fig. 7. The fracture surface of section A (see Fig. 5) shows fibre bundle pull-out and some fibre fracture (bottom left-hand corner of micrograph) and flat featureless resin fracture (upper right-hand half of micrograph). The picture was taken close to the edge of the flange where the zone of fibre pull-out changes into the flat featureless zone of resin fracture. This corresponds to a change of mode I to mixed mode fracture. The local growth direction within the micrograph is from left to right; this corresponds to damage propagating from the flange free edge towards the fillet region. (Tilt angle is 45° .)

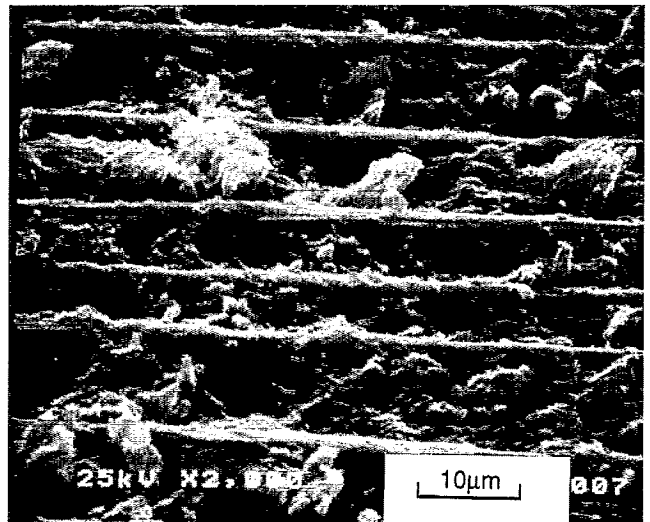
Fig. 8. Evidence of mode II dominated mixed mode fracture which was typically observed on the compression flange away from the flange free edge. Cusps ($\approx 5-10 \mu\text{m}$ in size), oriented at a high angle to the plane of fracture ($\approx 40^\circ$), can be seen spaced between fibres which are relatively clean of matrix material. The local direction of growth within this micrograph is from left to right. This corresponds to a global direction of damage growth that is from the flange edge toward the centre of the flange. (Tilt angle is 65° .)

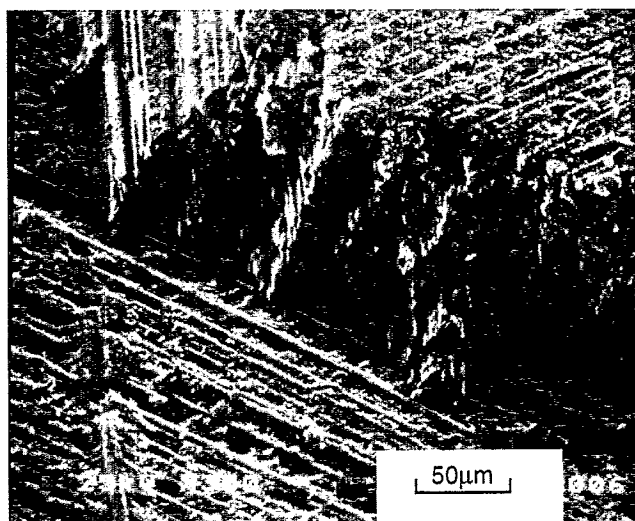
Fig. 9. Fracture surface of section B (see Fig. 5) shows delamination growth which occurred along two different interfaces, i.e. the main crack jumped through a ply. Delamination was through $+45^\circ/0^\circ$ (bottom left-hand corner of micrograph) and $0^\circ/-45^\circ$ (upper right-hand corner of micrograph) ply interfaces. Cusps can be seen on the fracture surface in the top right-hand corner of the micrograph but not clearly at this low magnification. This delamination along two interfaces was accompanied by matrix cracking and fibre fracture of the 0° ply. The local growth direction is from left to right in this micrograph. (Tilt angle is 65° .)

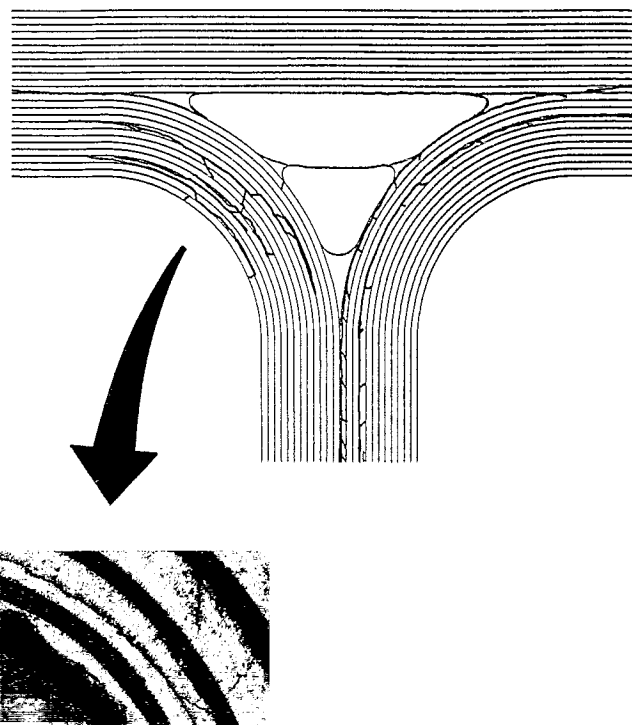
Fig. 10. Schematic representation of damage in the fillet region of the compressive flange of the unnotched carbon/epoxy I-beam (see section M of Fig. 5). Damage consists principally of delamination between the backs of the channel sections and the flange cap and various $0^\circ/45^\circ$ and $+45^\circ/-45^\circ$ ply interfaces. Matrix cracking of plies in the curved fillet region had also occurred (see text). Each ply has a nominal thickness of 0.125 mm.

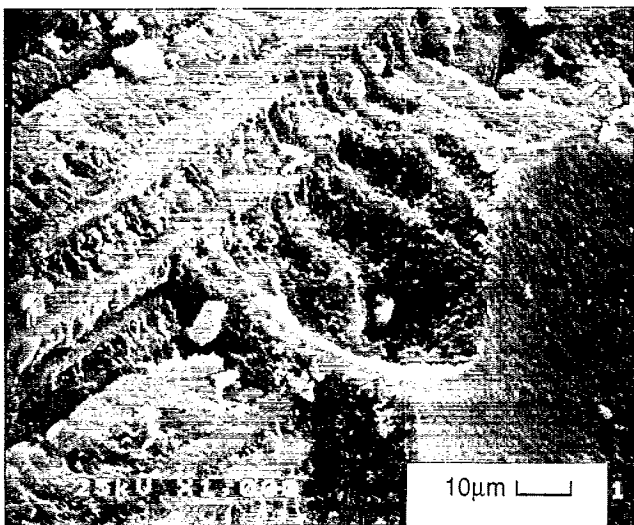
Fig. 11. Zones of resin richness and voids have been seen (bottom right-hand half of micrograph) close to the junction of the compression flange and the web of the carbon/epoxy I-beam. The river markings, seen in the middle area of micrograph, indicate the direction of fracture as being from the fibres of the flange into the resin of the fillet (top left to bottom right). (Tilt angle is 35° .)

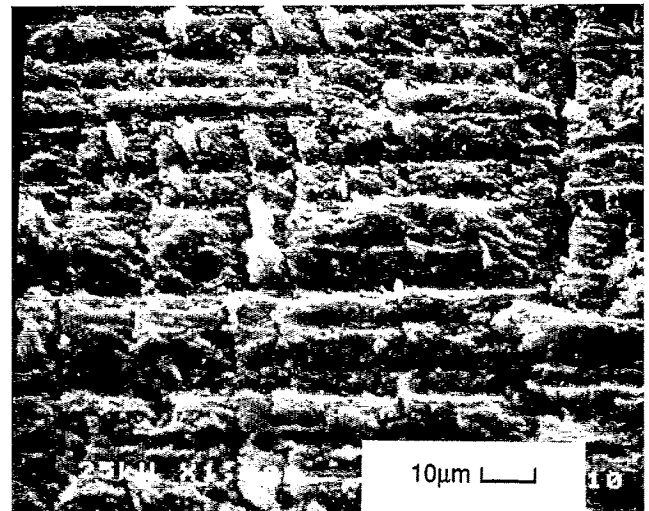
Fig. 12. Resin fracture surface of section C, which is towards the centre of the web of the unnotched carbon/epoxy I-beam (see Fig. 5), is relatively flat. Frequent matrix cracks in the underlying ply (seen typically running top-bottom in the right edge of the micrograph) and some valleys in the matrix (irregularly spaced and oriented left-right in the micrograph) are seen. Small cusps are also present throughout the matrix (at $\approx 45^\circ$ to the fracture plane) and the appearance of this fracture surface corresponds to a mixed mode of failure with approximately equal components of mode I and mode II. (Tilt angle is 55° .)

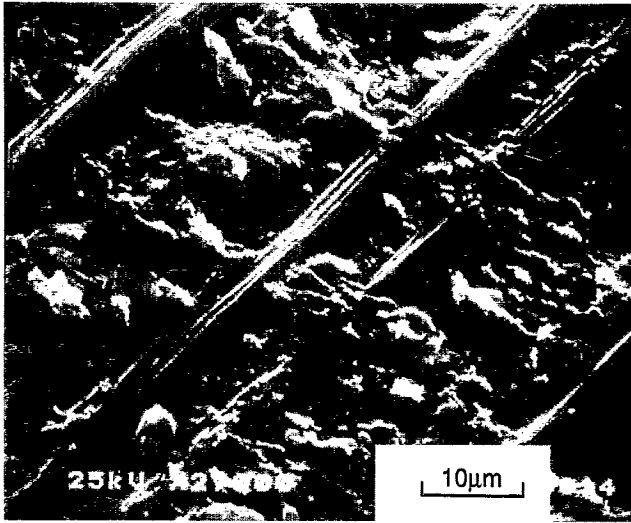
Fig. 13. Section D_I (see Fig. 5), taken from the web region of the unnotched carbon/epoxy I-beam, is the mating surface of section D_{II} (see Fig. 14). Very clean fibres, sparse resin and rough resin fracture between the fibres, and resin cusps oriented at a large angle ($\approx 66^\circ$) to the fracture plane are evident. This suggests a highly mode II dominated fracture. Resin rivers can be seen propagating from a fibre into the resin (indicated by arrow). The fact that this particular fracture surface is sparse of resin implies that the opposite fracture surface (see Fig. 14) should be resin rich with many fibre imprints: this is indeed the case. The local growth direction in the micrograph is from left to right. (Tilt angle is 40° .)

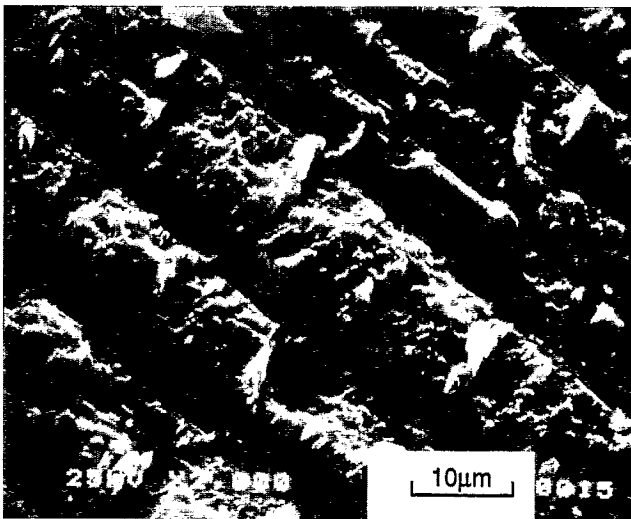
Fig. 14. Section D_{II} (see Fig. 5), taken from the web region of the unnotched carbon/epoxy I-beam, is the mating surface of section D_I (see Fig. 13). The fact that this particular fracture surface is resin rich implies that the opposite fracture surface (see Fig. 13) should be sparse of resin: this is indeed the case. The local growth direction in the micrograph is from left to right. (Tilt angle is 40° .)

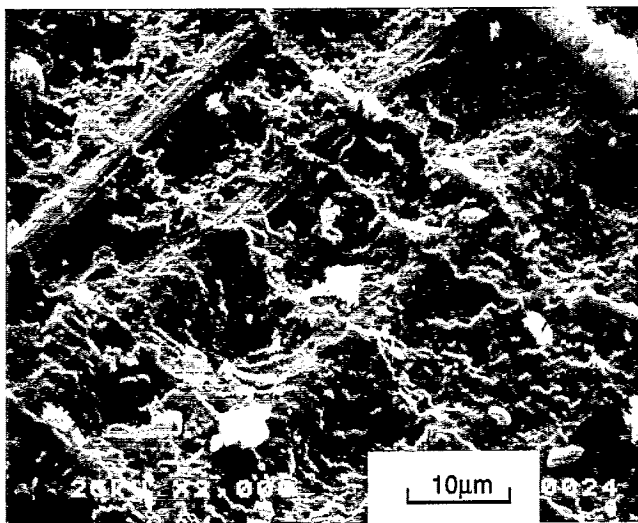
Fig. 15. The morphology of the fracture surface (section E of Fig. 5) of the tensile flange, some distance away from the flange/web junction, is relatively flat, with fibres being clearly coated in resin. This is characteristic of a mixed mode fracture having approximately equal components of mode I and mode II. The local direction of growth is from left to right; this corresponds to growth from the web/flange junction toward the flange free edge. (Tilt angle is 40° .)

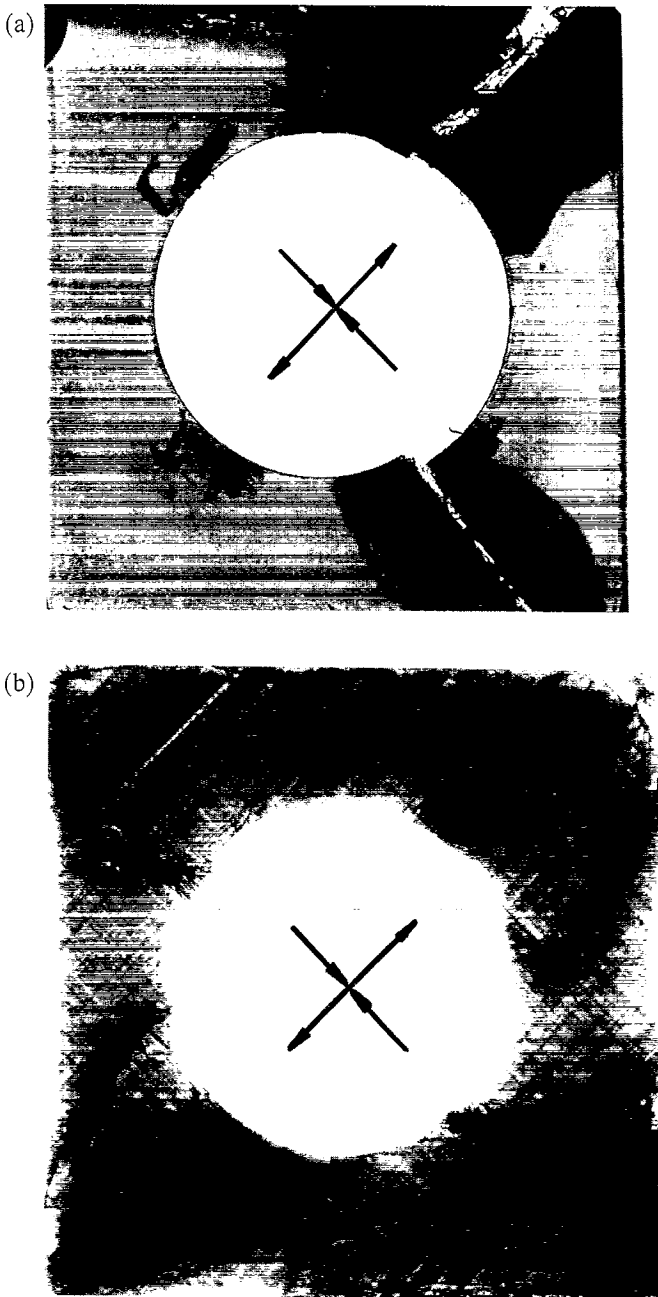
Fig. 16. The damage (delamination, matrix cracking, fibre fracture, splitting, etc.) that was detected around the large cutouts (60 mm diameter) in the web regions of (a) the notched carbon/epoxy I-beam and (b) the notched E-glass/epoxy I-beam using dye-penetrant enhanced X-radiography. In both cases, the compression flange is along the top of the photographs and the tension flange along the bottom. The local directions of resolved tensile and compressive stresses are indicated.

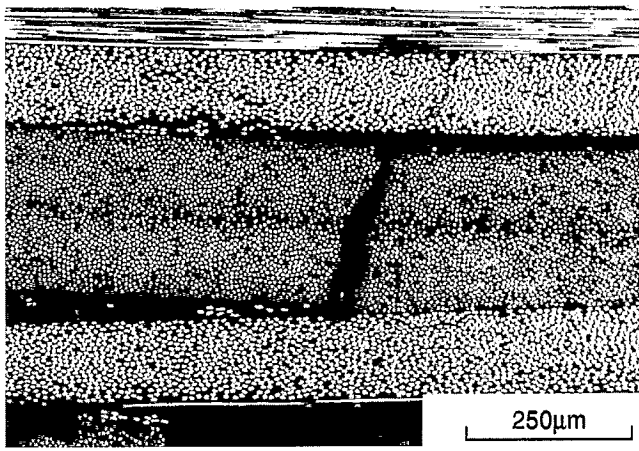
Fig. 17. Optical micrograph of the through-thickness damage typically identified ahead of the large web cutout (60 mm diameter). A single continuous matrix crack is present in two local $90^\circ/90^\circ$ plies (global $-45^\circ/-45^\circ$ plies) subjected to local tensile stresses. This matrix crack joins delaminations that are present along two $45^\circ/90^\circ$ interfaces. Some matrix cracking is also evident in the 45° plies. Each ply has a nominal thickness of 0.125 mm.

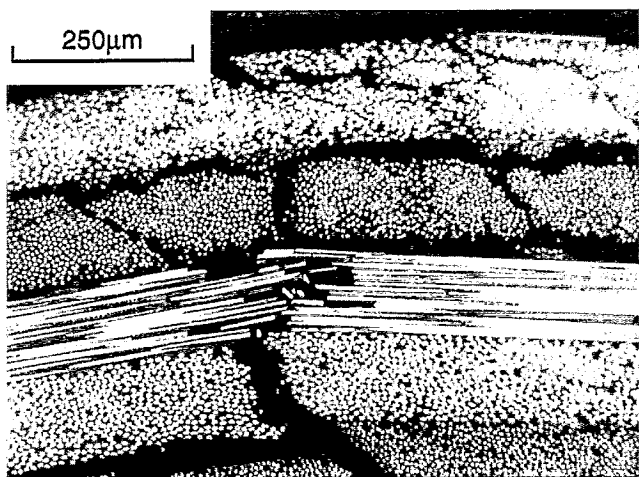
Fig. 18. Optical micrograph of the through thickness damage typically identified ahead of the large web cutout (60 mm diameter). Fibre fracture of a local 0° ply (global 45° ply) is evident, together with delamination along local $45^\circ/90^\circ$ and $0^\circ/90^\circ$ interfaces, and matrix cracking and intraply cracking of local 90° and 45° plies. These plies are subjected to local tensile stresses. Each ply has a nominal thickness of 0.125 mm.
