# Dewatering Induced Settlement of a Historic Landmark

**ABSTRACT:** Construction related dewatering in urban areas often induces damage of existing structures. The following forensic investigation highlights the complexities of such a phenomenon. Somerset plantation, a national historic landmark located in northeastern North Carolina is currently exhibiting distress. At many locations, these wooden structures on brick piers are experiencing sufficient differential settlement to impact building functionality. Heavy visitor traffic was proposed by the site staff as the cause of the building displacements. Given a perched aquifer located within a fatty clay, dewatering based settlement was suspected. Two potential sources of ground water change were investigated – (1) general drought conditions or (2) a nearby mining operation.

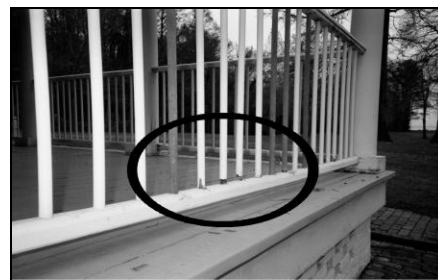
Further investigation revealed shearing of porch rails and cracks in brick piers (Figure 3).

Figure 3. Porch Rails (November 2001)

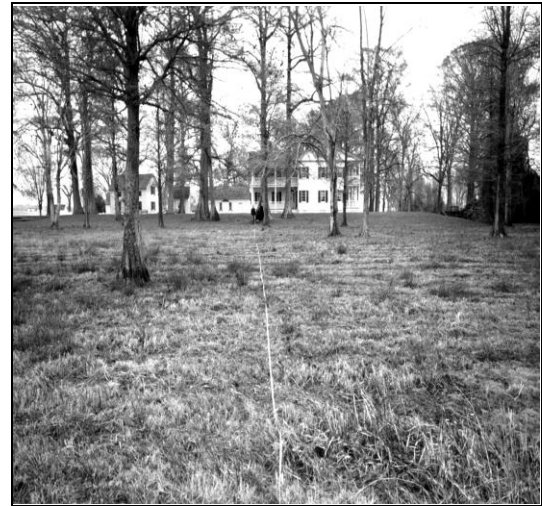
Through the middle of the 20<sup>th</sup> century, the water line came within 50 feet of the buildings at high water line, but now the lake lies 560 feet beyond the main house (Figures 4 and 5). The direction of settlement was clearly in the southern direction, towards Lake Phelps. The preliminary analysis implied a drought related

Figure 5. Collins house from current lake level (November 2001)

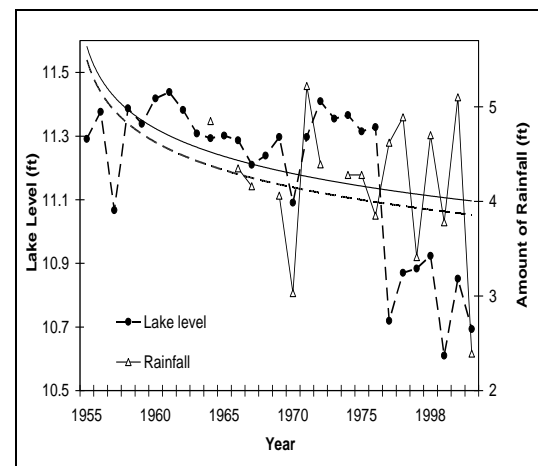
Figure 6. Yearly average of rainfall and lake levels 1955-2001 (adapted from DPR, 1993-2001 and DOA, 1977a,b)

Beginning around 1975, a disparity began to be evident. The lake began to drop faster than the rain levels. If the dewatering was strictly drought related, a more symmetric behavior would be anticipated. Thus, an additional cause of water loss was sought. To this end the soil configuration was investigated.

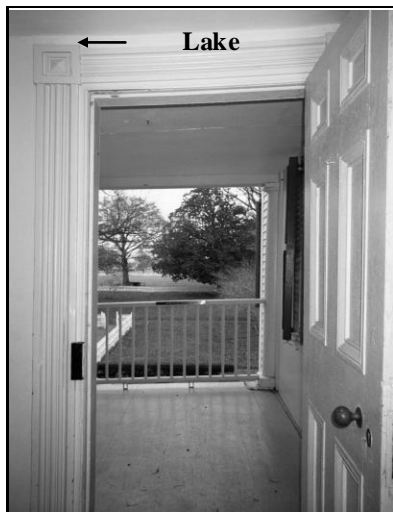
As part of an investigation into the new deformation, measurements were taken in the doorways and windowsills on all three floors of the main dwelling. Distortions and displacements in doors, doorframes, and windows were measured with a tape measure, a plumb bob, and a level. Localized displacement was considered over the width of each specific frame. On the first floor, the doorways exhibited a racking (or localized deformation) of up to 1 to 3 inches across a 2 foot width along the top of the doorways (Figures 8 and 9), with generally more deformation in east-west diagonals. The windows showed less deformation but still sloped in the same direction as the doorways (towards the lake). Doors and windows measured on the second floor showed similar results. These deformations were opposite to the differential heights in the groundwater table previously recorded, which would indicate a change in the direction of the groundwater table draw down.

Figure 8. Second floor doorway in November 2001

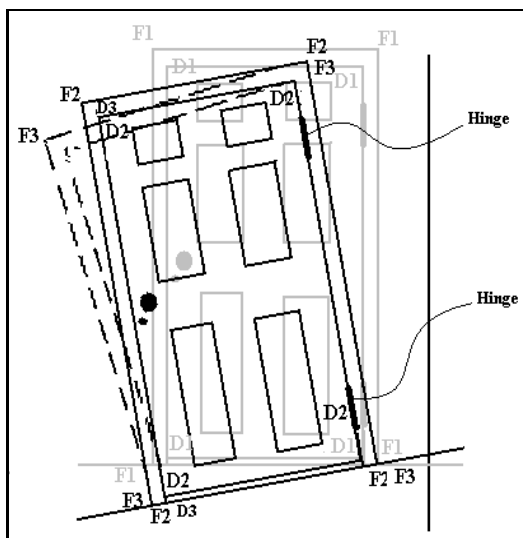
Figure 9. Displacement measurements, F3 shows racking in door causing D3 to stick (November 2001)

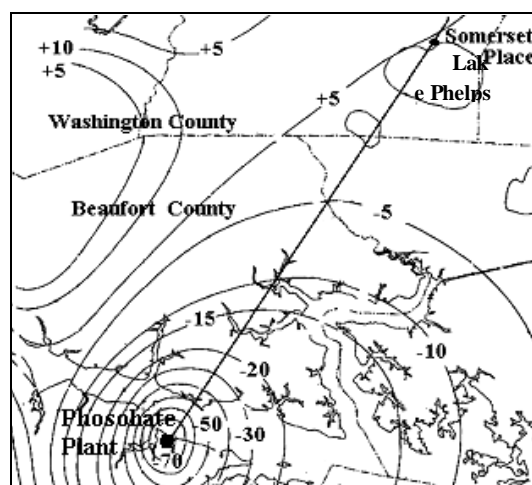
In 1965 a mining operation opened near Aurora, North Carolina, south of Somerset Place (Figures 10 and 11). Initial permitting information projected a cone of depression causing measurable draw downs over a large area (Figure 12), and preliminary data collection showed an increasing zone over which the draw down occurred (Peek, 1975a-f).

Figure 12. Castle Hayne aquifer Surface in Jan. 1975 approximately 35 miles (adapted from Peek, 1975c)

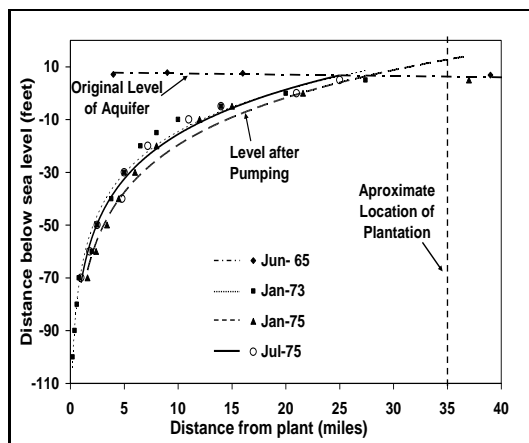
After industrial pumping began at the mine, the hydraulic head of the aquifer was lowered, which caused the formation of cones of depression in the potentiometric surface, resulting in a change of water flow toward the inland pumping centers. This could account for the reversal of the direction of water flow at Somerset Place towards the south, as evidenced by the direction of settlement. From the time the mine opened in 1965 until 1973, the predicted draw down of groundwater at Somerset, located approximately 35 miles from the plant, was in the range of 8.5 inches (Figure 13). To discover if the mining operation was indeed the cause of the troubles at Somerset, the rate of draw down was back calculated to determine the level of changes in the groundwater table needed to induce sufficient primary consolidation in the silt to gene-

rate significant structural movement. The new rate of groundwater change at the plantation was calculated at 0.31 ft/yr, compared with previous rates of 0.87 ft/yr from 1965 to 1975 and 1.9 ft/yr from 1973 to 1975, (Peek, 1975a-f). This amount far exceeds drought related forces, signifying that the mining operation is most likely the cause of dewatering. Confirmation of the analysis will be made through well installation and monitoring over the next few years.

Figure 13. Potentiometric surface of the Castle Hayne Aquifer (adapted from Peek, 1975b-e)
