Dewatering Induced Settlement of a Historic Landmark

ABSTRACT: Construction related dewatering in urban areas often induces damage of existing structures. The following forensic investigation highlights the complexities of such a phenomenon. Somerset plantation, a national historic landmark located in northeastern North Carolina is currently exhibiting distress. At many locations, these wooden structures on brick piers are experiencing sufficient differential settlement to impact building functionality. Heavy visitor traffic was proposed by the site staff as the cause of the building displacements. Given a perched aquifer located within a fatty clay, dewatering based settlement was suspected. Two potential sources of ground water change were investigated – (1) general drought conditions or (2) a nearby mining operation.

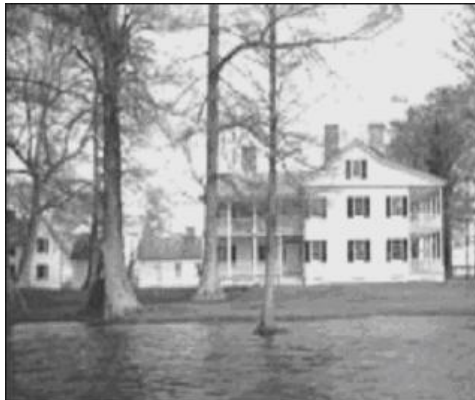
By 2001 the main structure (the Collin's House) at Somerset Place, the largest extent plantation in North Carolina, was exhibiting sufficient deformation of the doors and windows to interfere with the functionality of the building, resulting in safety and maintenance concerns (Figures 1 and 2).

Figure 1. Collins House from Lake Phelps (adapted from NCOAH, 2003b)

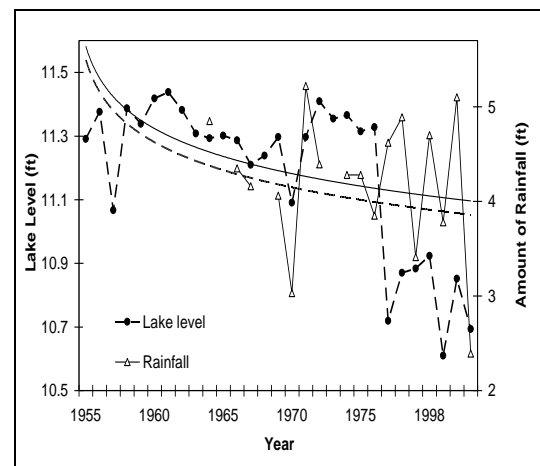
Figure 6. Yearly average of rainfall and lake levels 1955-2001 (adapted from DPR, 1993-2001 and DOA, 1977a,b)

Beginning around 1975, a disparity began to be evident. The lake began to drop faster than the rain levels. If the dewatering was strictly drought related, a more symmetric behavior would be anticipated. Thus, an additional cause of water loss was sought. To this end the soil configuration was investigated.

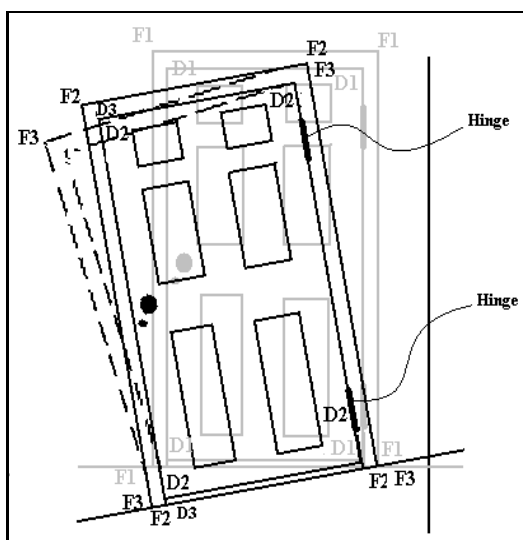
Figure 9. Displacement measurements, F3 shows racking in door causing D3 to stick (November 2001)

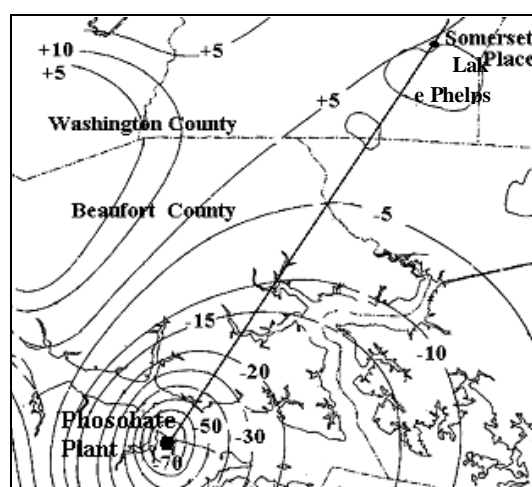
In 1965 a mining operation opened near Aurora, North Carolina, south of Somerset Place (Figures 10 and 11). Initial permitting information projected a cone of depression causing measurable draw downs over a large area (Figure 12), and preliminary data collection showed an increasing zone over which the draw down occurred (Peek, 1975a-f).

Figure 12. Castle Hayne aquifer Surface in Jan. 1975 approximately 35 miles (adapted from Peek, 1975c)

After industrial pumping began at the mine, the hydraulic head of the aquifer was lowered, which caused the formation of cones of depression in the potentiometric surface, resulting in a change of water flow toward the inland pumping centers. This could account for the reversal of the direction of water flow at Somerset Place towards the south, as evidenced by the direction of settlement. From the time the mine opened in 1965 until 1973, the predicted draw down of groundwater at Somerset, located approximately 35 miles from the plant, was in the range of 8.5 inches (Figure 13). To discover if the mining operation was indeed the cause of the troubles at Somerset, the rate of draw down was back calculated to determine the level of changes in the groundwater table needed to induce sufficient primary consolidation in the silt to gene-
