A FRACTOGRAPHIC ANALYSIS OF DELAMINATION WITHIN MULTIDIRECTIONAL CARBON/EPOXY LAMINATES

M. D. Gilchrist^a & N. Svensson^b

Abstract

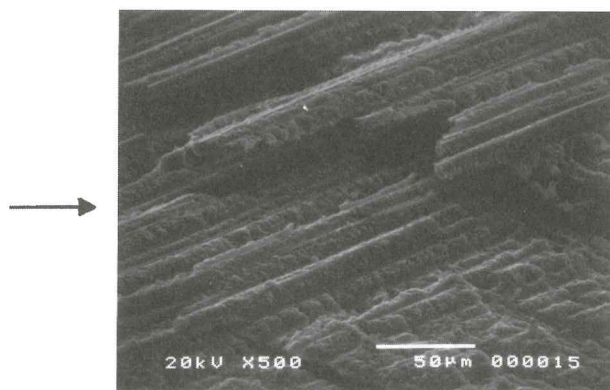
Fig. 1. Extensive fibre pull-out in mode I static fracture. The fibres are covered with resin. Cracks can be seen extending to the underlying ply (tilt angle is 70°). The globally induced direction of crack propagation is from left to right as shown by arrow.

in Fig. 1 is greater than that observed in unidirectional laminates; this degree of pull-out is peculiar to multidirectional laminates with delamination along a $+45^\circ/-45^\circ$ interface. The fracture energy associated with such a delamination is also greater than that of a $0^\circ/0^\circ$ interface. This higher fracture energy can be explained by considering the greater number of cracks that are generated in the laminate: cracks can be seen extending into the underlying plies in Figs 1 and 2.

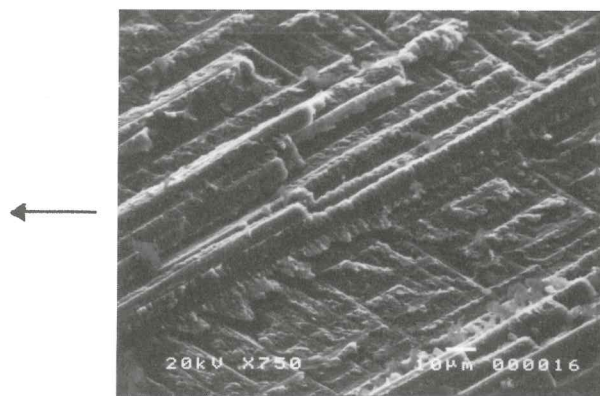
In the present work on the T300/914 system, fibre pull-out was the dominant feature of the mode I fracture surface and this consisted mainly of fibre bundles rather than single fibres. The fibres were covered with a layer of resin indicating a strong interface (Fig. 1), whilst the resin itself was mainly featureless (Fig. 2). The extensive fibre pull-out shown

Fig. 2. Fibre pull-out with a lot of resin on the fibres and featureless resin fracture away from the fibres are characteristics for a mode I static failure (tilt angle is 75°). The globally induced direction of crack propagation is from right to left as shown by arrow.

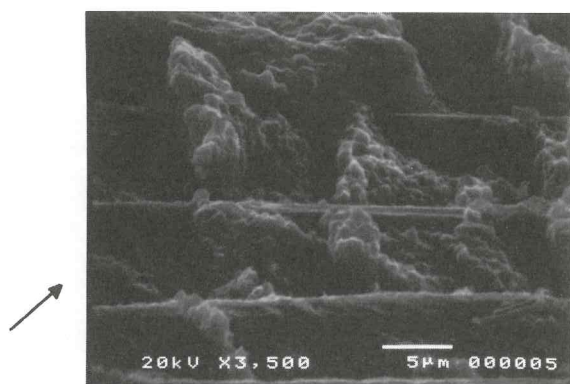
Fig. 3. Cusps standing at a large angle to the plane of a mode II static fracture surface. The cusps are present between the fibres (tilt angle is 75°). The globally induced direction of crack propagation is from bottom left to top right as shown by arrow.

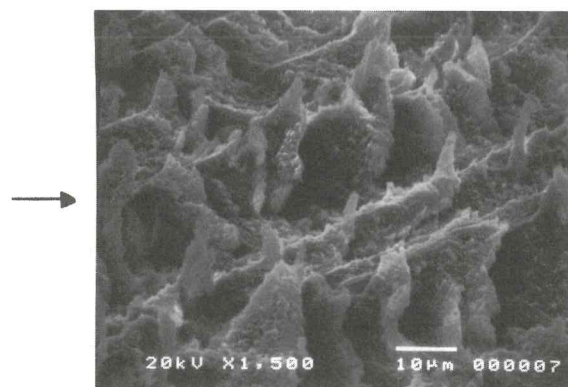
Fig. 4. Many upright cusps are visible and appear to stand on the underlying fibres on this mode II static fracture surface (tilt angle is 65°). The globally induced direction of crack propagation is from left to right as shown by arrow.

Several matrix features have shown a preference to form at the fibres of the underlying ply, as shown typically in Fig. 4. No similar observations have been found in the literature. This may be caused by failures very close to the boundary of the interlaminar resin region or by stress concentrations induced by the fibres. The phenomenon is probably dependent on the orientation of the fibres in the adjacent plies since a smoother fracture surface was seen at delaminations which did not occur along a cross-ply interface.⁴⁸ If

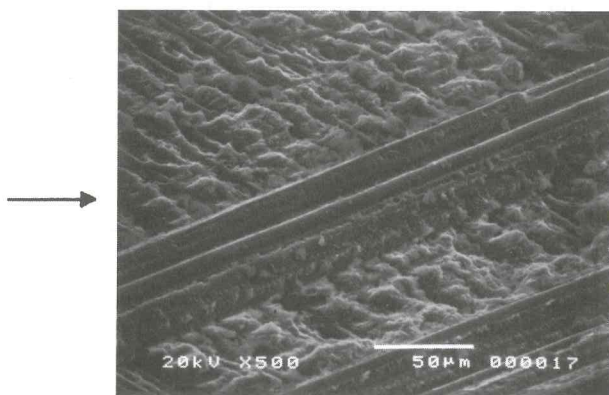
Fig. 5. The mixed mode I:II = 6:1 static fracture surface with featureless resin and fibre pull-out. The general appearance of this fracture surface is similar to that of a pure mode II surface, as shown in Fig. 2 (tilt angle is 65°). The globally induced direction of crack propagation is from left to right as shown by arrow.

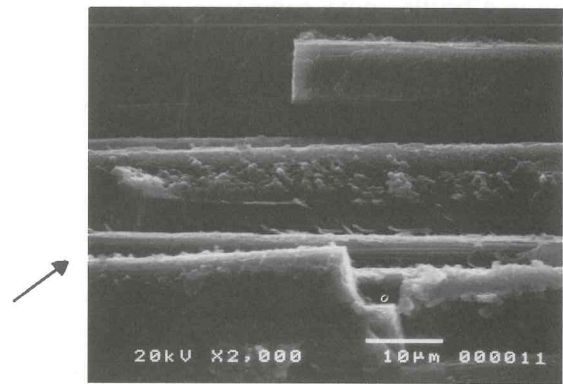
Fig. 6. Fractured fibres covered with a thin layer of resin. Minute cusps on a fibre are indicated by the arrow. Very sharp fibre fractures indicate good interfacial strength. Mixed mode I:II = 4:3 static fracture (tilt angle is 15°). The globally induced direction of crack propagation is from bottom left to top right as shown by arrow.

Evidence has been found for the stress distribution proposed by Bascom *et al.*²⁴ around the fibres loaded in peel. Figure 7 shows resin flanges on a pulled-out fibre. In Fig. 6 minute cusps are seen (indicated by the arrows) as a result of the localised shear stresses present in the fibre/matrix separation process. This occurs around a fibre where the radial stress changes from tensile to compressive, causing local shear yielding to be induced in the matrix. This failure of the matrix material due to local shear yielding leaves flanges of resin on the edges of the fibres as they are peeled out.²⁴

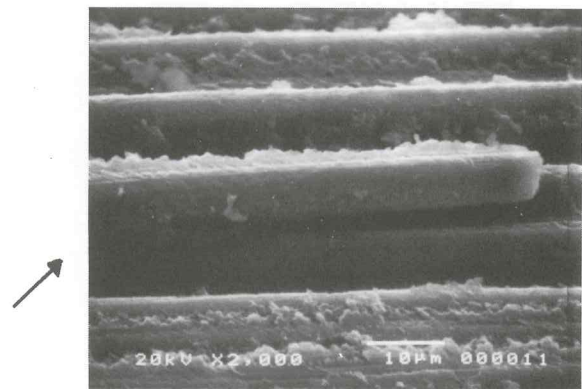
Fig. 7. A pulled-out fibre with resin flanges (similar to those cusps indicated in Fig. 6) found on a mixed mode I:II = 4:3 static fracture surface (tilt angle is 75°). The globally induced direction of crack propagation is from bottom left to top right as shown by arrow.

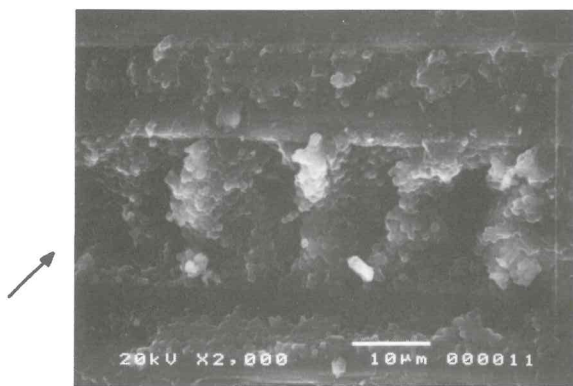
Fig. 8. Cusps as observed at a low tilt angle. A few resin nodules can be seen and the resin structure is quite clear. Mixed mode I:II = 4:3 static fracture (tilt angle is 15°). The globally induced direction of crack propagation is from bottom left to top right as shown by arrow.

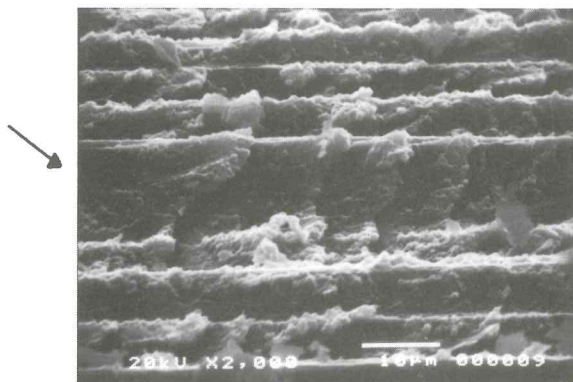
Fig. 9. Relatively well defined cusps from a mixed mode I:II = 4:3 static fracture. The cusps are present between the fibres (tilt angle is 70°). The globally induced direction of crack propagation is from top left to bottom right as shown by arrow.

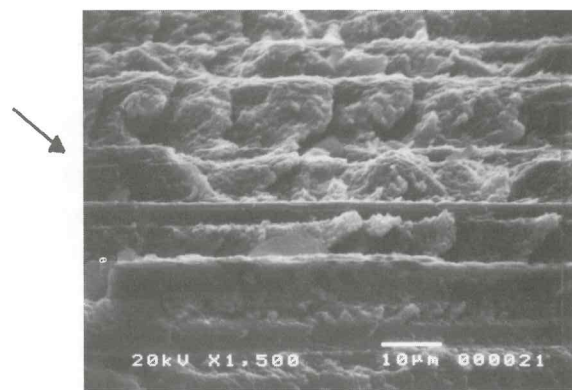
Fig. 10. Cusps on a mixed mode I:II = 3:4 static fracture surface. The cusps are present between the fibres (tilt angle is 70°). The globally induced direction of crack propagation is from top left to bottom right as shown by arrow.

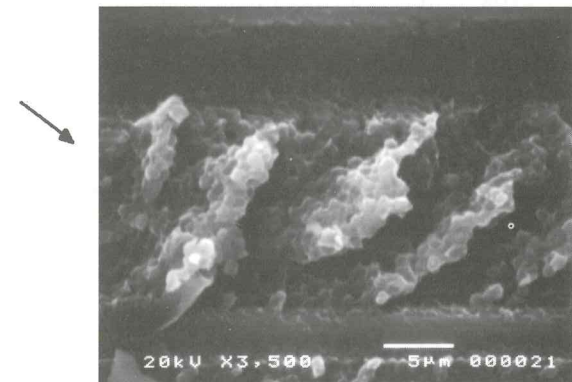
Fig. 11. Cusps oriented perpendicular to the fracture direction as observed at a low tilt angle. Mixed mode I:II = 3:4 static fracture (tilt angle is 10°). The globally induced direction of crack propagation is from top left to bottom right as shown by arrow.

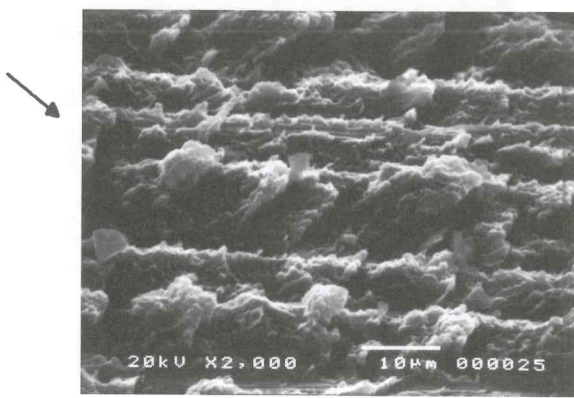
Fig. 12. Cusps which are oriented perpendicular to the crack direction and are standing more upright than on other mixed mode fracture surfaces. Mixed mode I:II = 3:10 static fracture (tilt angle is 65°). The globally induced direction of crack propagation is from top left to bottom right as shown by arrow.
