Impact fatigue fracture of polycrystalline diamond compact (PDC) cutters and the effect of microstructure.

Kanyanta, V., Dormer, A., Murphy, N, Ivankovic, A.

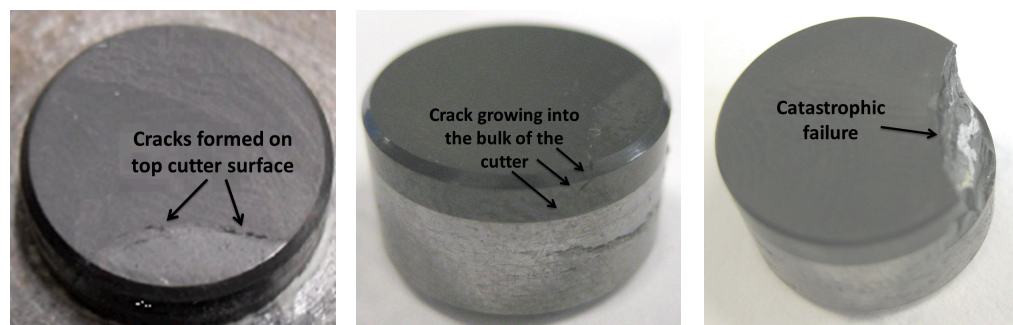
Figure 5: Failure of the PDC cutter under cyclic impact loading, showing the (a) initial stage, (b) intermediate stage where the crack has extended by more than 2mm into the diamond layer thickness and (c) final stage (catastrophic failure).

Three stages of cutter failure were identified, i.e. first visible surface crack (FVSC), crack growth through the polycrystalline diamond layer (CG-PCD) and catastrophic failure (CF). Here catastrophic failure is defined as extensive cracking and large-scale chipping or gloss fracturing. During application, a cutter will continue cutting until catastrophic failure occurs. The first two criteria (i.e. FVSC and CG-PCD) are relatively more difficult to quantify as they are based on visual inspection of the cutter. As a consequence, the test was stopped at set intervals and the cutter surface inspected for surface cracks and the extent of crack growth in the polycrystalline diamond layer. FVSC is the first appearance of a visible crack at the top surface of the cutter and CG-PCD is when the crack extends to more than 2mm

into the polycrystalline diamond layer thickness. Figure 5 shows examples of the three failure criteria used, i.e. FVSC (Figure 5(a)), CG-PCD (Figure 5(b)) and CF (Figure 5(c)).
