Selective demolition of masonry unit walls with a soundless chemical demolition agent

Atteyeh S. Natanzi, Ph.D. ^a, Debra F. Laefer, Ph.D. ^{b*}, S.M. Iman Zolanvari, Ph.D. ^c

A Soundless Chemical Demolition Agent was applied for selective demolition to unit masonry [2 full-scale concrete brick walls in Type N mortar and 2 wallettes in lime mortar – 1 historic brick and 1 concrete brick]. Typically, cracking began shortly after 9 hours and ultimately produced an average crack length of 418mm per hole and an average maximum 5.22mm crack width. Samples in Type-N mortar exhibited slower but significantly more cracks and wider cracking. Ninety-three percent of cracking occurred within 4 days. No masonry units were damaged and partial demolition was successful, although selective unit removal was not due to confinement.

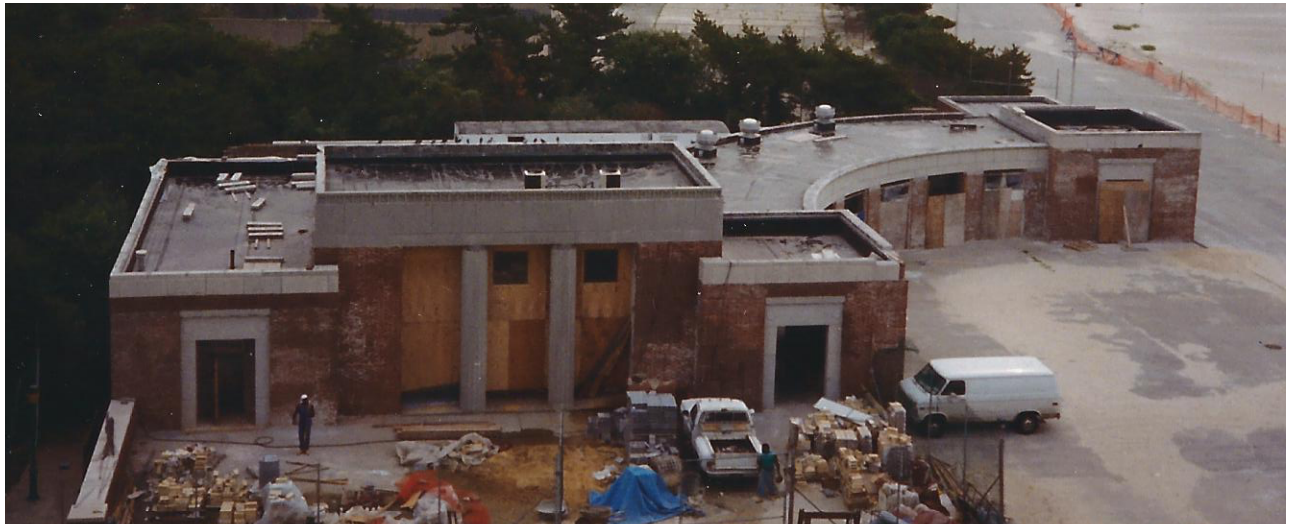
Fig. 1. Half of Jacob Riis Bathhouse Used as a Source for Masonry Unit Reclamation for a Full Restoration of the Mirrored, Counterpart Structure further up the Beach.

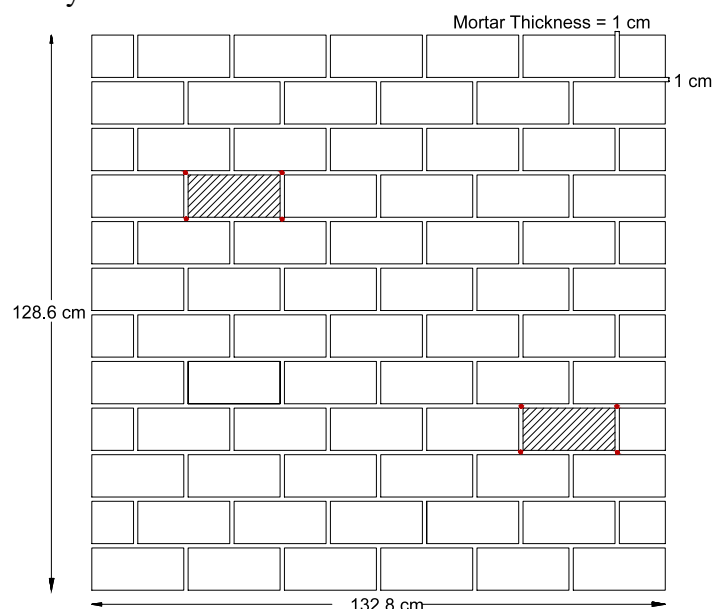
Fig. 4. Schematic of specimens and testing arrangements with thermocouple locations for temperature monitoring in the SCDA labelled with T, other SCDA locations shown in red, and units selected for removal shown as hashed

In the larger specimens (1 and 2), the materials were identical, but the hole layout and demolition objectives differed. Specifically, Specimen 1 (Fig. 4a) was constructed with 8 holes: 1 at each corner of the two selected bricks to attempt selective removal of a masonry unit in the upper and lower portions of a wall. The two locations were selected to explore the relative influence of confinement. In contrast, Specimen 2 (Fig. 4b) was constructed with 22 holes organized along 2 diagonals, as per the typical cracking patterns that occur in masonry walls under differential settlement. This layout was chosen to investigate the partial demolition of a masonry wall. The wallettes (Specimens 3 and 4) (Fig. 4c) were identical to each other in hole layout with 4 holes around the center masonry unit but differed in their material composition with Specimen 3 of concrete bricks and Specimen 4 of historic clay bricks.

After a minimum of 28 days of curing, the pre-specified 5mm diameter holes were drilled into the mortar joints according to the patterns shown in Fig. 4 with red dots. In contrast to previous, cast-in-place efforts (Natanzi et al. 2016b), this approach was a deliberate effort to begin to develop a viable field procedure for the application of SCDA to vertical unit masonry walls. In the testing herein, the holes were cleaned with compressed air and then filled with Bristar 150, which, according to the manufacturer, is designed for temperatures up to 20°C. The Bristar was mixed according to the manufacturer’s recommendations (tap water at 15°C; 30% by weight). The SCDA was injected under light hand pressure using a syringe with a 5mm diameter opening.

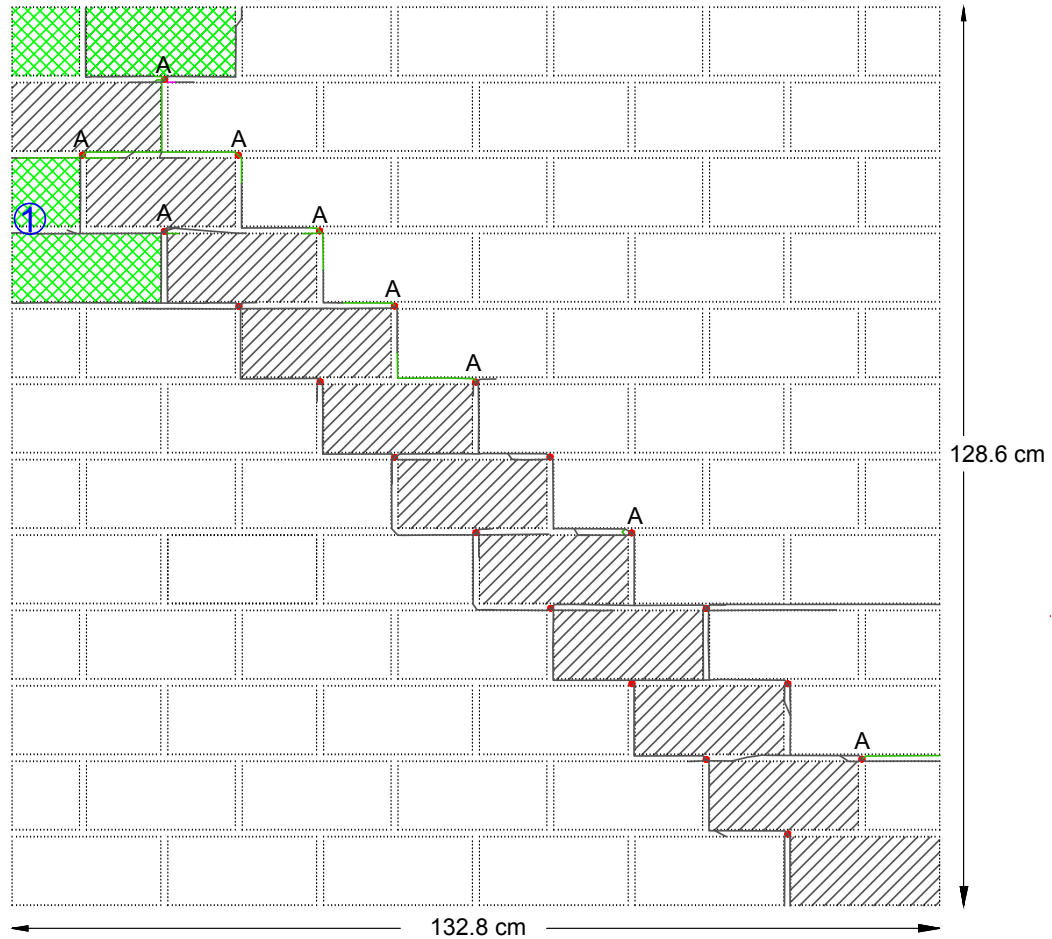
b) Crack propagation sketch
Fig. 6. Specimen 2 after testing

Specimen 2 had the highest number holes (22) [red dots in Fig. 6b]. Each hole generated at least one crack and cumulatively produced cracking along the pre-designated diagonal pattern across the entire wall in two parallel bands. All units above the diagonal band could be removed by hand and without further damage to the units below the band (cross-hatch bricks in Fig. 6); Larger walls are likely to need more holes. There was also a small amount of unintentional damage in the top left-hand corner probably caused by the lack of confinement during the cracking process (green double cross hatched units in Fig. 6b). As with Specimen 1, all cracking was confined to the mortar joints.

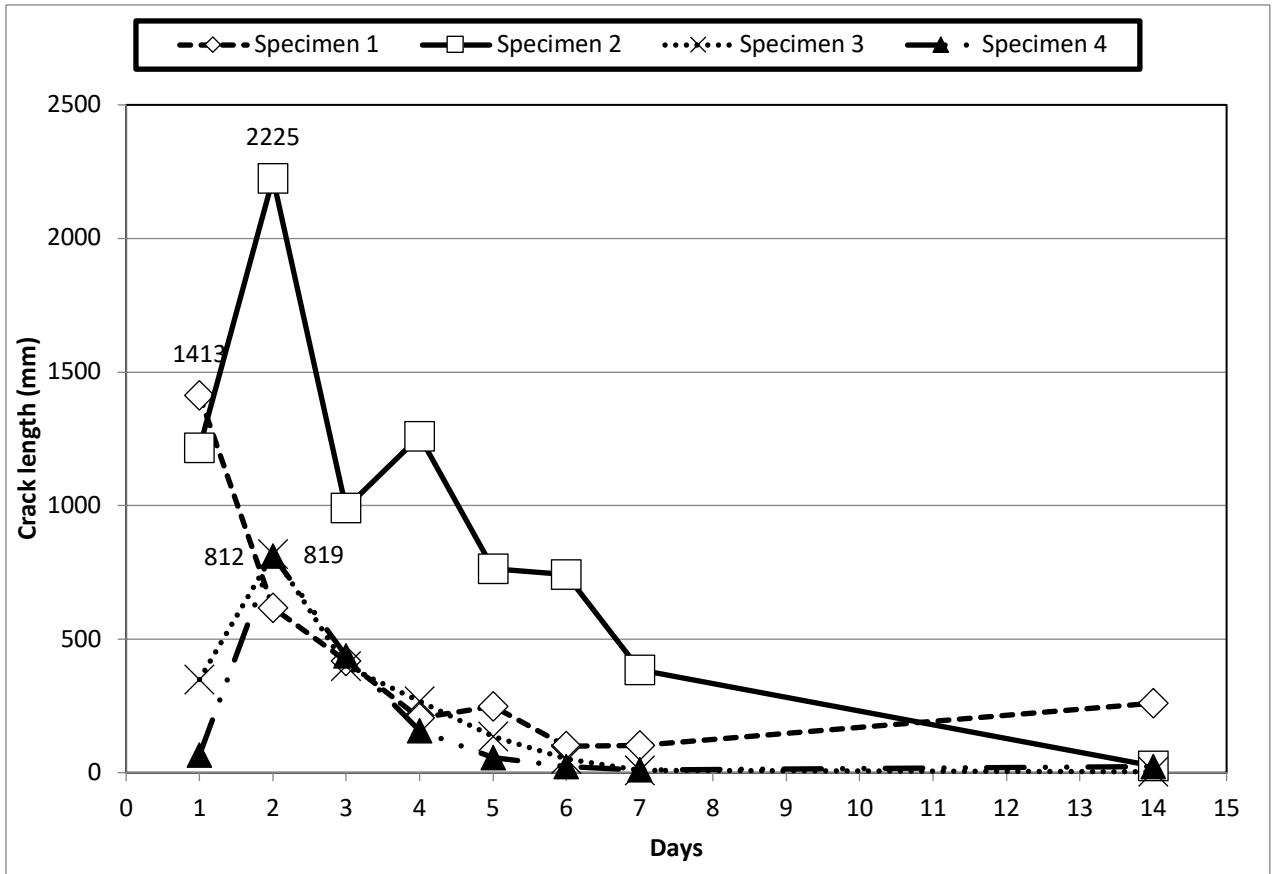
a) Crack length propagation during two weeks of testing

Fig. 9. Crack length propagation in the four specimens

As illustrated in Fig. 9a, experimental results showed that the greatest rate of crack generation occurred within the first week, during which the ambient temperature ranged from 17-23°C. In the first 4 days, 93% of the total, final crack length was achieved, after which cracking slowed noticeably (Fig. 9a). For each specimen, the majority of the cracking happened between days 1 and 2. At the end of two weeks, the cumulative crack length was highest in Specimen 2 and lowest Specimen 3 (Fig. 9b). In this specimen, like all other cases, the cracks appeared only in the mortar joints, and the units remained wholly intact.

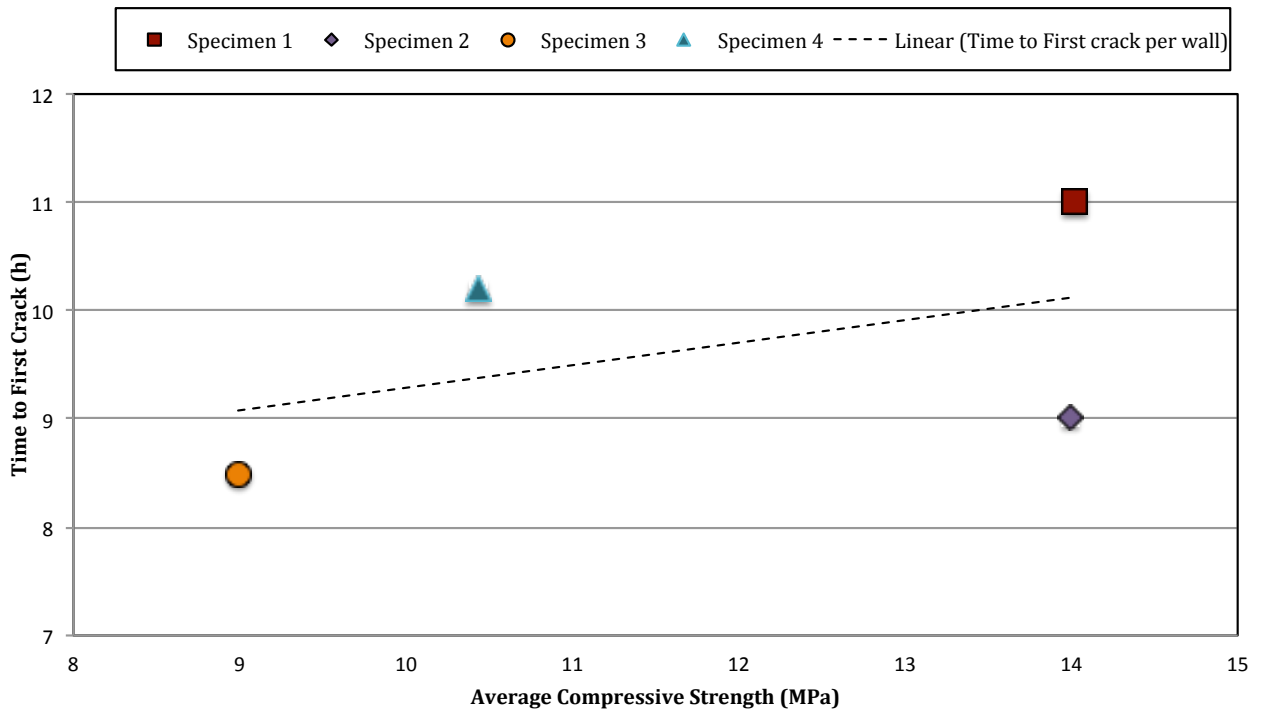
a) Time to first crack

Fig. 10. Time to first crack and crack propagation in different strength walls

was double that of Specimen 1, which had only 8 holes. Time to first crack was also 2 hours faster in Specimen 2 than Specimen 1. When the hole pattern was identical (Specimen 3 and 4), the materials controlled the difference in the demolition process. Namely, Specimen 3 with the stronger masonry units (2.8MPa versus 1.8MPa), started to crack 2 hours later than Specimen 4, and Specimen 3 had a non-measurable final crack width versus 3.67 mm in the weaker Specimen 4. Overall, the TFC was shortest in Specimen 4, with its weaker mortar and salvaged bricks. Specimen 4 also had the greatest overall cumulative crack length per hole (Fig. 10b). As the materials in Specimens 1 and 2 were identical, Fig. 10b also shows the potential variability achieved where only the number of holes and their distribution changed. Similar disparities were shown previously in the work by Natanzi et al. (2016b). As an additional note, generally, the TFC was faster and the cumulative crack length per hole was higher in the specimens of lower strength (Specimens 3 and 4 in Fig. 10).

In the experimental research herein, the TFC was fastest in Specimen 4 with the salvaged bricks, which had the lowest compressive strength of the specimens (Fig. 10). While the SCDA manufacturer predicted expansion completion after 16 hours, the research herein demonstrated that mortar continued to crack for up to 3 weeks (albeit at slower rates). This was also observed by Huynh et al. (2017) in experimental testing of 1m³ unreinforced concrete blocks. Research by Tang et al. (2017) showed that the TFC is a function of the mortar stiffness and heterogeneity based on the simulation of crack initiation and propagation assuming a Weibull distribution. In that work, In heterogeneous materials like mortar exhibited two types of crack generation – high stress and low strength, where crack generation may start at a point where the stresses are not the highest but where the local strength is lower because of the effect of pores and micro cracks. If the material is completely homogeneous, failure initiates at locations of high stress (Tang et al. 2017). When using SCDA in concrete or rock, the slurry is often introduced into the drill holes at the end of the day's work shift, with the expectation that material removal could begin at the onset of the morning shift 16 hours later. Because of the significantly small amount of SCDA material that can be introduced, the timeframe of a weekend may be more appropriate. Conversely, like with the rock removal done beneath the Carnegie Hall concert facility (Natanzi and Laefer 2014; Laefer 2002), in-situ material removal could be done progressively. In that case, efficient removal of the hundreds of tons of material was predicated on have an open face into which the cracked material could expand. Similarly, the partial demolition of walls may need a phased approach and should, along with multi-wythe construction be the subject of future tests.

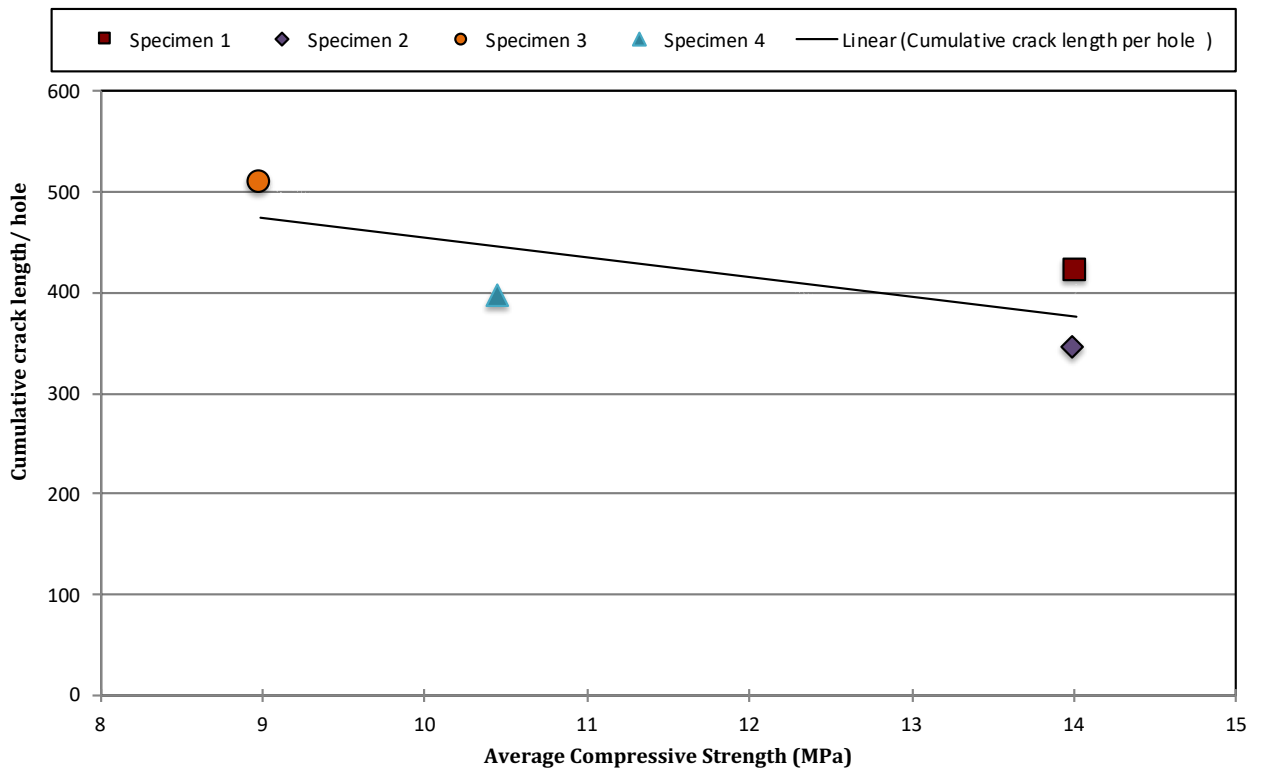
b) Crack propagation

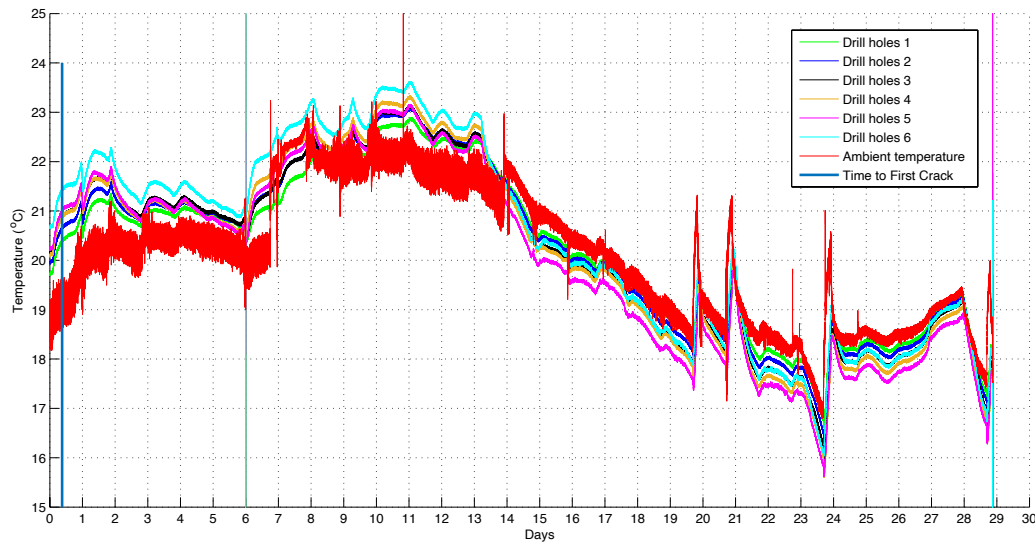
Fig. 12. Heat of hydration inside holes in Specimen 2 as compared to ambient temperature

As noted in the testing methodology section, only Specimen 2 was monitored for temperature. Temperature was monitored at 6 of the SCDA insertion locations, as well as in the ambient environment. Within all monitored drill holes, the temperature started to increase almost immediately, but cracking only began after 9 hours (Fig. 11). In the first 14 days, SCDA temperatures exceeded the ambient temperature by 1-2°C (Fig. 12).

While the gross temperature trends in the SCDA followed the ambient temperature pattern (Fig. 11), a closer look at the data showed a high degree of independence (Fig. 12). As the ambient temperature was uncontrolled and allowed to fluctuate, this test provides insights as to the heat being generated in these very small holes was influenced by the macro-environment. After 14 days, SCDA temperatures were lower than the ambient temperature, thereby implying that the hydration heat generation process was complete. A small amount of cracking, however, continued for up to 7 more days. Similar extended cracking was also reported by Hyunh et al. (2017) in large concrete blocks under equivalent environmental conditions.

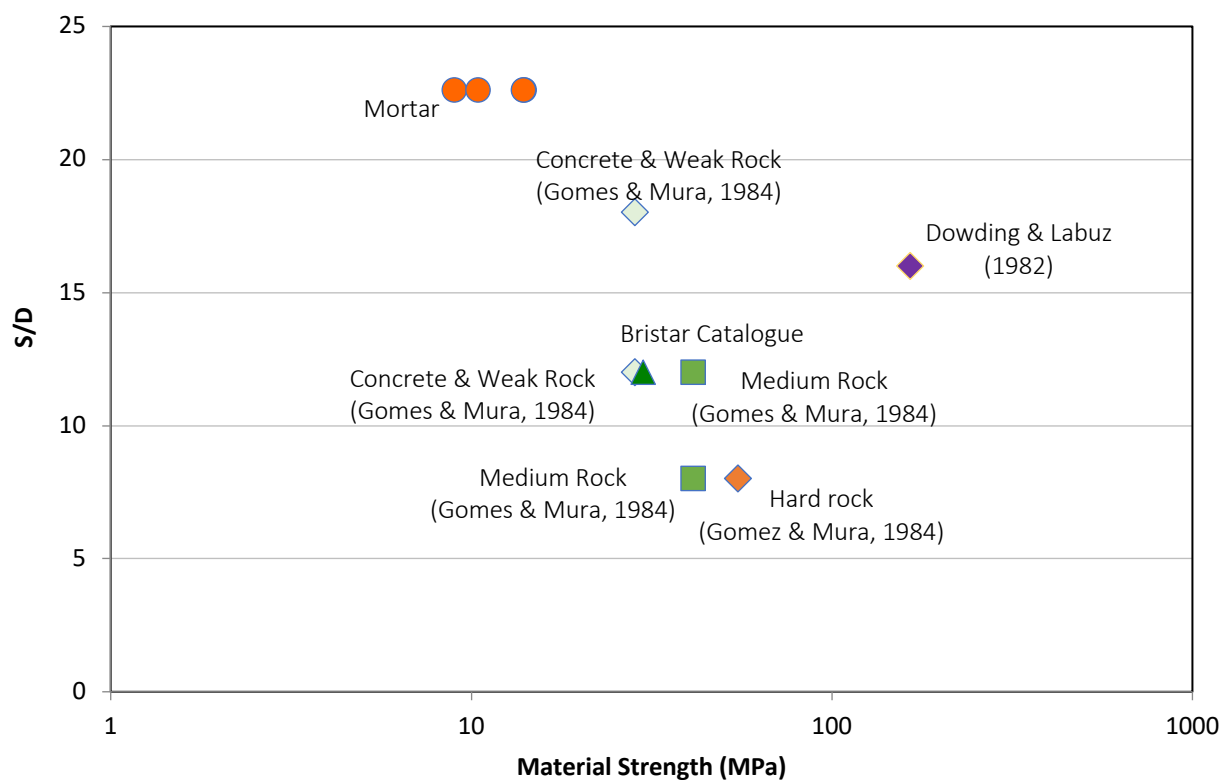
Fig. 19. Proposed relationship between S/D ratio and material strength

In terms of hole spacing, Dowding and Labuz (1982) proposed that the volume of demolished material could be optimized using a ratio of hole spacing (S) over hole diameter (D) and recommended an $S/D = 16$ for dolomite blocks of 165MPa. Applying the recommended ratio to the unit masonry testing herein would result in a spacing of 80mm. The actual minimum spacing was 113mm in the vertical direction ($S/D = 22.6$), which was 140% larger than Dowding and Labuz's (1982) recommendation. The research herein also had a maximum spacing of 225mm ($S/D = 45$). BASF Construction Chemicals UK Ltd. (2016) recommends a spacing of 400-600mm with a drill hole diameter of 36-50mm for horizontally oriented, hard rock samples ($S/D = 11$ to 12) [Fig. 19]. These show a general trend of higher spacing to diameter ratios with weaker surrounding material, but in general all had relatively low S/D values compared to the $S/D=45$ used herein, which may account for the incomplete cracking.
