Title of paper: Soil nailing in Dublin Boulder Clay

Names of authors: C.O. Menkiti¹, M. Long², G.W.E. Milligan¹ and P. Higgins³

Figures for paper by Menkiti et al on Soil Nailing in Dublin Boulder Clay

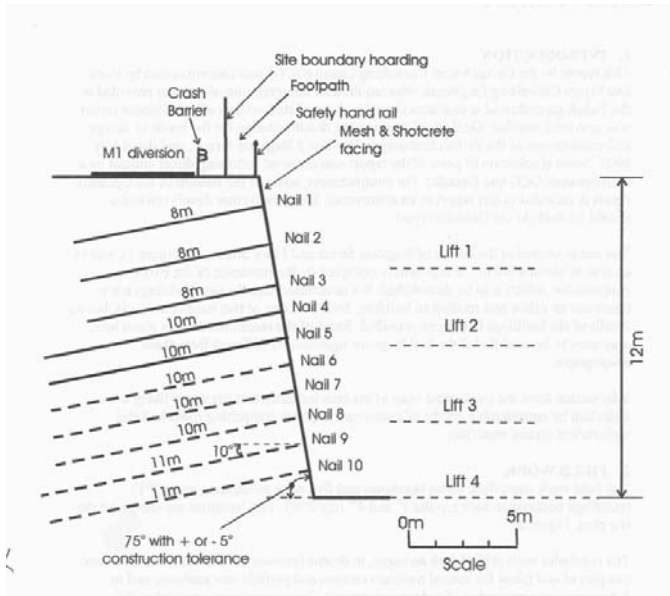
Figure 1. Observational method for soil nailed slope at DPT. Support used: 75 mm to 100 mm thick C40 mesh reinforced shotcrete facing and 100 mm diameter soil nails with 20 mm to 32 mm diameter steel tendons.

An observational approach, aided by sophisticated finite element modelling, was developed (Long et al. 2003; Kovacevic et al. 2008). It provided a design stand-up time of 1 to 1.5 years by using a partly nailed slope. The slope would collapse after this period as stability relied on excavation induced soil suctions, augmented by soil nails. Nails were always provided in the top 5 m (Figure 1). Additional nails were provided at depth if indicated by the observed ground conditions or monitored results. In the end, some 1700 linear metres of slope was constructed with 18530 m² of shotcrete facing and 7460 soil nails. This represented savings of more than 20% in nail quantities relative to a fully nailed slope with a long design life. There were additional savings in time and costs equivalent to 12 nail-rig weeks of construction, equipment and personnel.

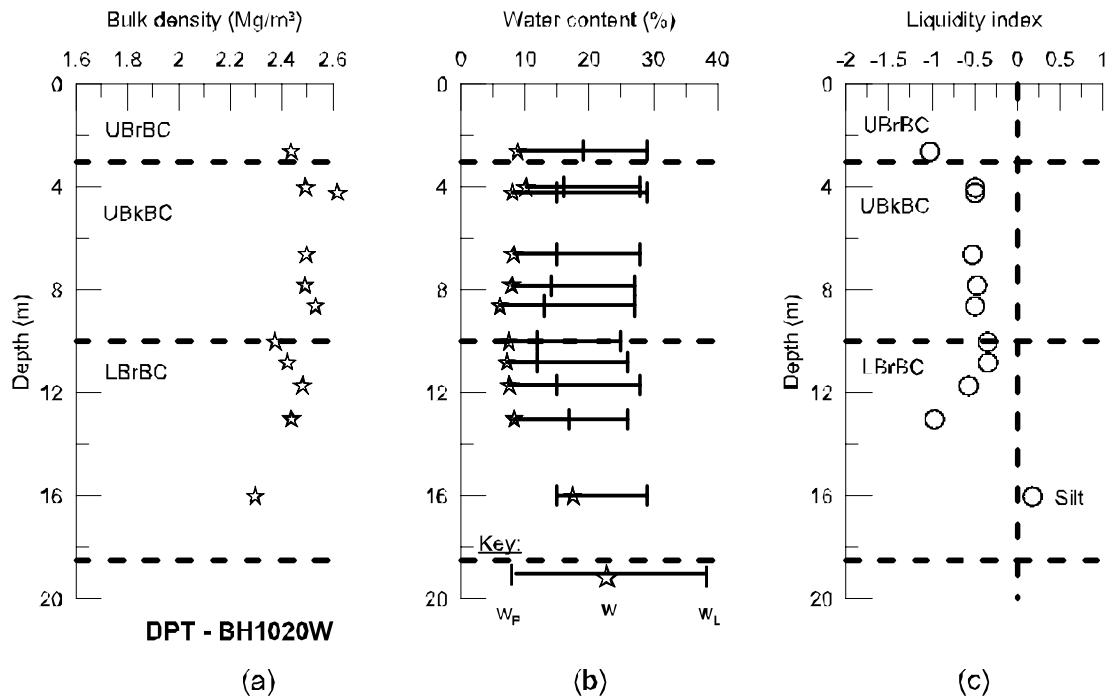
Figure 2. (a) bulk density, (b) water content and (c) liquidity index for DPT – BH1020W

The boulder clay has been sub-divided into units reflecting the degree of weathering and different depositional phases (Skipper et al. 2005). At the site (Figure 2), the top 0 to 1 m of the boulder clay is the upper brown boulder clay (UBrBC) (undrained shear strength ≈ 120 kPa). This is underlain by the upper black boulder clay (UBkBC) (undrained shear strength ≈ 300 kPa). and the lower brown boulder clay (LBrBC) respectively, see Figure 2.

Values of water content versus depth for a single borehole from the site (BH1020W) are shown on Figure 2b. In general water content is highest in the UBrBC, sometimes exceeding 20% but on average is about 13%. For the UBkBC water content is generally less than 10%. Bulk density (ρ_b) values (Figure 2a) are generally high and are on average 2.3 Mg/m³ for all 4 units of the DBC. Liquid (w_L) and plastic (w_P) limit values (Figure 2b) are relatively constant with depth and show average values of about 29% and 15% respectively.

Liquidity index [$I_L = (w-w_p)/I_p$] can sometimes be a very useful parameter for distinguishing between different strata, e.g. as demonstrated by Hight et al, (2003) for London clay. I_L values for the BH1020W at the DPT site are shown on Figures 2c. For the UBkBC values are more or less constant with depth and fall in the range -0.4 to -0.5 . For the UBrBC I_L usually tends to be closer to zero but is also relatively constant with depth. These slightly lower values reflect the weathering processes subjected to this unit. Data for the LBrBC and are more scattered but on average are also less than zero. The LBkBC has on average the lowest values being about -0.66 , consistent with this material having been subjected to the most intense shearing. All of these negative values reflect the highly “overconsolidated” state of the material.

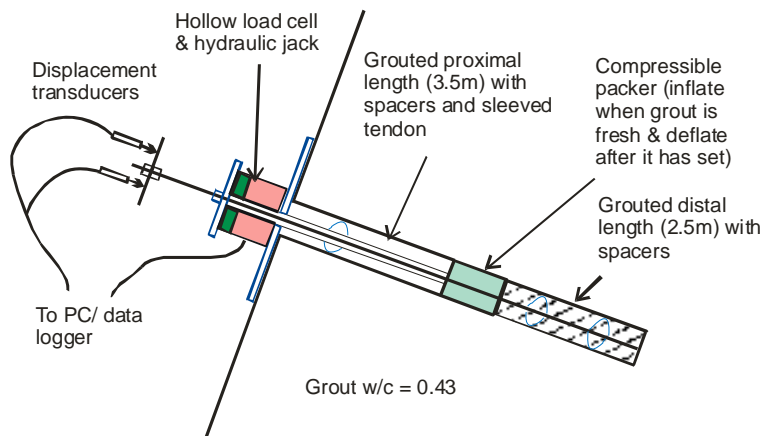
Figure 3. Set-up for sacrificial soil nail tests.

The sacrificial test nail layout is shown in Figure 3, with nails inclined at 10° to the horizontal. Pullout tests were undertaken at various depths, on nails installed in exactly the same manner as the main works nails. Drilling was by rotary methods with rock roller bit or down-the-hole hammer. Air / foam flush was used, powered by a 7.5 bar or 12 bar compressor. Figure 4 shows a typical borehole before nail installation. Gravel and cobbles in the stony soil become incorporated into the grout, giving a very rough interface.

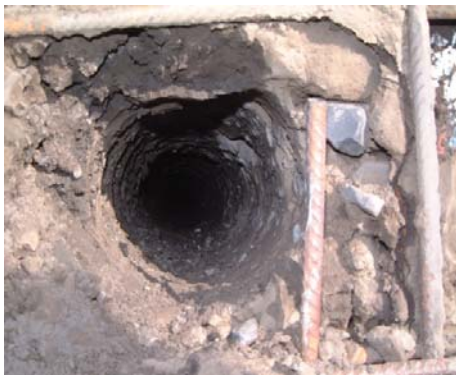
Figure 4. Borehole (diameter 100 mm) before nail installation.

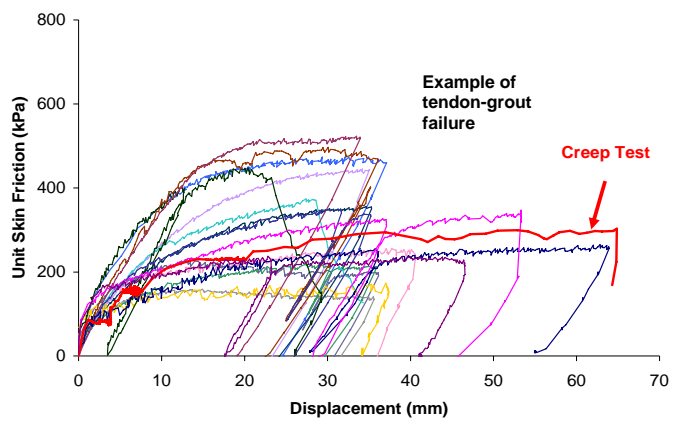
Figure 5. Measured unit skin friction (soil-grout interface).

The pullout tests revealed the following characteristics (Figures 5 to 9). Figure 5 shows the measured unit skin friction (soil-grout interface). A very high ultimate skin friction (or bond strength) was mobilised at the soil-grout interface, which was higher than the undrained strength. This is consistent with the rough soil-grout interface obtained.

These skin friction values are much lower than the available bond strength by a factor of say 3 to 6 (see Figures 5 and 9). The observed movements of the instrumented fully constructed, partly nailed slope were small (Figure 12). Maximum horizontal displacements were typically about 16 mm, being 0.13% of the slope height. This is within the range of 0.1% (rock) to 0.4% (clay) suggested in Clouterre (1991) and FHWA (2003) for nailed slopes. Measured crest settlement were also small, typically 3 mm or 0.03% of the slope height.

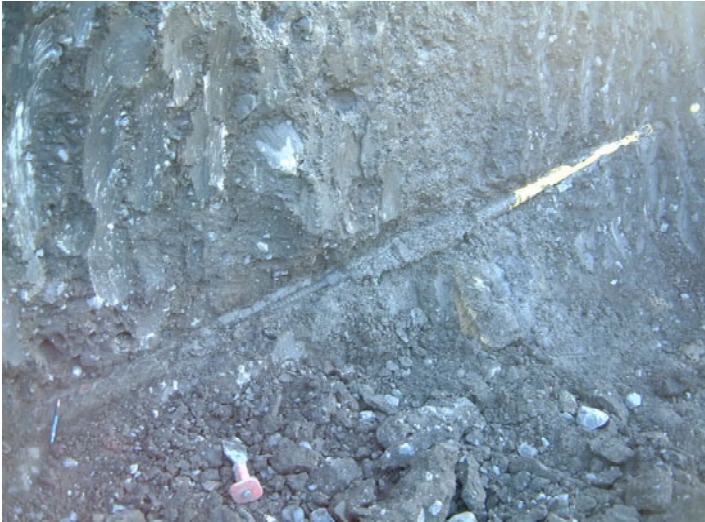
Figure 6. Photograph of exhumed test nail.

A photograph of an exhumed test nail is shown on Figure 6 and confirms the good adhesion between the soil and the grout body. The rough soil-grout interface was also visually confirmed. Good adhesion was also observed between the ribbed steel tendon and the grout body. Tensile load in the tendon was efficiently transferred to the grout body and thus to the soil. This is illustrated by the cracking observed in the first 500 mm of the distal section.

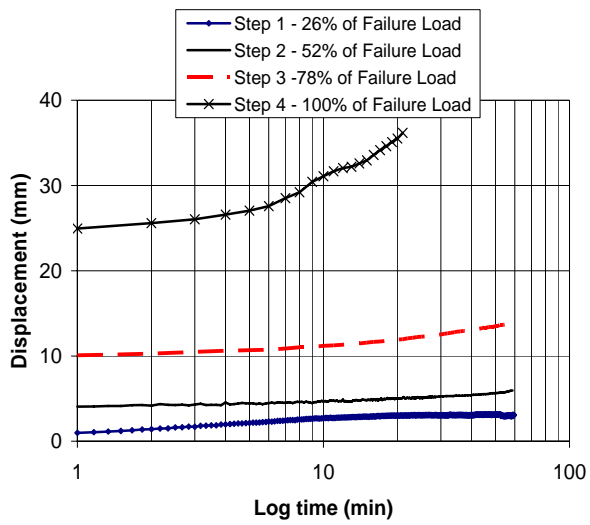
Figure 7. Typical creep test data – displacement versus time for four constant load stages (Nail 37, Lift 1).

Creep tests indicated increasing creep deformations with load level (Figure 7). They also highlighted the risk of significant creep, possibly leading to instability, if the mobilised skin friction is more than about 60% to 70% of the ultimate value (Figure 8).

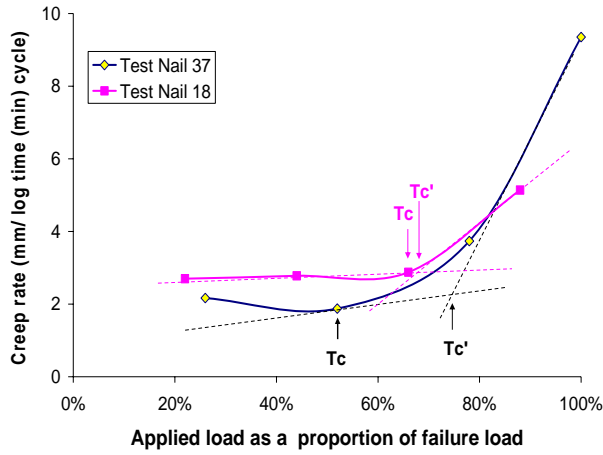
Figure 8. Example creep tests: creep rate versus applied load (as percentage of failure load) Nail 37, Lift 1 & Nail 18, Lift 4.

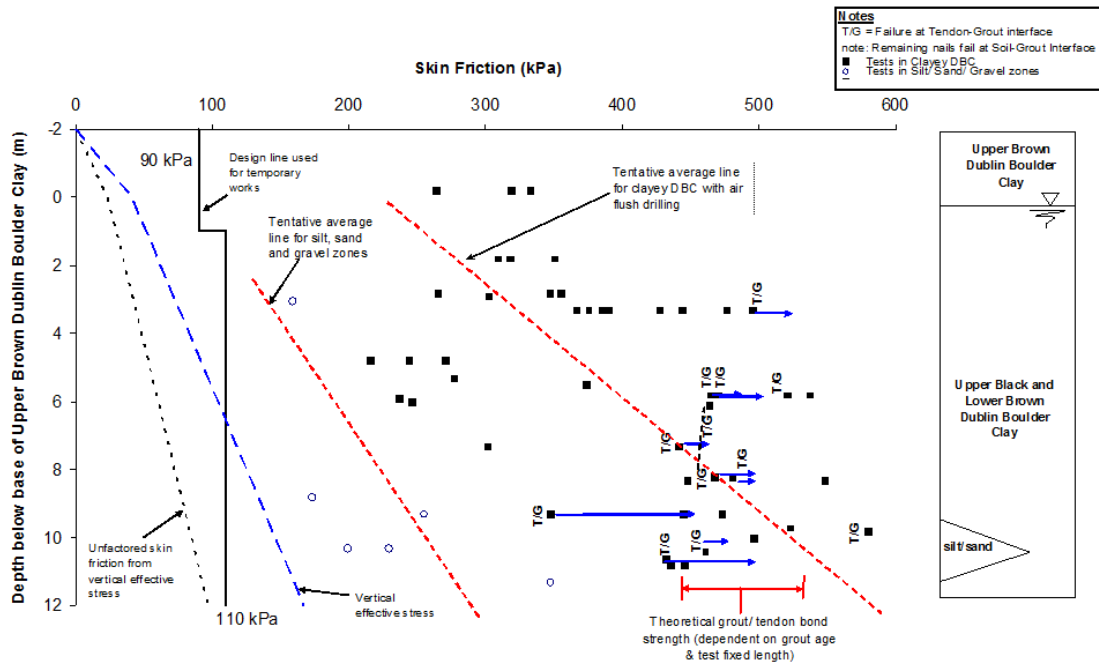
Figure 9. Results of pull-out tests: measured bond strength, design assumptions & ground conditions. Tendon/grout failure denoted as “T/G”; associated arrows show soil-grout bond strength derived by extrapolation.

Figure 9 shows the results of all the pull-out tests, the measured bond strength and the design assumptions. Tendon/grout failure is denoted as "T/G" and the associated arrows show soil-grout bond strength derived by extrapolation. Based on the good performance of the pullout tests, nail spacing (horizontal x vertical) was optimised from 1.5m x 1.2m to 1.9m x 1.5m.

FHWA 2003). In this project, the adopted design bond stress was increased from 50 kPa to 90 kPa – 110 kPa, based on the site testing (Figure 9). This still gave a significant margin relative to the measured pullout strengths. In comparison, the unfactored bond from effective stress considerations can be seen to be significantly smaller. Thus further refinement of common design methods may be possible for short term nails in Dublin Boulder Clay.

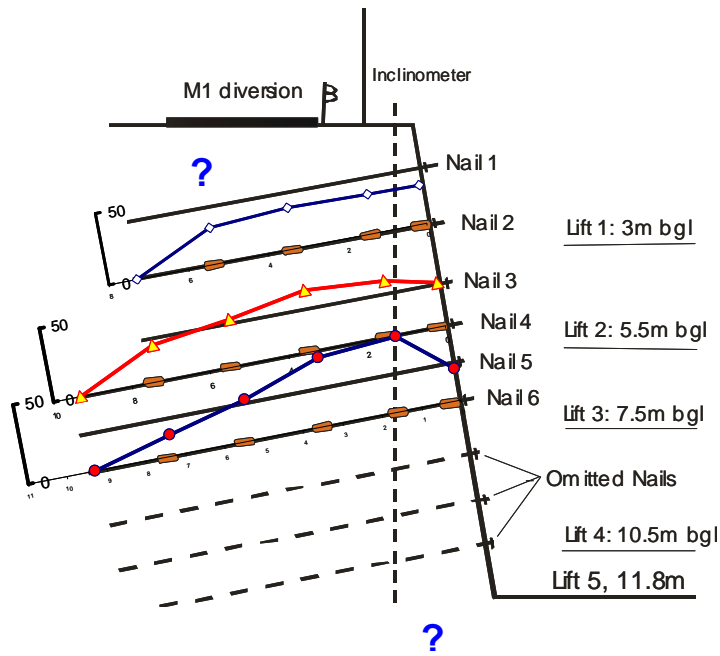
Figure 10. Soil nail tension (kN) at strain gauge locations and potential slip surface that was restrained

The tensile forces within working nails in the constructed slope were monitored using strain gauges at two cross sections (Chainage 980E and Chainage 940E). Full details of these trials and the instrumentation used are given by Menkiti and Long (2008). The highest forces occurred at the end of the life of the slope with peak loads of 47 kN (Figure 10). Examination of the peaks in the tensile force profiles suggest that a potential failure surface that would have intersected the diverted motorway was successfully restrained.

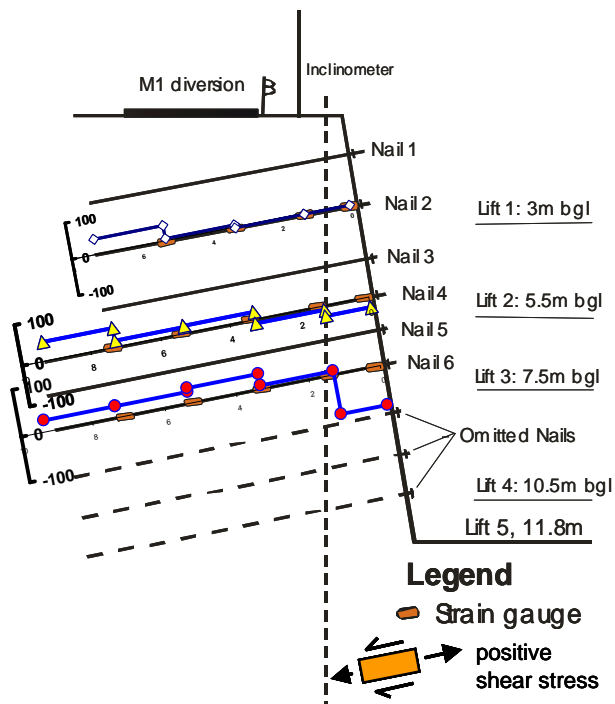
Figure 11. Soil-grout shear stress (kPa, averaged between strain gauge locations).

Shear stresses mobilised in the instrumented nails have been inferred from the measured tensile forces and shown in Figure 11. The maximum mobilised skin friction during the life of the slope was typically 42 kPa, but was up to 87 kPa in Row 6.

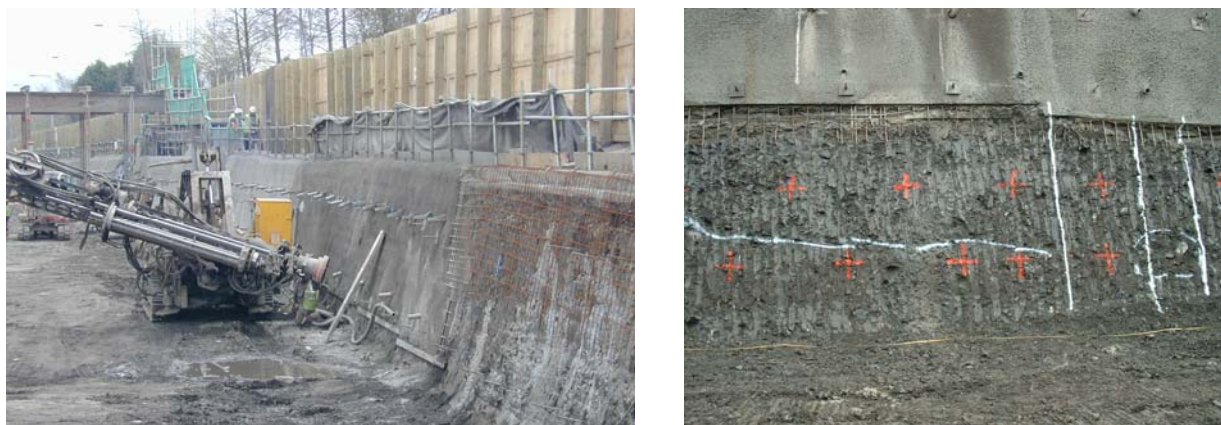
Figure 12. Soil nailed slope under construction at Chainage 1300E, (a) Lift 1 and (b) Lift 2

Some photographs of the soil nailed slope at Chainage 1300E under construction are shown in Figure 12. The photographs show the nails and shotcrete protection for Lift 1 (Figure 12a) nearing completion and work underway for Lift 2 (Figure 12b). It can be seen that the material is very competent and stands unsupported allowing the works to proceed without difficulty. Similar good conditions existed over the majority of the soil nailed section. There were some incidents of local overbreak in the cut slope as can be seen in Figure 13. Here this was caused by the blocky and highly fissured Dublin Boulder Clay found in the top 3 m at Chainage 1250E to Chainage 1265E.

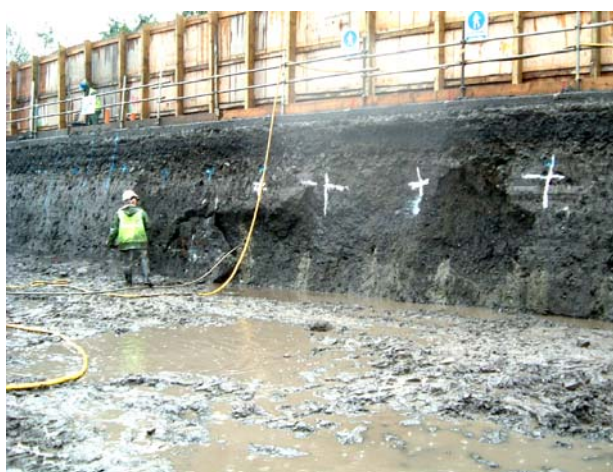
Figure 13. Blocky and highly fissured Dublin Boulder Clay found in the top 3m at Chainage 1250E to Chainage 1265E. This led to local overbreak in cut slope

The shotcrete was required to have a minimum thickness of 75 mm and to be placed on a single layer of A252 mesh. The requirements for the 24-hour characteristic compressive strength and the 28-day strength were 8 MPa and 40 MPa respectively. One series of samples was taken for every 300 m² of shotcrete placed. Weepholes were provided through the construction facing to drain water from behind the shotcrete on a nominal 2.0 m centres grid. A face plate and nut was attached to each nail after the application of the shotcrete as shown on Figure 13b.

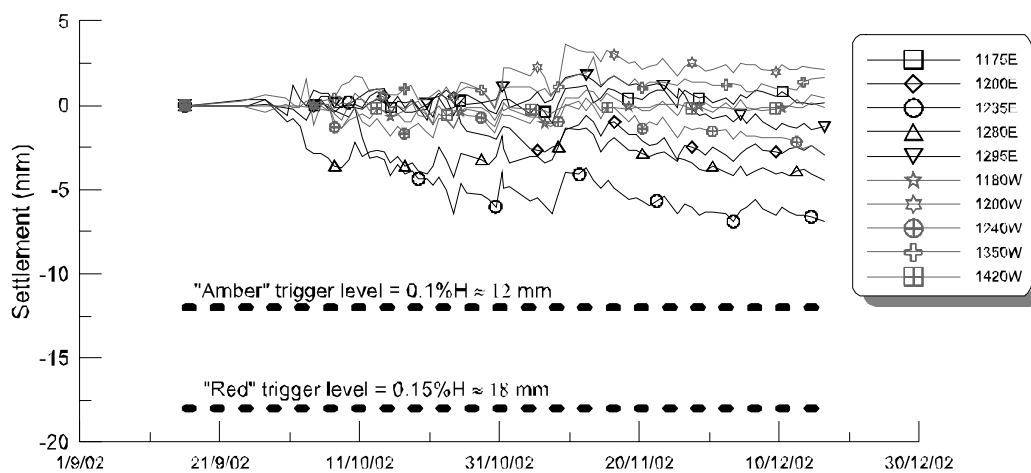
Figure 14. Surface settlements behind soil nailed slopes

Measured surface settlements behind the soil nailed slope are shown on Figure 14. The data were obtained using conventional geodetic surveying. Not all points are shown but the data have been chosen to reflect the range of measurements. It can be seen that the movements are very modest and in general do not exceed 3 mm to 4 mm, values which are close to the accuracy of the system used. The settlements on the west side of the excavation were in general less than those on the east. The reason for this is not clear.

In particular the measurements are well within the observational method “amber” and “red” trigger levels which were set at 0.1% H (H = maximum slope height) and 0.15% H respectively.

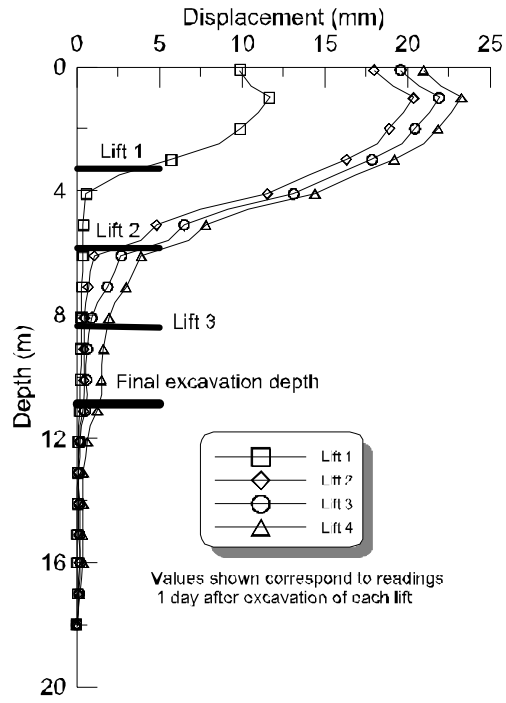
Figure 15. Lateral movement – Chainage 1295E

The development of lateral movement in the slope is shown for a typical profile (Chainage 1295E) in Figure 15. It can be seen that more or less all of the movement is concentrated in the upper half of the excavation. Most of the movements occurred during the excavation for Lift 1 (3.3 m) and the subsequent nailing of Lift 1 and the excavation for Lift 2 (5.8 m). Subsequently little additional movement occurred until final excavation of 10.9 m was reached.

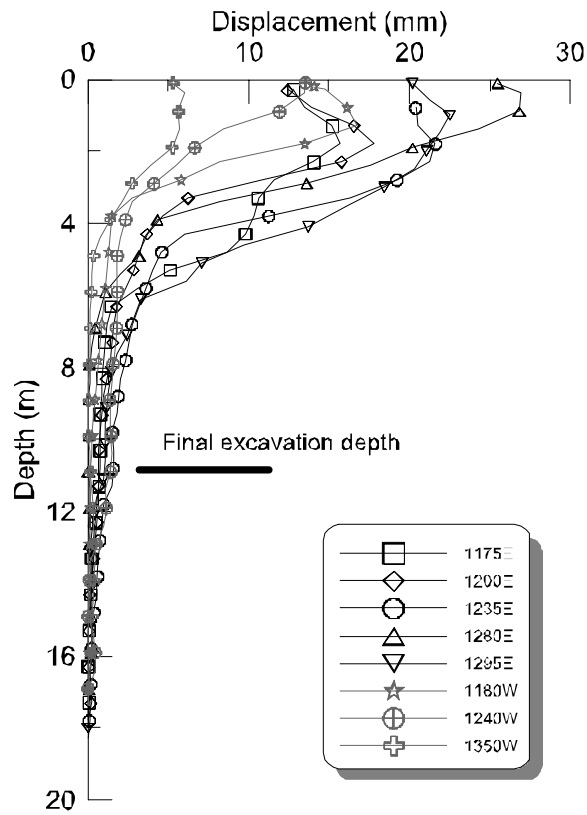
Figure 16. Selected maximum lateral movements

Selected maximum lateral slope movements (for the same profiles as selected for surface settlement) are shown on Figure 16. A similar pattern, as observed for Chainage 1295E, can be seen for all the profiles. Again movements on the west side of the excavation are less than those on the east.

The measured movements do not exceed 0.25% of the excavation height. This is within the range of 0.1% (rock) to 0.4% (clay) suggested in Clouterre (1991) and FHWA (2003) for nailed slopes.

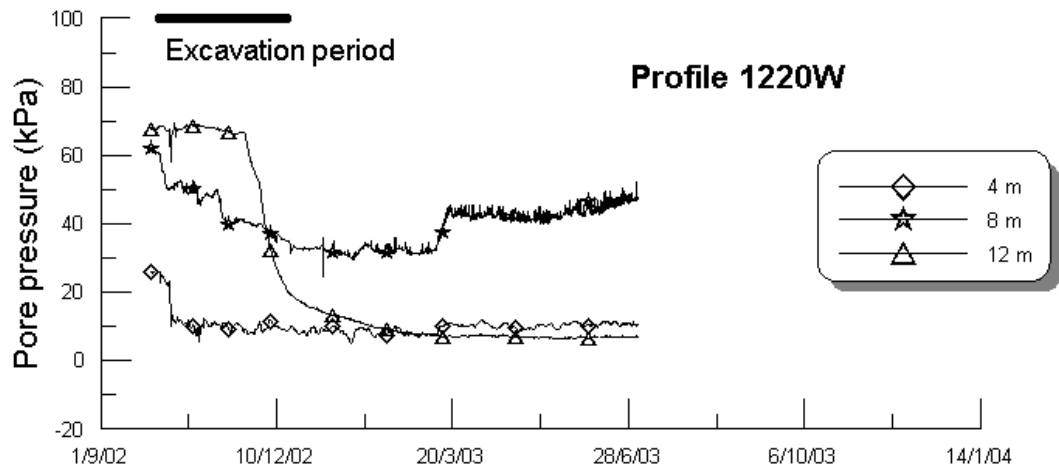
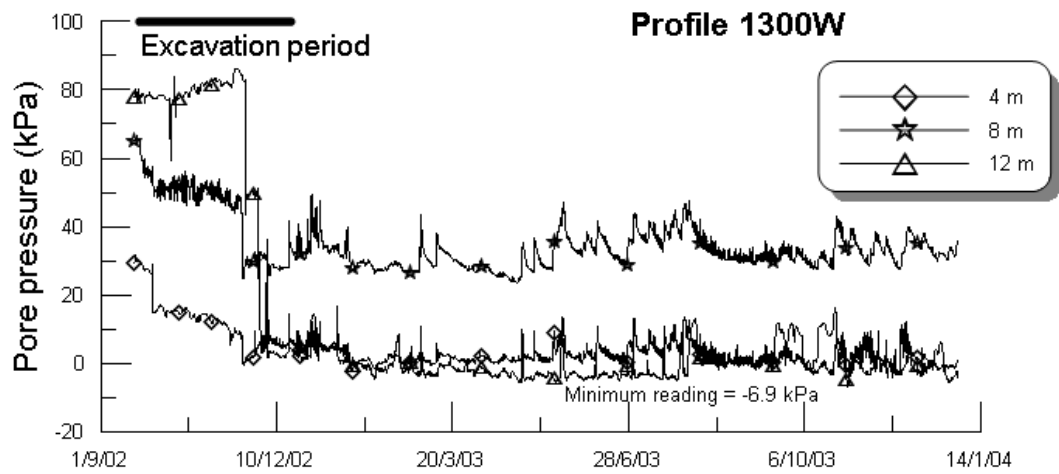
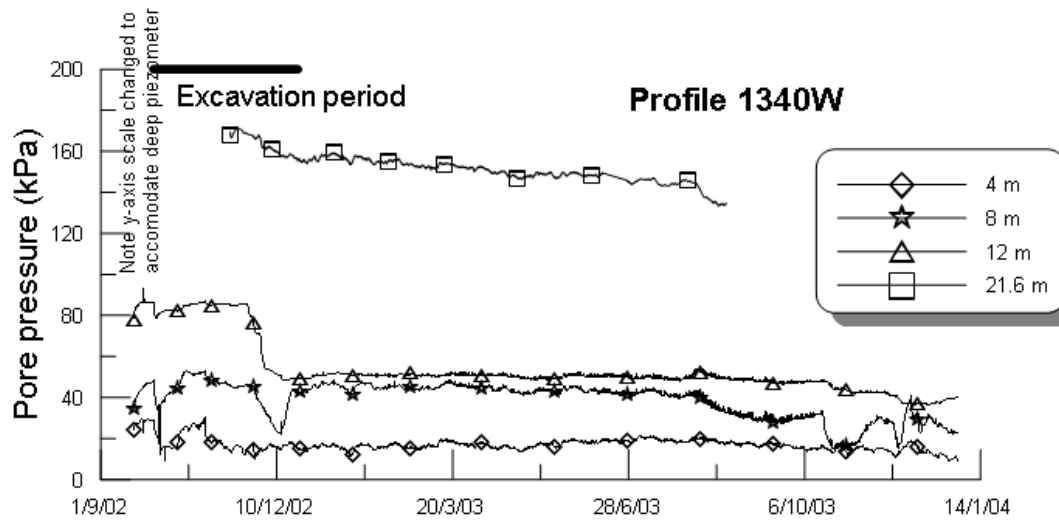
Figure 17. Selected piezometer readings

Pore water pressures in the slope were monitored using vibrating wire piezometers which had been installed in fully grouted boreholes as described by Long et al. (2004). Generally piezometers were installed at 4 m, 8 m and 12 m depth. Some typical piezometer data, for three profiles where the excavation depth was about 11 m, are shown on Figure 17. Initially the piezometer readings correspond to hydrostatic conditions with a ground water table at about 2 m depth. Subsequently the values decrease on excavation due to the release of total stress. The decrease in pore pressure is most considerable for the 12 m piezometer and correspondingly less for the 8 m and 4 m piezometers respectively.

On reaching a minimum value towards the end of the excavation period the values remain sensibly constant for the remainder of the monitoring period and completion of the works. Some modest suction values, up to about -7 kPa, were recorded. Similar depressed and negative values were reported by Menkiti et al. (2004) for a trial excavation at the site. These depressed pore water pressures (and suctions) are a major contributory factor to the stability and good performance of the slopes.

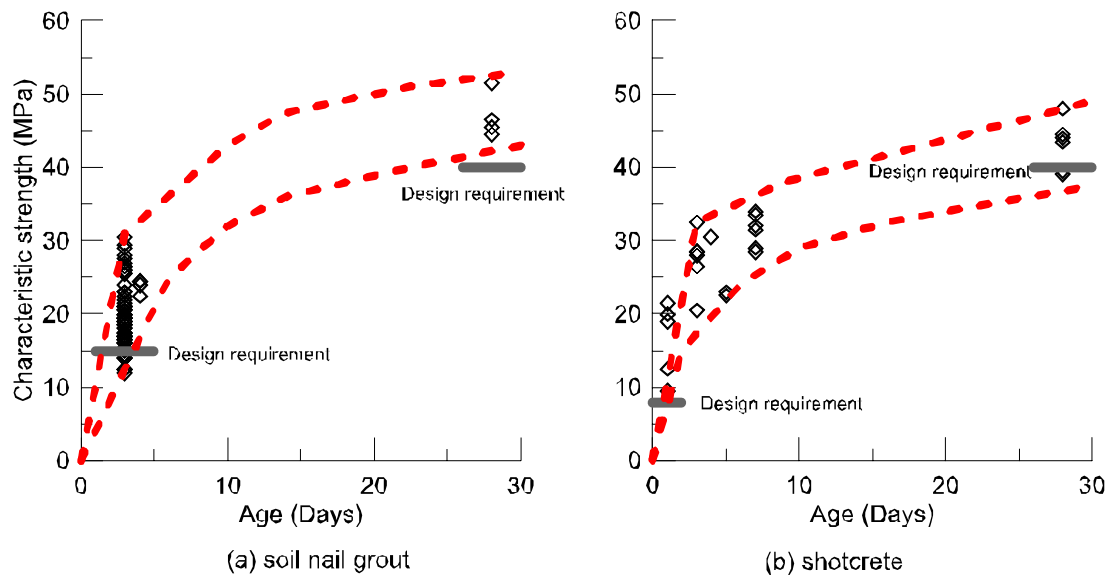
Figure 18. Measured characteristic strength of (a) soil nail grout and (b) shotcrete

Test results shown on Figure 18a confirm that the material satisfied the design criteria for strength. A small number of test cubes showed 3-day values less than 15 MPa. However as the average of 4 samples was greater than 18 MPa, and the lowest result exceeded 12 MPa, the material was deemed acceptable. The average measured grout density was 1940 kg/m³.

Measured shotcrete strength data is shown on Figure 18b. Again the progressive increase in strength with time is clear and the material was deemed acceptable. Average measured shotcrete density was about 2300 kg/m³.

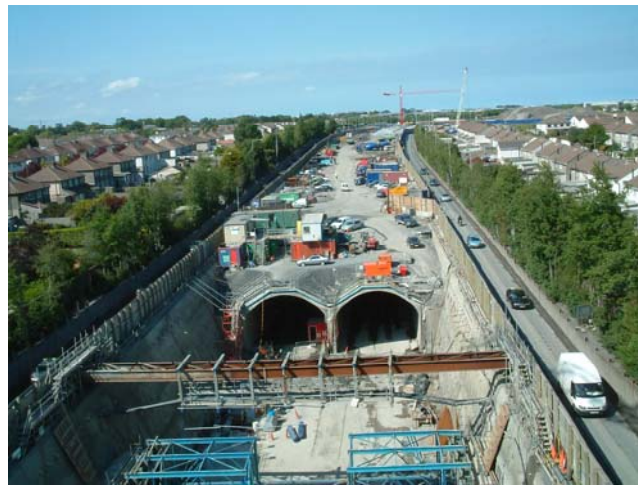
Figure 19. Scheme nearing completion

The development of depressed pore pressures in the slope due to stress relief was a very significant factor in the very good behaviour of the slopes, as can be seen in the photograph of the scheme nearing completion on Figure 19.
