Manufacturing, assembly, and testing of scaled, historic masonry for one-gravity, pseudo-static, soil-structure experiments

Debra F. Laefer¹, James H. Long², Edward J. Cording³, Aykut Erkal⁴, and Linh Truong Hong⁵

ABSTRACT: In many model-scale experiments, geometric scaling is upheld but kinematic and/or dynamic similitude is not because of the difficulty in manufacturing and assembling small models. This paper describes scaling, manufacturing, assembly, and testing of 1/10th scaled historic masonry materials for one-gravity, pseudo-static, soil-structure testing. Prototype selection, manufacturing limitations, constructability constraints, and testing decisions are presented, alongside details related to model construction. Compressive, tensile, and shear capacities of one-tenth scale prototype values, as well as failure mechanisms, were achieved by adopting traditional brick extrusion and firing methods, in conjunction with modifying mortar products developed for historic restoration. When scaled-masonry structures were subjected to adjacent excavation, damage levels and patterns and levels were consistent with full-scale, field observations.

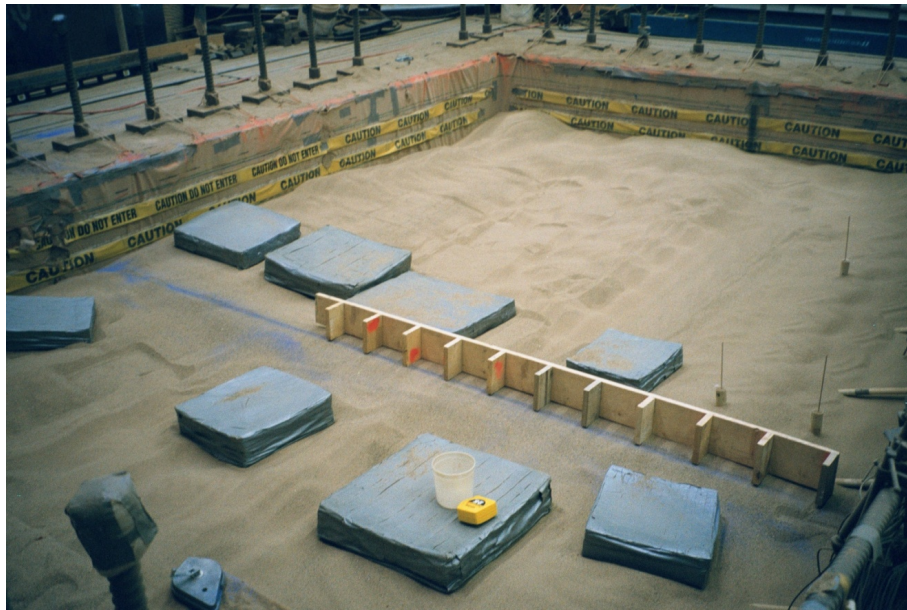
Fig. 3. Formwork shown for laying discrete URM footings.

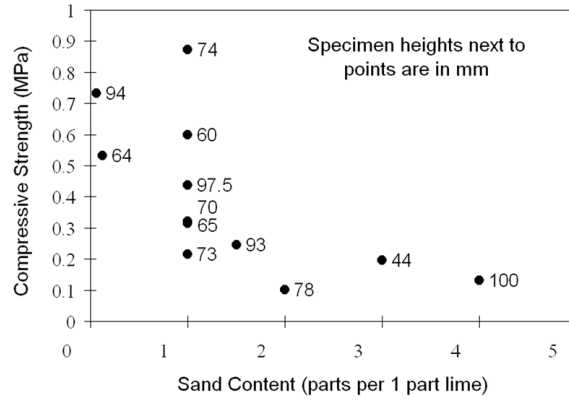
Fig. 4. Oversanding in lime mixes.

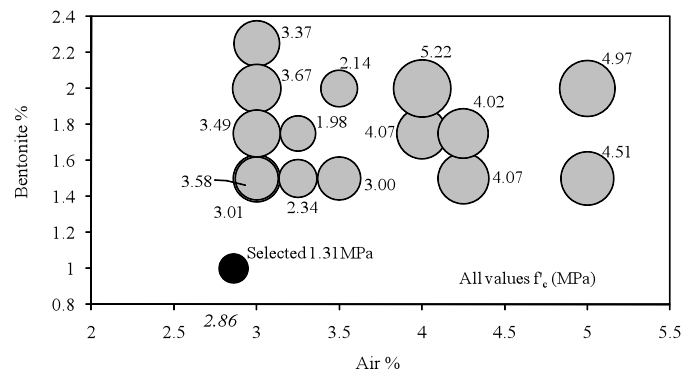
Fig. 5. Mortar strength as a function of bentonite and air entrainment levels.

A preslaked, lime putty-based, restoration mortar by GenLime was selected as the binder/base material. Its 25% water content (by weight) required special additives and curing to prevent excessive shrinkage-induced cracking. Shrinkage in full-scale masonry is usually controlled by aggregate quantity and type. However, even a small amount of sand substantially interfered with workability. Workability issues also precluded lowering strength with an over-sanding approach – having insufficient binder for the aggregate to fully bind (Fig. 4). Several fillers were tried including flour, baking soda, baking powder, crushed limestone dust, silt, and glass microspheres. None produced a workable mortar that could be consistently placed with a uniform mortar joint thickness. Instead, small amounts of bentonite and air entrainment were added to the mix but no aggregate. Table 3 shows the final mix; mortar is usually described as parts per volume but weight was selected in this case, to ensure repeatability. The strength of the selected mix is shown in the context of other mixes using various levels of air entrainment and bentonite.

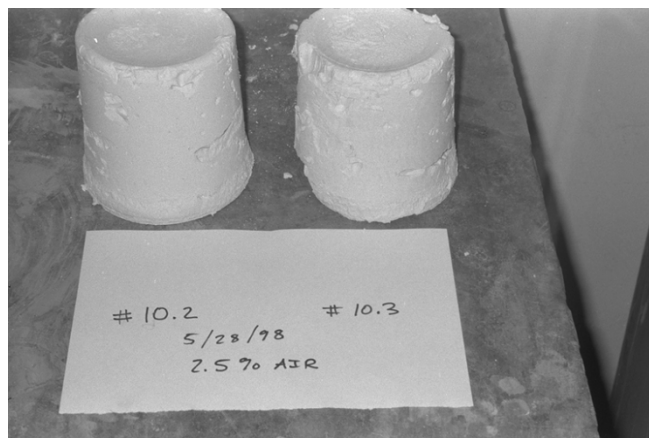
Fig. 7. Oversized cast mortar samples from which 5.1 cm x 5.1 cm samples were cut.

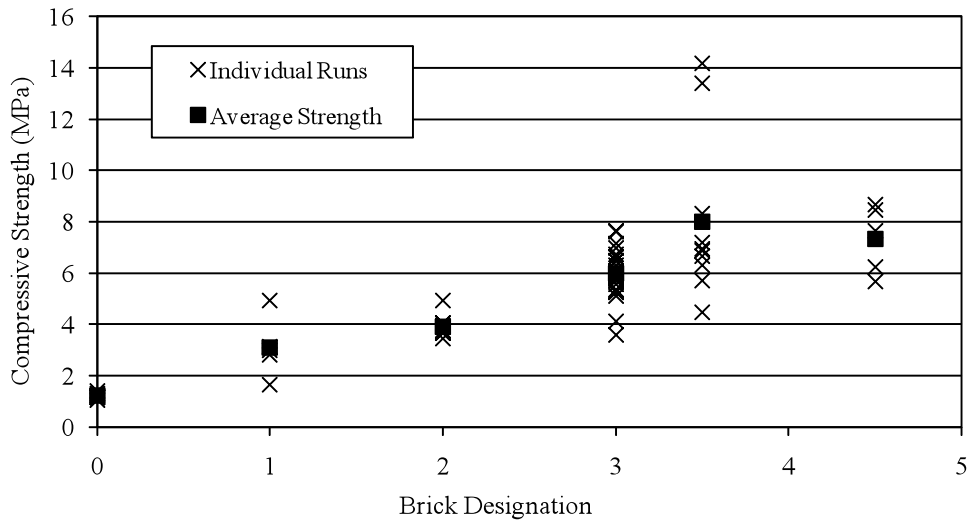
Fig. 9. Brick compressive strength by colour designation.

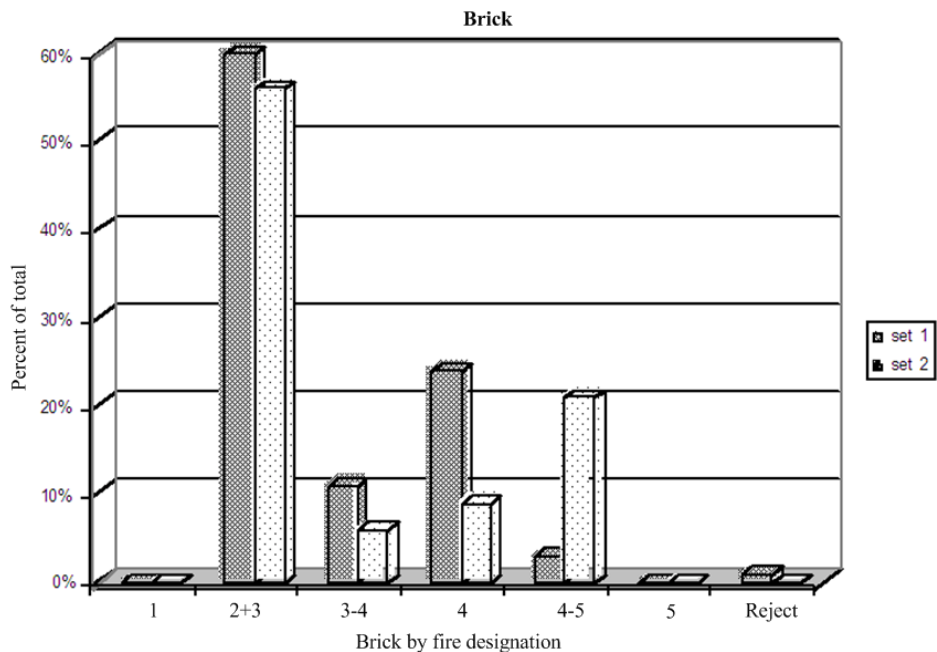
Fig. 10. Kiln yield by colour designation.

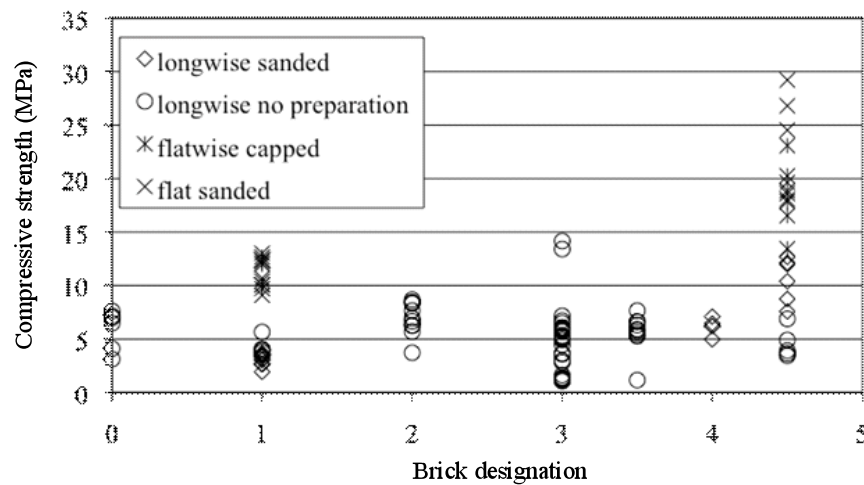
Fig. 11. Comparative compressive strength by end condition.

Initially, the individual bricks were capped prior to compressive testing in accordance with ASTM C67 [34]. When compared to specimens tested with sanded ends and those without any end preparation, those without end preparation were indistinguishable from the capped ones, with the added benefit of replicating historical data collection methods (Fig. 11). Finally, a full brick was tested instead of a half brick, because of the small unit size; traditionally half bricks were favoured because of testing machine load limits.

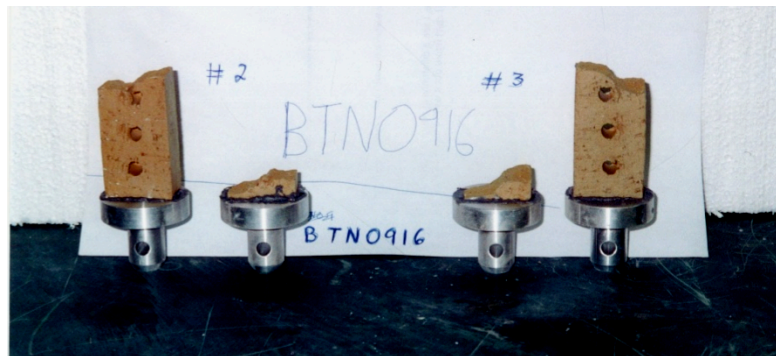
Fig. 12. Photograph of tensile brick testing.

The Modulus of rupture (f_r') value was established in accordance with ASTM C67. The average was 144.8 kPa (flat-tested) and 627.4 kPa (edge-tested). Tensile capacity determined by testing units end-wise with a no-moment connection averaged 1.26 MPa for the 2-3 bricks (connector detail and broken bricks shown if Fig. 12). Absorption was 16.31%, but this value and much of those in the early literature may be better categorized as saturation potential and should not to be confused with initial rate of absorption, which requires a boiling portion to the test, which could not be performed because of disintegration problems because of the bricks' low sintering levels. Bricks were strain gauged to obtain the material's tangent Young's modulus (81.28 MPa) and Poisson's ratio (0.25).

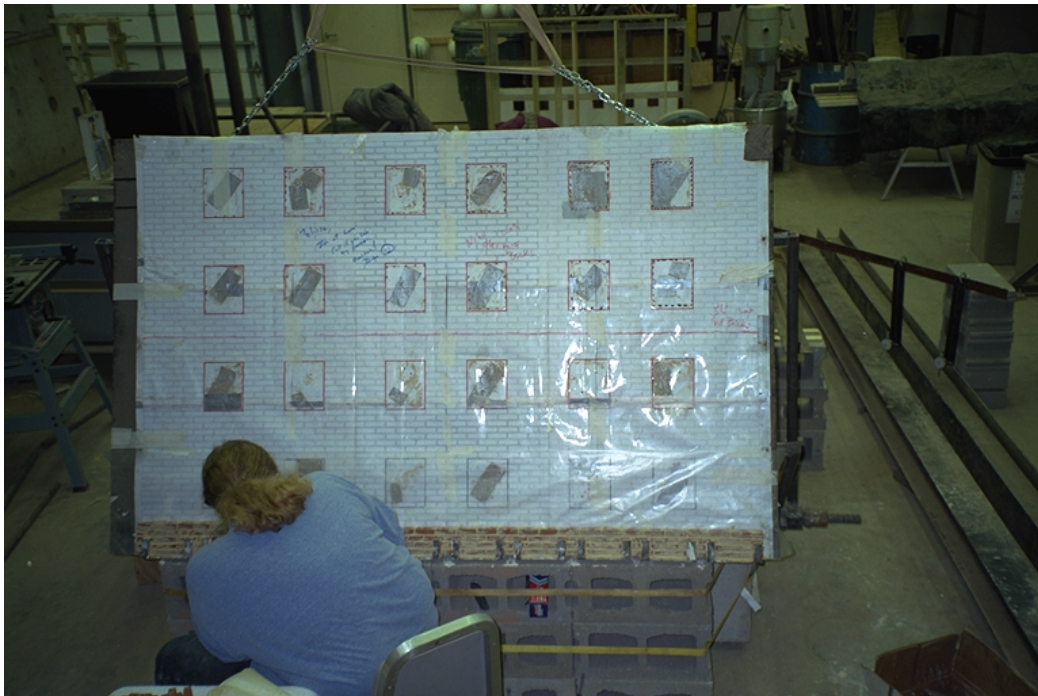
Fig. 17. Photograph of bricks being laid (formwork set for up to 4 storeys).

The brick walls (610 mm high, 1830 mm long, and 29.75 mm wide) were built in a large, frame inclined approximately 20° from vertical, to counter the walls' tendency to cure towards the air and curl, especially along the most freshly laid rows. Prior to initiating assembly, a laminated, computer-aided design (CAD) generated template of the wall layout was secured to the dismountable frame (Fig. 17). The template was an exact, scaled representation of the wall layout and provided a constant means to visually check unit placement and joint thickness at all points. Upon wall construction, no deviations from the template were visible. Prior to bricklaying, the template was covered by a thin sheet of wax paper to prevent sticking between the laminate and the brick. This was removed after the model was positioned in the testing chamber (Fig. 18 and 19).

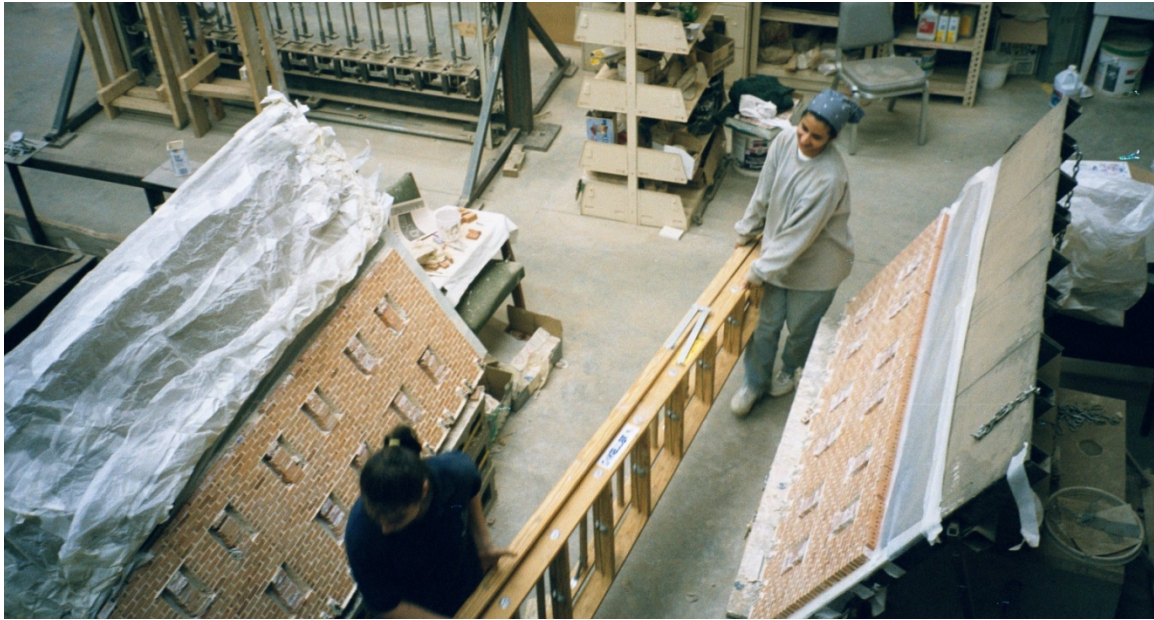
Fig. 18. Two model walls shown in their transport frames.

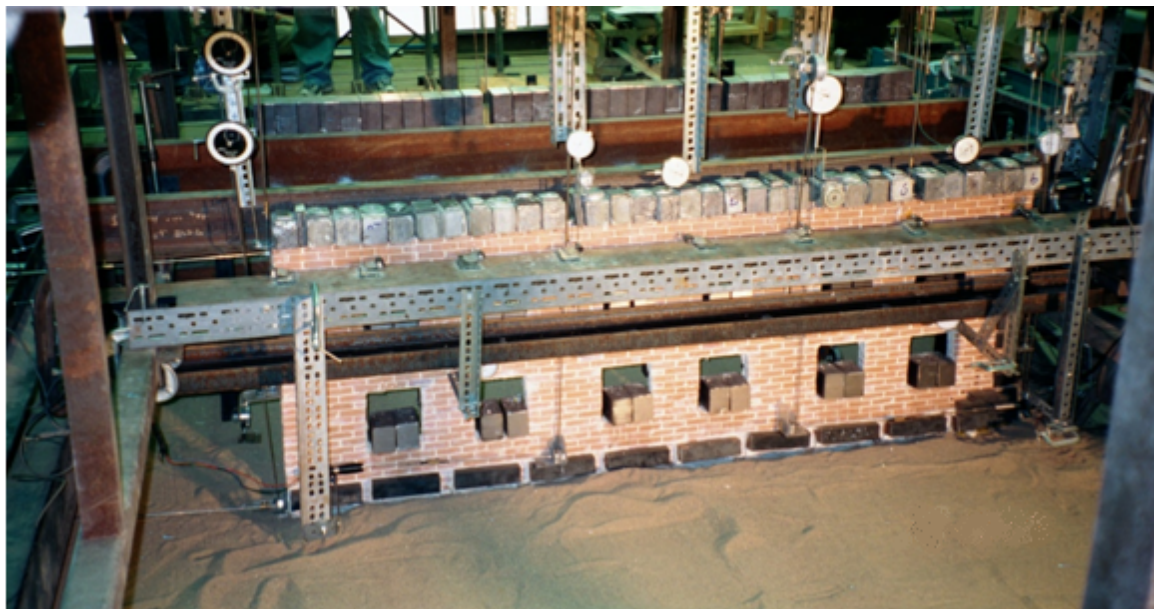
Fig. 19. Wall in place awaiting testing.

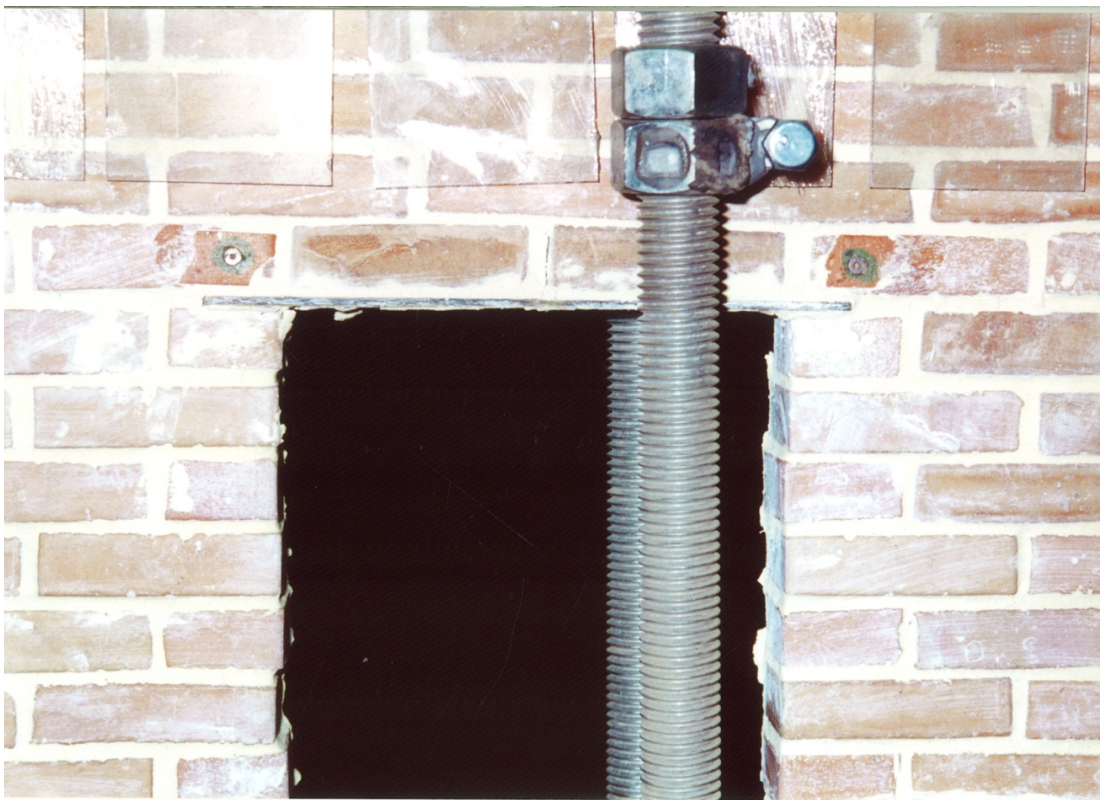
Fig. 20. Window opening with oak lintel visible.

The only other wall components were 2.0mm thick oak lintels atop each window to provide support the bricks above (Fig. 20). Wood was selected instead of metal or stone to meet scaling stiffness requirements. The lintels were double-coated with polyurethane to prevent mortar desiccation. The lintels extended into the mortar joint approximately half a brick length beyond the window on each side emulating field practices. Loading details are summarized elsewhere [21, 22].

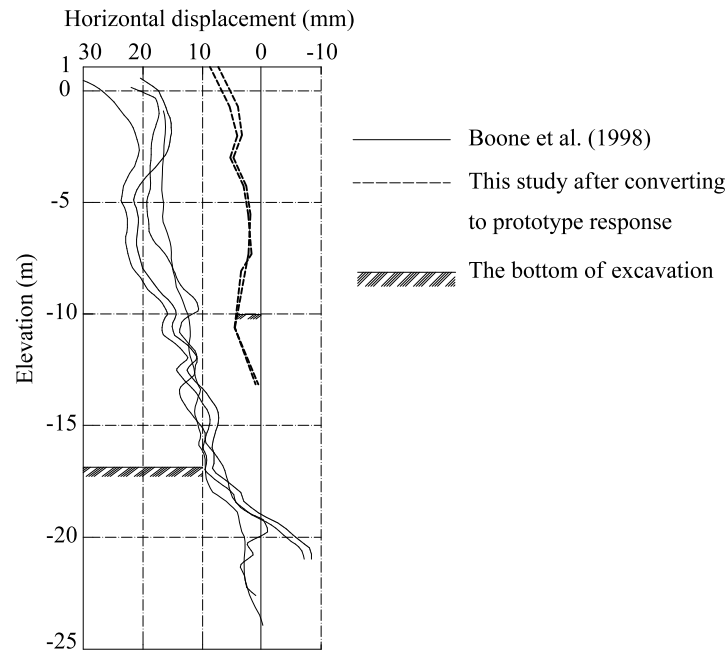
Figure 21. Horizontal displacements of the excavation wall

Lateral excavation wall movements observed by Boone [43] for an excavation 20m in depth and over 650m long through glacial till and a highly, over-consolidated glaciolacustrine sand, silt, and clay deposit are shown in fig. 21. The excavation was generally supported by wide-flange steel beams combined to vertical spacing of struts ranged from 2.4m to 5.8m. In general, the experimental data when scaled to a factor of 10 was not dissimilar. Boone’s final displacements ranged from 0.12% to 0.18% of the excavation depth, while the experimental results were around 0.07-0.08% of the excavation depth. The smaller displacements from the experiments can be understood as an artefact of the more shallow excavation depth of the laboratory tests.

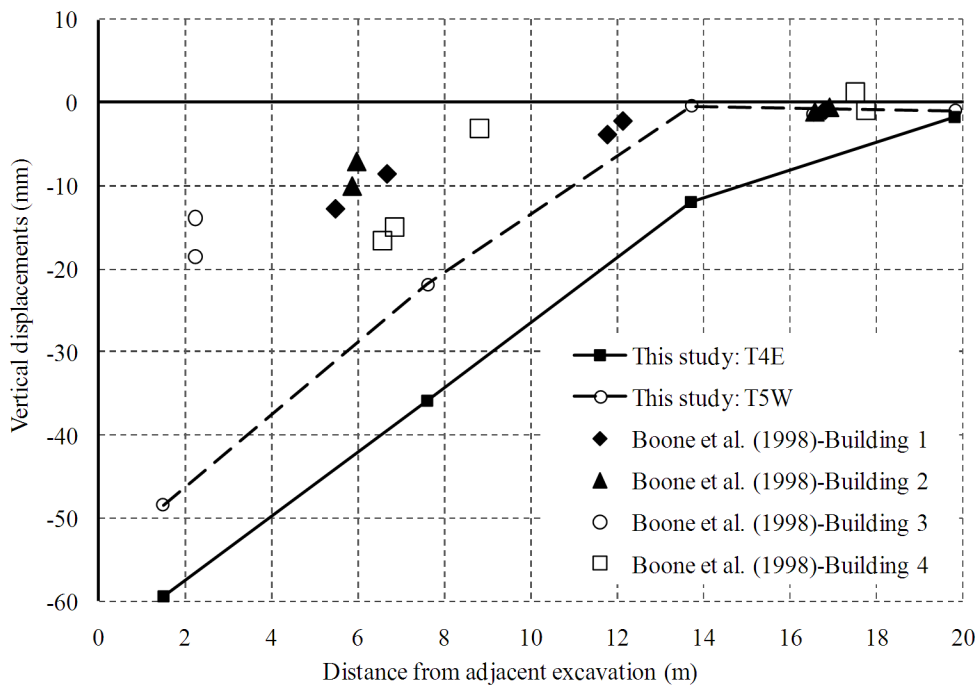
Figure 23. Vertical displacements of the bottom building

The third area of comparison was vertical building movements. Boone [43] published vertical displacements for four load-bearing masonry buildings for the abovementioned excavation. The structures ranged in height from 5.5m to 6.7m and in length from 10.9m to 29.0m (scaled up experimental walls were 6.1m x 18.3m). The trends were similar in response shape, even though the experimental wall movements were generally larger (maximum 60mm when scaled up) versus the field observations (maximum 20mm). The difference can be understood as the extreme proximity of the experimental buildings to the adjacent excavation, (Figure 21).

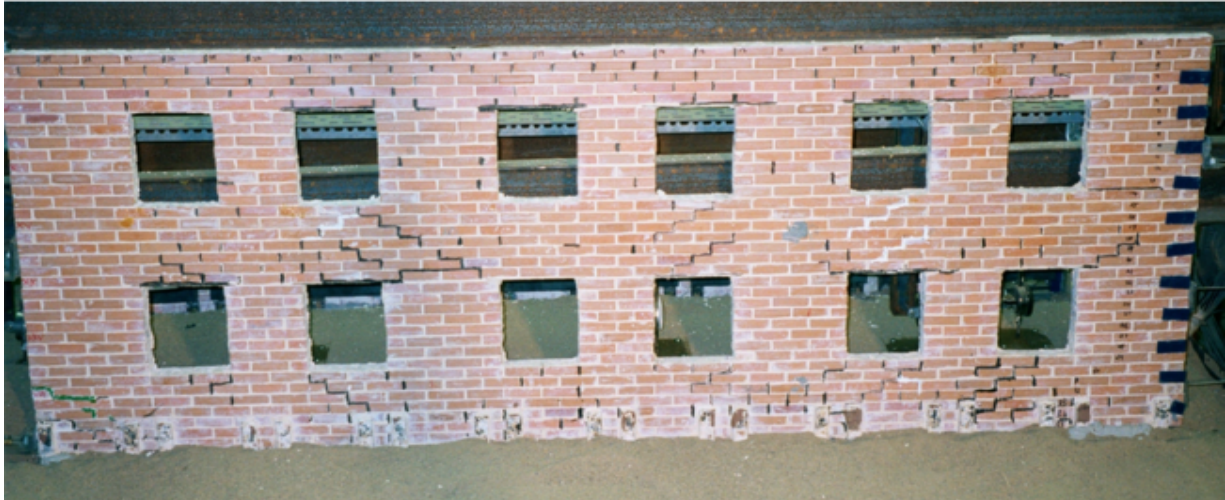
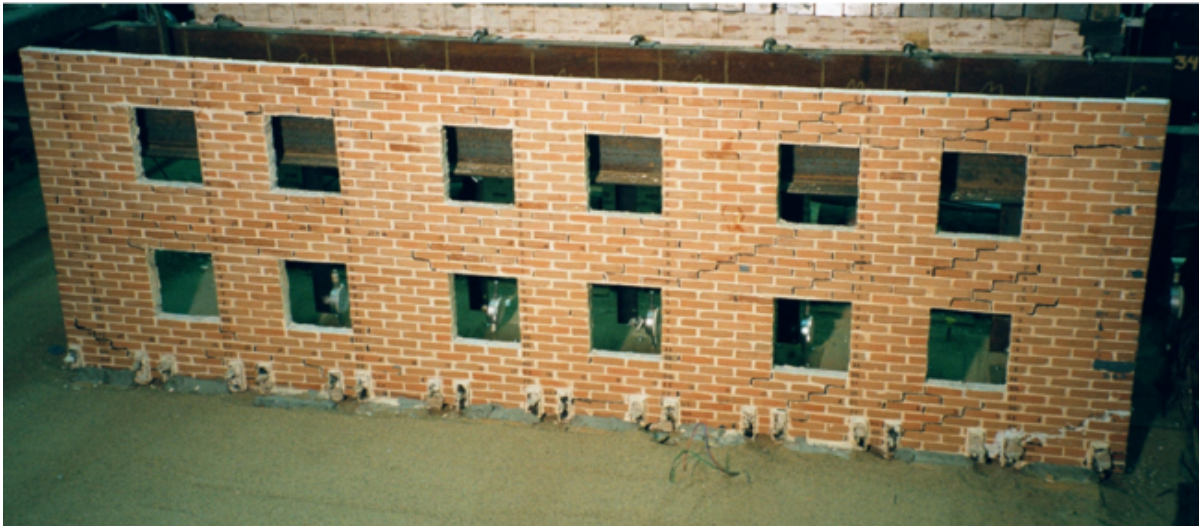
Figure 24. Cracks on the building model.

a) Test 4 at end of study (excavation from right side)

b) Test 5 at end of study (excavation from right side)

c) Cracks in a real building (adapted from Boone et al. 1998)

The final validation area was damage patterns in the masonry. The general damage and distortion patterns, magnitudes, and cracking densities were commensurate with previously reported cases [43, 44]. The major difference was that damage was more distributed over the entirety of the model, as there were no roof or floor elements to act as diaphragms. Cracks on the scale model propagated from the building bottom toward the building top, in which most of crack appeared on brick-mortar interface that was parallel to diagonal lines of the windows. In the half of the building model closest to the excavation face, the diagonal crack parallel to diagonal lines of the window from a bottom left corner to a top right corner and in another building model, cracks appeared in opposite direction (Figure 24a and b). This observation was consistent to the cracks on real building (Figure 24c). Model damage across the top was due to the lack of a confining roof member. The model walls generally showed diagonal shear cracking, similar to that recorded by the lead author at a site in central Illinois in 2001 (fig. 25), where damage was heavily concentrated in the front lower corner and around the windows.

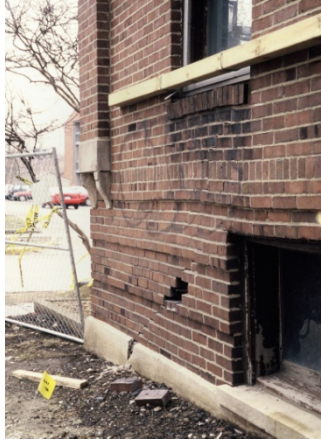
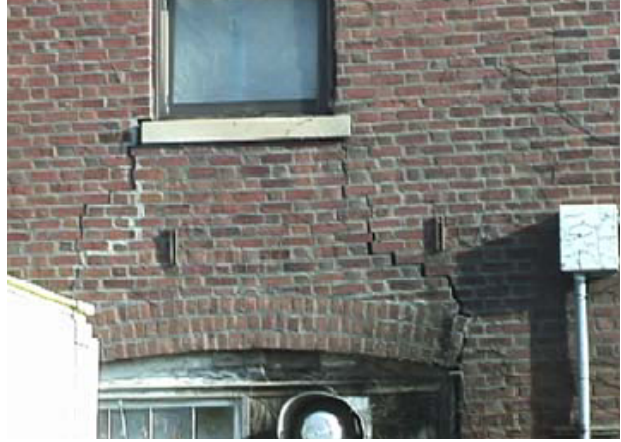
a) Front corner of building

b) Ground floor and first floor windows

Fig. 25. Adjacent excavation induced damage at a building in central Illinois 2001
