Impact fatigue fracture of polycrystalline diamond compact (PDC) cutters and the effect of microstructure.

Kanyanta, V., Dormer, A., Murphy, N, Ivankovic, A.

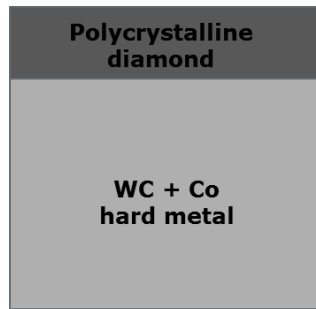
Figure 1: Geometry of a typical PDC cutting tool used in Oil & Gas drilling.

Polycrystalline diamond compact (PDC) cutters are widely used in oil and gas drilling [1-8]. Their superior abrasion resistance is seen as the main contributor to the greatly improved drilling efficiency and economy [1]. These cutters are composed of a layer of polycrystalline diamond bonded in-situ on to a tungsten carbide substrate as shown in Figure 1. The bonding is done during a high pressure and high temperature sintering process. The polycrystalline diamond layer is also created during this process to form a sintered material characterised by strong diamond to diamond bonding [2]. However, despite their extensive use and excellent abrasion resistance PDC tools are still highly susceptible to fractures [3-8]. This is mainly a result of their relatively low fracture toughness [9].

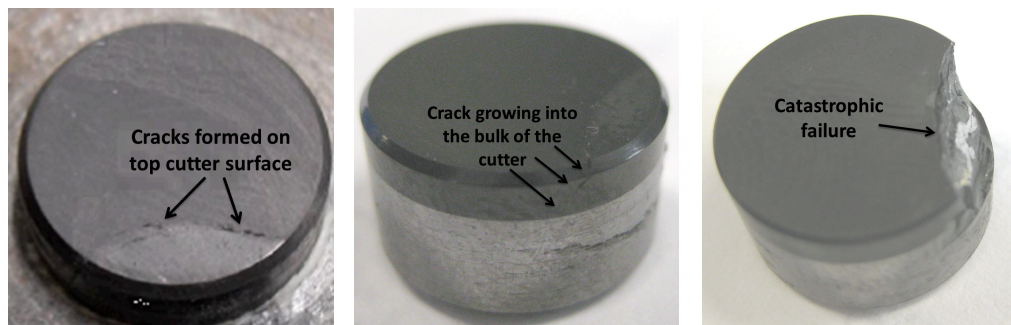
Figure 5: Failure of the PDC cutter under cyclic impact loading, showing the (a) initial stage, (b) intermediate stage where the crack has extended by more than 2mm into the diamond layer thickness and (c) final stage (catastrophic failure).

Three stages of cutter failure were identified, i.e. first visible surface crack (FVSC), crack growth through the polycrystalline diamond layer (CG-PCD) and catastrophic failure (CF). Here catastrophic failure is defined as extensive cracking and large-scale chipping or gloss fracturing. During application, a cutter will continue cutting until catastrophic failure occurs. The first two criteria (i.e. FVSC and CG-PCD) are relatively more difficult to quantify as they are based on visual inspection of the cutter. As a consequence, the test was stopped at set intervals and the cutter surface inspected for surface cracks and the extent of crack growth in the polycrystalline diamond layer. FVSC is the first appearance of a visible crack at the top surface of the cutter and CG-PCD is when the crack extends to more than 2mm

into the polycrystalline diamond layer thickness. Figure 5 shows examples of the three failure criteria used, i.e. FVSC (Figure 5(a)), CG-PCD (Figure 5(b)) and CF (Figure 5(c)).

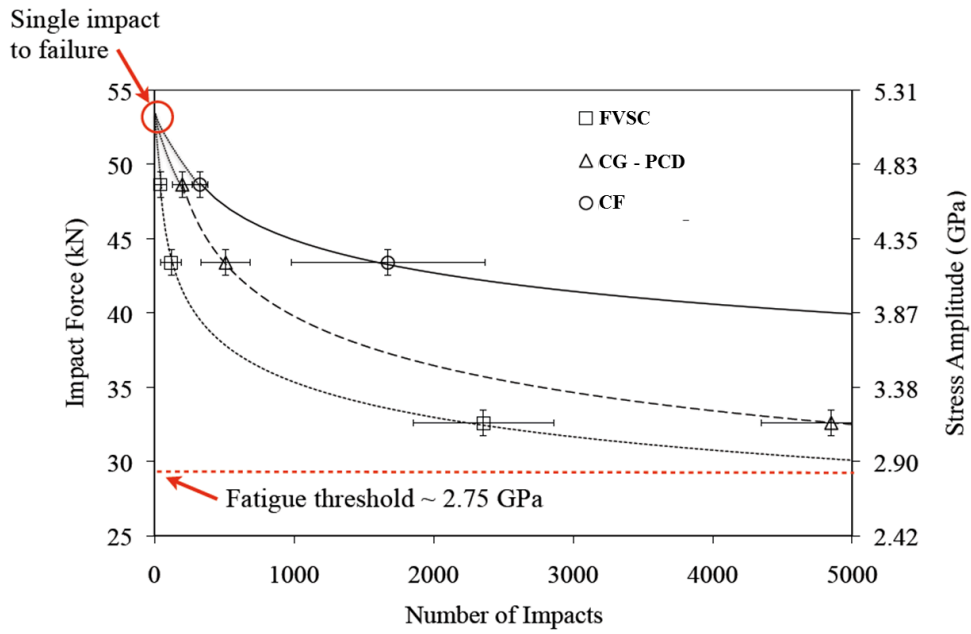
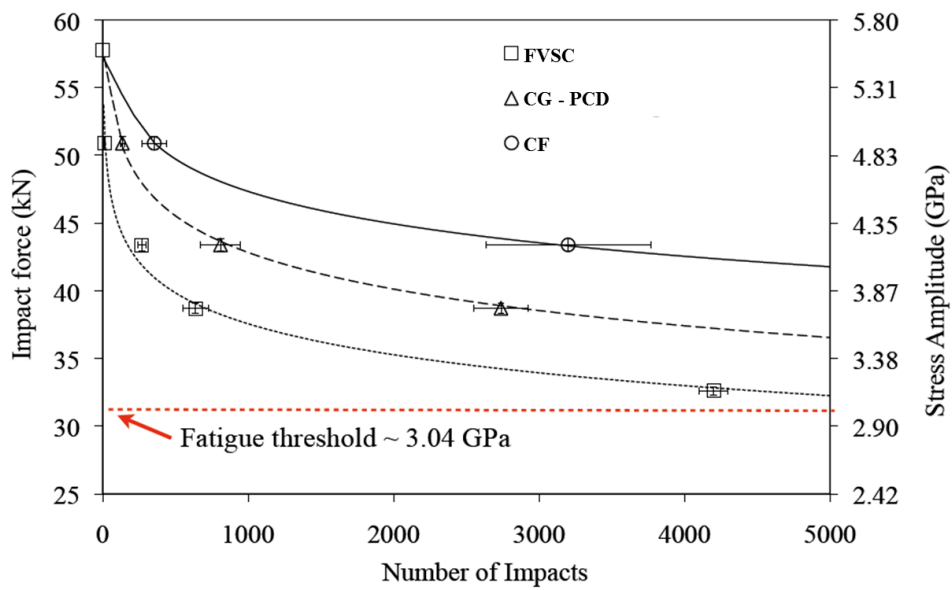
Figure 7: Cyclic impact S-N fatigue curves for (a) PDC-A and (b) PDC-B. Three curves plotted in each case, i.e. first visible surface crack (FVSC), crack growth through PDC thickness (CG-PDC) and catastrophic failure (CF).

The test results for the two PDC cutter variants are presented in Figure 7(a) and 7(b) in form of force (or stress) vs. number of impacts to failure (S-N curves) for PDC-A and PDC-B, respectively. Three curves are plotted in each case, showing the number of impacts to first visible surface crack (FVSC), crack growth through polycrystalline diamond layer (CG-PCD) and catastrophic failure (CF) at each force amplitude. The results show a typical fatigue behaviour pattern with the force or stress needed to cause fracture decreasing with the number of cycles. As the applied force continues to be lowered, it approaches an asymptote, also known as a fatigue threshold. This threshold, obtained by fitting an exponential curve to experimental data, is estimated to be around 28.5 kN (2.75 GPa) and 31.5 kN (3.04 GPa) for PDC-A and PDC-B, respectively. The three curves (FVSC, CG-PDC and CF) when extrapolated backwards converge at a single point on the vertical axis, which corresponds to the single impact to failure. This is about 54 kN for PDC-A and 58 kN for PDC-B. At this force (or impact energy) there is sufficient energy to initiate cracks and almost instantaneously grow them to catastrophic failure in a single impact. Hence the three events (crack initiation, growth and catastrophic failure) appear superimposed in one single event. This is normally the value that would be measured in the traditional impact drop tests. At any force amplitude less than this critical force, an initiated crack tends to extend with each successive impact until it reaches a critical size to cause catastrophic failure. This is believed to also be the case during application where cutter failure is likely to result from multiple impact loads. The significance of these curves is that if the average impact force amplitude associated

with a given application is known, the number of cycles to FVSC until catastrophic failure can easily be estimated.

The high scatter in the results, especially for CF, is expected for the fatigue fracture of such brittle materials. This can be due to the non-uniform distribution of pre-existing flaws in the bulk of the material. The number and distribution of these flaws is also expected to vary between the cutters. As a consequence, the variation in the number of impacts to failure is high. In addition, fatigue is a stochastic process and often shows considerable scatter even in well controlled experiments. This scatter tends to increase for longer fatigue lives. Therefore, the scatter is less for FVSC and CG-PCD in comparison to CF as also shown in Figure 7. Figure 8(a) shows the schematic of the sample loading configuration. The first sign of cutter failure during the test was the formation of circular cracks on the top surface of the polycrystalline diamond layer of the PDC cutter. This occurs just outside the impact contact region as shown in Figure 8(b). Once initiated the cracks continue to grow with each successive impact until catastrophic failure occurs (Figure 8(c)).

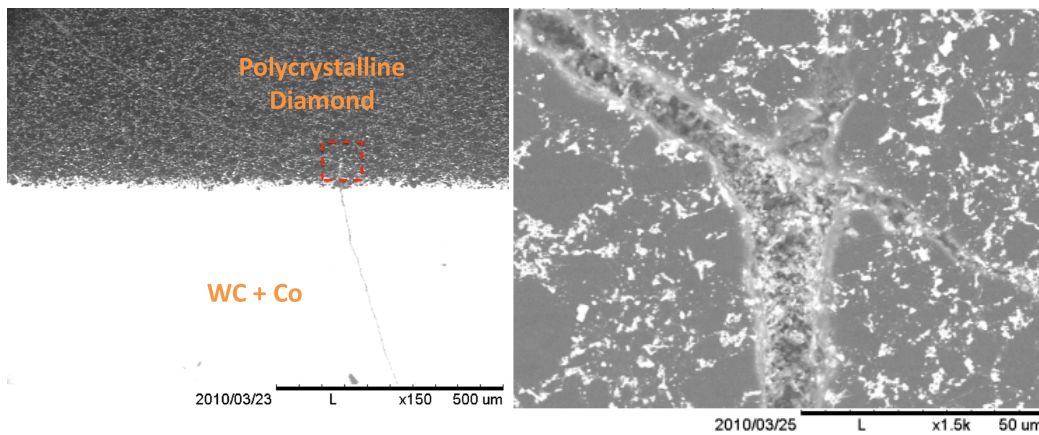
Figure 11: SEM images showing change in crack direction (and bifurcation) at the PDC-substrate interface. Right: close-up of the image on left, showing attempted crack bifurcation on path change.

Typical values of the angle the crack makes with the surface has been reported to be 20-30° for pure mode I [15-18] and 30-55° for mixed mode I/II crack propagation [17]. In the current study, this angle is about 47° (Figure 9(b)). However, this may not necessarily suggest mixed mode of crack propagation. It may be due to the presence of high pre-existing residual stresses in the PDC cutter [12]. Fracture in this case can still be predominantly under mode I, with the crack following the normal stress or maximum principal stress trajectories. Figure 9(b) also shows abrupt change in the direction of the main crack as it approaches the interface between the polycrystalline diamond layer and the carbide substrate. This can be attributed to the influence of the high tensile residual stresses in this region [11, 12]. The crack bifurcates into two cracks with the small crack continuing in the same direction of the initial crack as shown in Figure 11. The larger crack is pulled towards the polycrystalline diamond-substrate interface and into the substrate. The other possible reason for the change in crack direction and/or crack bifurcation is the influence of the applied supporting pressure, p (Figure 8(a)).
