Difficulties with ground anchorages in hard rock in Dublin, Ireland

Michael Long, Department of Civil Engineering, University College Dublin, Ireland*

Bernard Murphy, BMA GeoEngineering, Carlow, Ireland

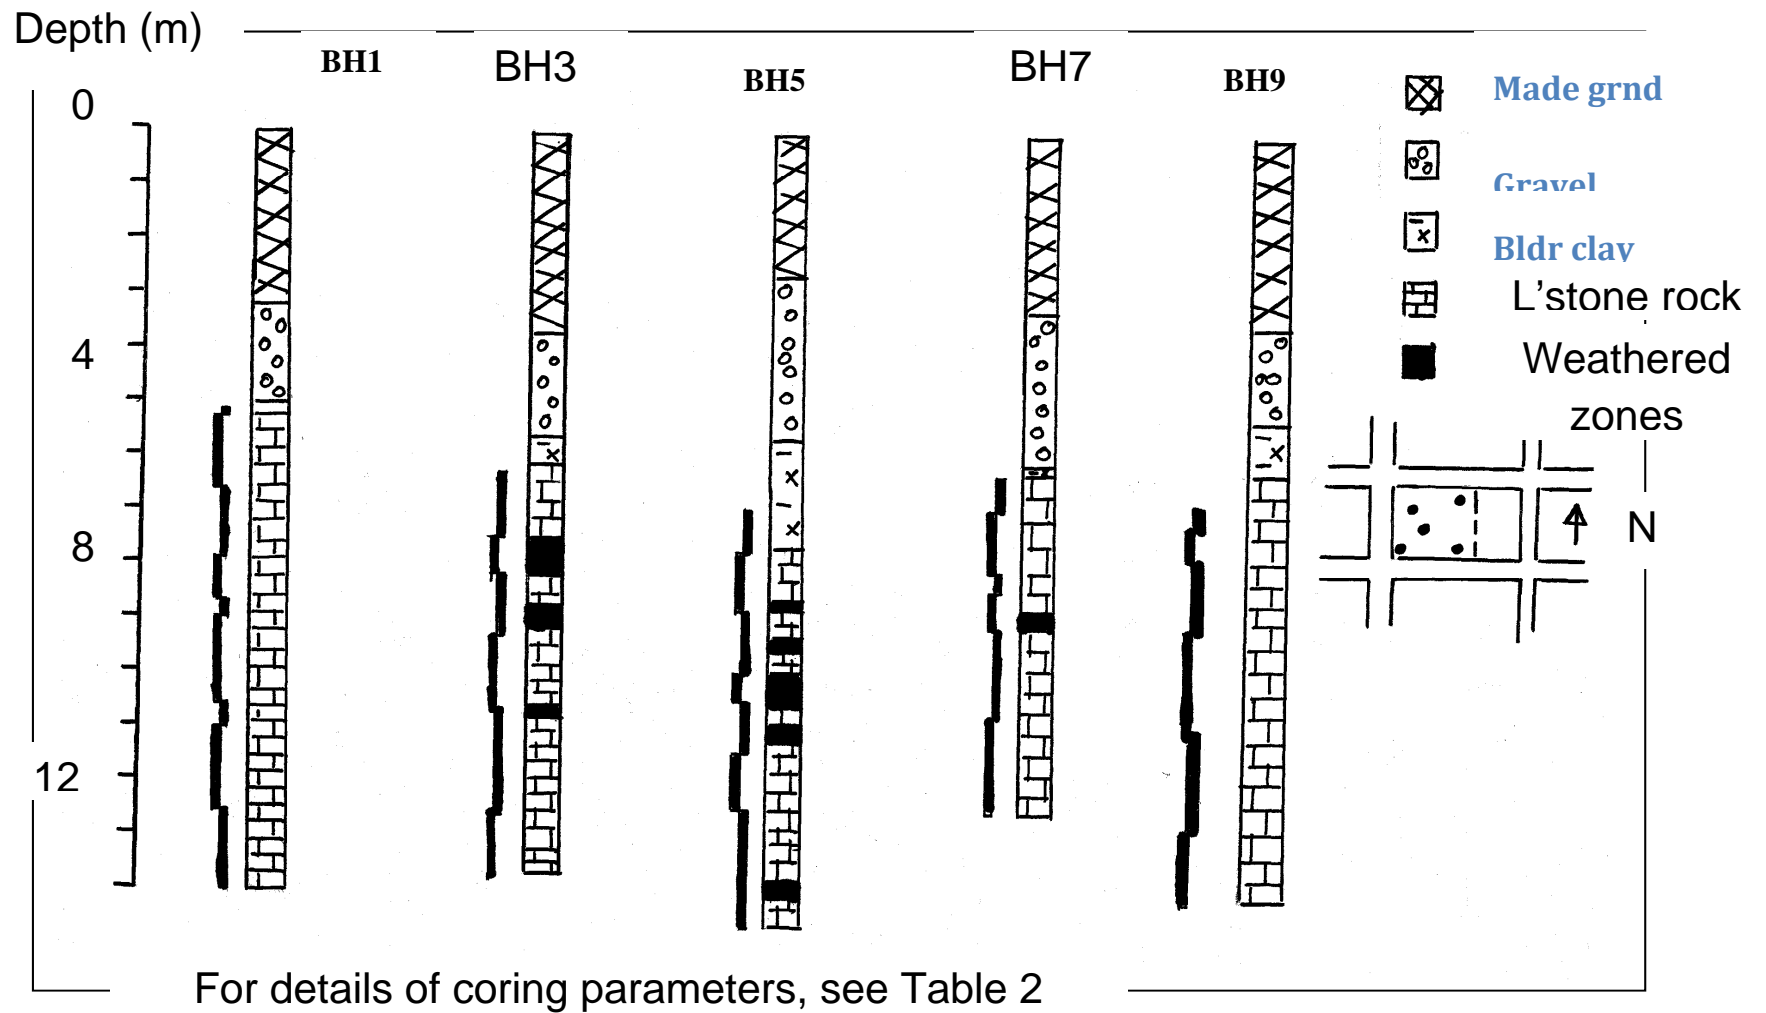
FIG 4. *Summary of rock coring*

when required. The upper 0.5 m to 1.0 m of the bedrock was confirmed to be weathered and fractured, see Figure 4.
