# Dewatering Induced Settlement of a Historic Landmark

**ABSTRACT:** Construction related dewatering in urban areas often induces damage of existing structures. The following forensic investigation highlights the complexities of such a phenomenon. Somerset plantation, a national historic landmark located in northeastern North Carolina is currently exhibiting distress. At many locations, these wooden structures on brick piers are experiencing sufficient differential settlement to impact building functionality. Heavy visitor traffic was proposed by the site staff as the cause of the building displacements. Given a perched aquifer located within a fatty clay, dewatering based settlement was suspected. Two potential sources of ground water change were investigated – (1) general drought conditions or (2) a nearby mining operation.

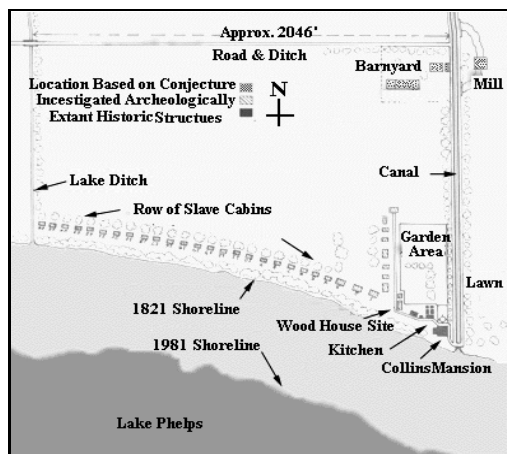
The present plantation site consists of a main dwelling, a kitchen, a smokehouse, a dairy, and a smaller house that originally served as the residence, until the main dwelling was built around 1830. These buildings are clustered relatively close to one another, approximately 600 feet north of the shore of Lake Phelps (Figure 4).

Figure 4. Somerset Plan (adapted from NCOAH, 2002a)
