A FRACTOGRAPHIC ANALYSIS OF DELAMINATION WITHIN MULTIDIRECTIONAL CARBON/EPOXY LAMINATES

Keywords: fractography, T300/914, carbon/epoxy composites, multidirectional laminates, fracture, delamination

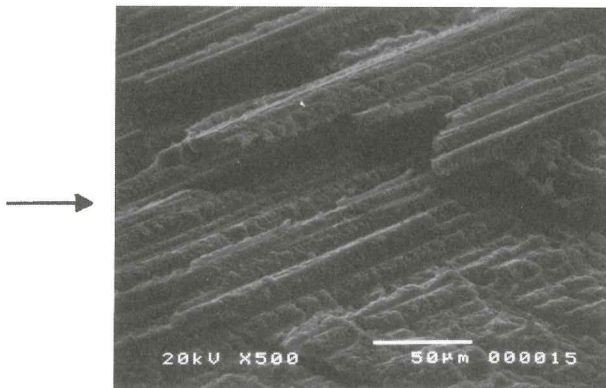
Fig. 1. Extensive fibre pull-out in mode I static fracture. The fibres are covered with resin. Cracks can be seen extending to the underlying ply (tilt angle is 70°). The globally induced direction of crack propagation is from left to right as shown by arrow.

In the present work on the T300/914 system, fibre pull-out was the dominant feature of the mode I fracture surface and this consisted mainly of fibre bundles rather than single fibres. The fibres were covered with a layer of resin indicating a strong interface (Fig. 1), whilst the resin itself was mainly featureless (Fig. 2). The extensive fibre pull-out shown

in Fig. 1 is greater than that observed in unidirectional laminates; this degree of pull-out is peculiar to multidirectional laminates with delamination along a $+45^\circ/-45^\circ$ interface. The fracture energy associated with such a delamination is also greater than that of a $0^\circ/0^\circ$ interface. This higher fracture energy can be explained by considering the greater number of cracks that are generated in the laminate: cracks can be seen extending into the underlying plies in Figs 1 and 2.

ends present, see, for example, Figs 1 and 2, this latter point being in contradiction to Lowe³⁶ and Davies³⁹ who reported only occasional broken fibres in mode I. A reason for this may be the use of different lay-ups (unidirectional versus multidirectional), fracture mechanics specimens, precracks, inserts, etc. The pull-out is chiefly in bundles with the same amount of fibre pull-out on the opposing fracture surfaces. The fibre/matrix interface is very strong as the pulled-out fibres all have a resin layer on them and all the fibres have fractured very cleanly. This was also observed by Lowe.³⁶ Ridges and valleys, together with very little pull-out, mainly single fibres, and a general flat appearance are the characteristics of a mixed mode fracture surface having about equal mode I and II components. According to Purslow,⁹ ridges and valleys form under a combination of peel and shear stresses. The characteristics of a mode II fracture surface have been determined in the present work to be few broken fibres, a rough resin fracture, relatively clean fibres and more cusps than in any other mode.

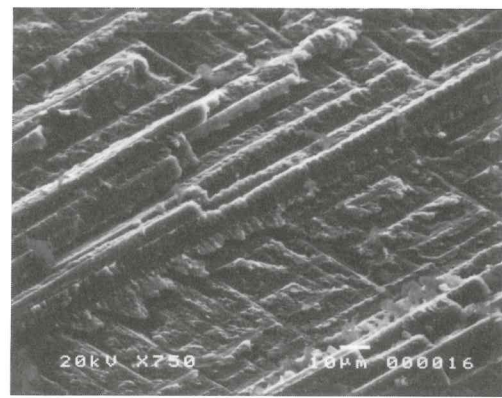
Fig. 2. Fibre pull-out with a lot of resin on the fibres and featureless resin fracture away from the fibres are characteristics for a mode I static failure (tilt angle is 75°). The globally induced direction of crack propagation is from right to left as shown by arrow.

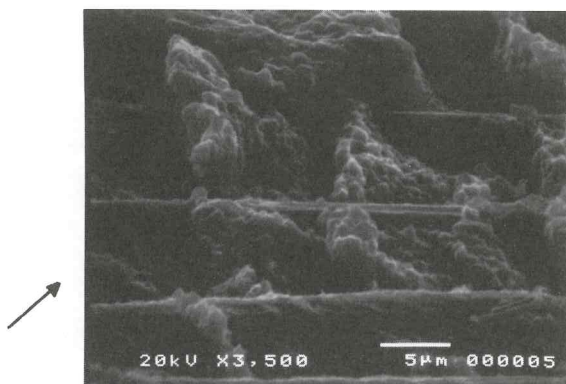
Fig. 3. Cusps standing at a large angle to the plane of a mode II static fracture surface. The cusps are present between the fibres (tilt angle is 75°). The globally induced direction of crack propagation is from bottom left to top right as shown by arrow.

In the present work, the macroscopic appearance of the mode II static fracture surface in T300/914 multidirectional laminates is flat with few fibre fractures being evident. Typical mode II static fracture surfaces can be seen in Figs 3 and 4 with rough resin fracture and some debris and nodules. The fibres are almost clean (Fig. 3) with only a thin sheath of resin around them. The cusps are more common, larger in size, more clearly defined and stand more upright than in any other mode. In Fig. 4 it looks as though there is a preference for the cusps to form at the fibres of the underlying ply. They also seem to be oriented perpendicular to the crack propagation direction. A short distance after the end of the insert, the crack jumped into a $0^\circ/45^\circ$ interface (not shown) and the surface appearance in this region is extremely flat and featureless indicating a much lower fracture energy. This implies that less energy has been required to generate the $0^\circ/45^\circ$ fracture surface.

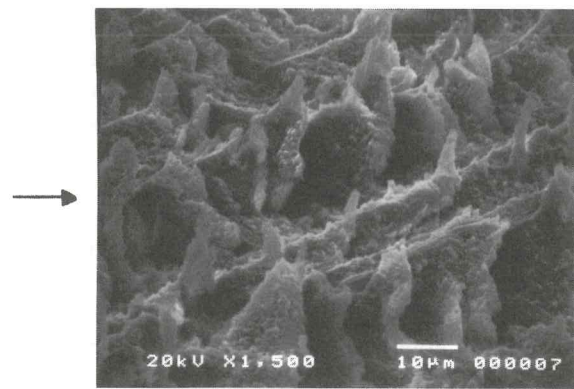
Fig. 4. Many upright cusps are visible and appear to stand on the underlying fibres on this mode II static fracture surface (tilt angle is 65°). The globally induced direction of crack propagation is from left to right as shown by arrow.

The cusp angle is quite difficult to determine accurately since the cusps in this particular resin system are not very clearly defined and hence it is hard to define the boundaries of the cusps. Another complicating factor is that the cusps do not show a great similarity with each other (see, for example, Figs 4 and 12), even in the same loading mode. The cusp angles for the different loading modes are given in Table 2. The errors in measuring cusp angle are estimated to be roughly $\pm 3^\circ$. Further studies relating cusp angle to the mode of fracture are to be discussed in future work.

Several matrix features have shown a preference to form at the fibres of the underlying ply, as shown typically in Fig. 4. No similar observations have been found in the literature. This may be caused by failures very close to the boundary of the interlaminar resin region or by stress concentrations induced by the fibres. The phenomenon is probably dependent on the orientation of the fibres in the adjacent plies since a smoother fracture surface was seen at delaminations which did not occur along a cross-ply interface.⁴⁸ If

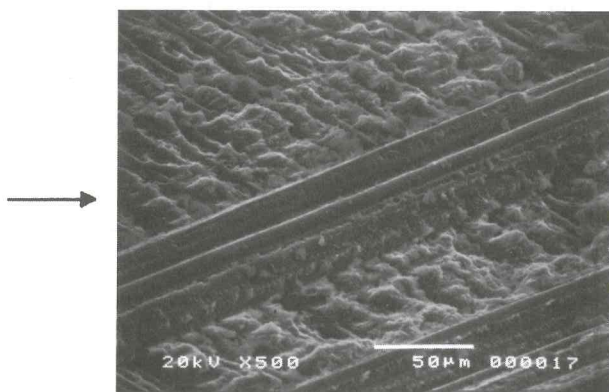
Fig. 5. The mixed mode I:II = 6:1 static fracture surface with featureless resin and fibre pull-out. The general appearance of this fracture surface is similar to that of a pure mode II surface, as shown in Fig. 2 (tilt angle is 65°). The globally induced direction of crack propagation is from left to right as shown by arrow.

The mixed mode I:II = 6:1 static fracture surfaces of the T300/914 multidirectional laminates of the present work were very similar to those observed in pure mode I loading. Less extensive pull-out and a rougher resin fracture appearance than that in pure mode I are the main differences, as shown in Fig. 5. Some few cusps were found due to the component of mode II loading. These cusps were quite shallow and not as well defined as in pure mode II.

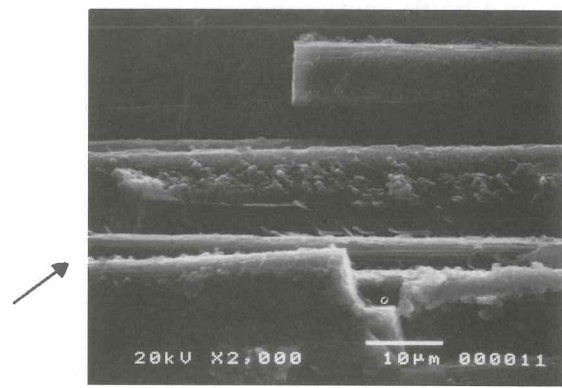
Fig. 6. Fractured fibres covered with a thin layer of resin. Minute cusps on a fibre are indicated by the arrow. Very sharp fibre fractures indicate good interfacial strength. Mixed mode I:II = 4:3 static fracture (tilt angle is 15°). The globally induced direction of crack propagation is from bottom left to top right as shown by arrow.

The fracture surface of static mixed mode I:II = 4:3 is macroscopically flat. Occasional fibre pull-out is seen and the fibres have some resin on them and are not as clean as in pure mode II (Fig. 6). Very minute cusp-like features can be seen around the sites of pulled-out fibres. A fibre with resin flanges, or wings, is seen in Fig. 7. Ridge and valley formations are frequently found and they seem to form in the vicinity of the fibres of the underlying ply. Cusps are rare although in Fig. 8 they can be seen in a micrograph taken at a low tilt angle. Figure 9 shows cusps from the middle of the sample a few millimetres ahead of the insert. Resin debris and nodules are present due to mixed mode I:II = 4:3 fatigue fracture in relatively large amounts. Very little fibre fracture occurred. No clearly defined cusps were found but some shallow, worn cusps were seen. The fibres are cleaner of resin in the fatigue fracture compared to the static. No fatigue striations were found.

Evidence has been found for the stress distribution proposed by Bascom *et al.*²⁴ around the fibres loaded in peel. Figure 7 shows resin flanges on a pulled-out fibre. In Fig. 6 minute cusps are seen (indicated by the arrows) as a result of the localised shear stresses present in the fibre/matrix separation process. This occurs around a fibre where the radial stress changes from tensile to compressive, causing local shear yielding to be induced in the matrix. This failure of the matrix material due to local shear yielding leaves flanges of resin on the edges of the fibres as they are peeled out.²⁴

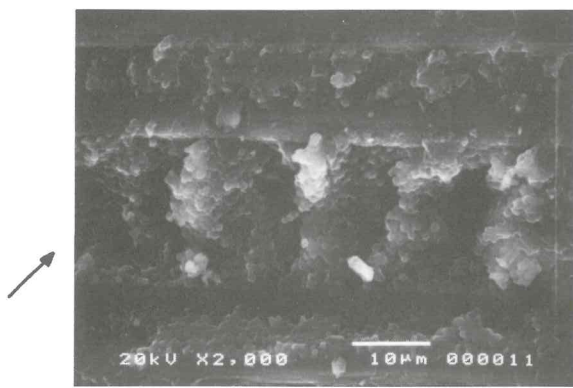
Fig. 8. Cusps as observed at a low tilt angle. A few resin nodules can be seen and the resin structure is quite clear. Mixed mode I:II = 4:3 static fracture (tilt angle is 15°). The globally induced direction of crack propagation is from bottom left to top right as shown by arrow.

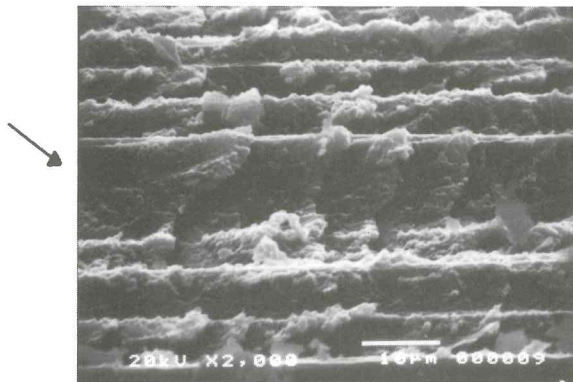
Fig. 9. Relatively well defined cusps from a mixed mode I:II = 4:3 static fracture. The cusps are present between the fibres (tilt angle is 70°). The globally induced direction of crack propagation is from top left to bottom right as shown by arrow.

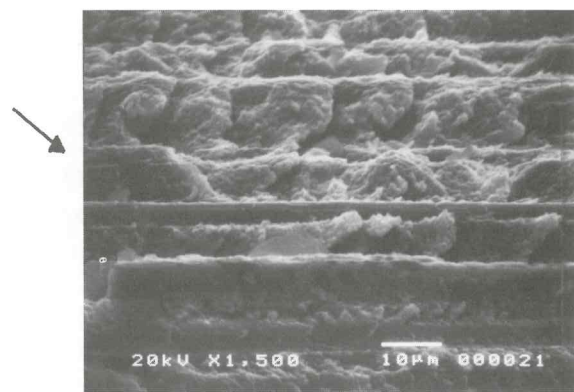
Fig. 10. Cusps on a mixed mode I:II = 3:4 static fracture surface. The cusps are present between the fibres (tilt angle is 70°). The globally induced direction of crack propagation is from top left to bottom right as shown by arrow.

Some single fibres were seen on the surface rather than completely pulled-out fibre bundles. The fibres are covered with little resin. Cusps are relatively common but they are quite small and ill-defined, as shown in Figs 10 and 11.

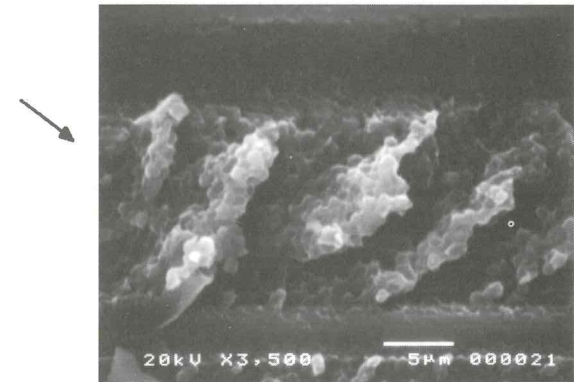
Fig. 11. Cusps oriented perpendicular to the fracture direction as observed at a low tilt angle. Mixed mode I:II = 3:4 static fracture (tilt angle is 10°). The globally induced direction of crack propagation is from top left to bottom right as shown by arrow.

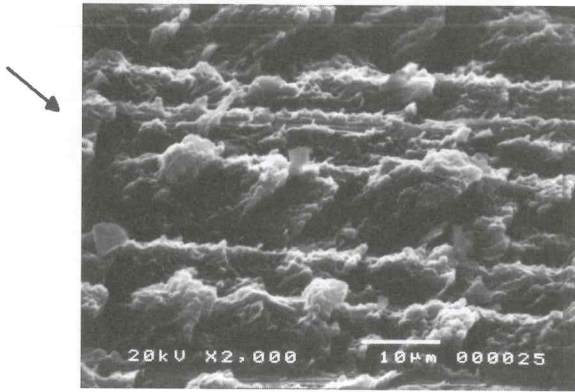
Fig. 12. Cusps which are oriented perpendicular to the crack direction and are standing more upright than on other mixed mode fracture surfaces. Mixed mode I:II = 3:10 static fracture (tilt angle is 65°). The globally induced direction of crack propagation is from top left to bottom right as shown by arrow.

The mixed mode I:II = 3:10 static fracture surface is also very flat macroscopically and extremely few fibre ends are found. Not surprisingly, the fibres are almost as clean as in pure mode II. The location of some ridges appears to be related to the sites of fibres on the opposite fracture surface. The very small amount of matrix found on the surface, especially between the fibres, implies that failure has taken place close to a ply interface. This would leave more resin on the other surface which is what has been observed. The cusps of Fig. 12 stand more upright than for the other mixed mode fracture surfaces which have been examined.
