**A Systematic Approach for Large-scale, Rapid, Dilapidation Surveys of Historic, Masonry Buildings**

## A SYSTEMATIC APPROACH FOR LARGE-SCALE, RAPID, DILAPIDATION SURVEYS OF HISTORIC MASONRY BUILDINGS

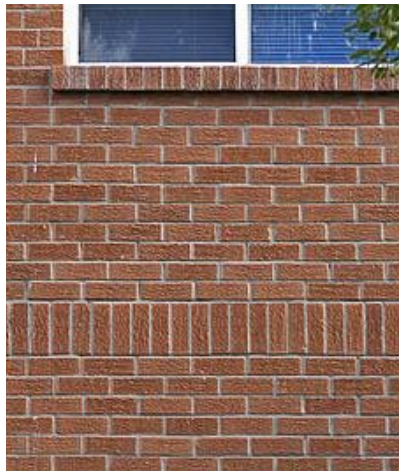
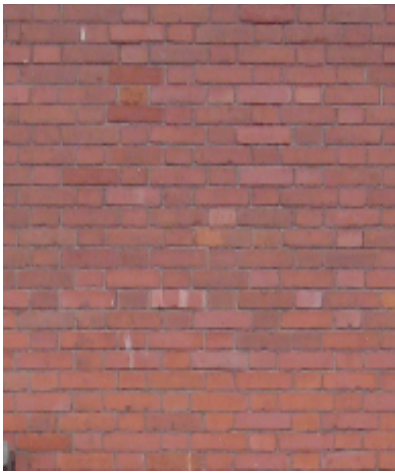
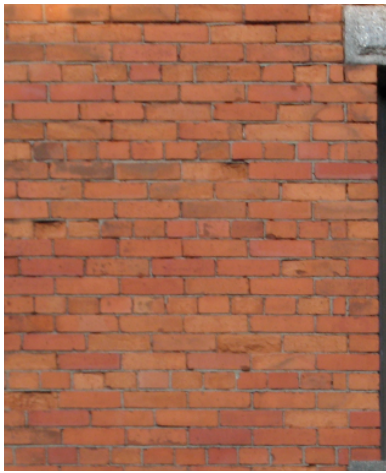
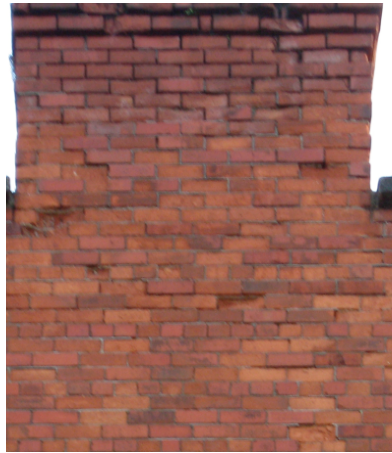
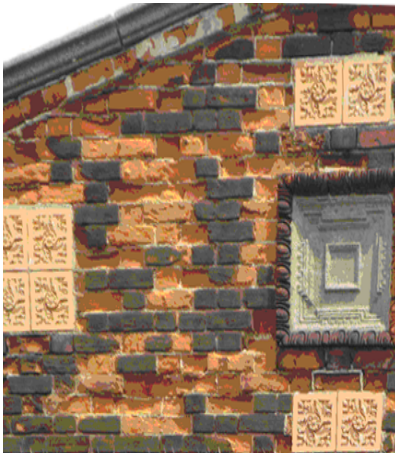
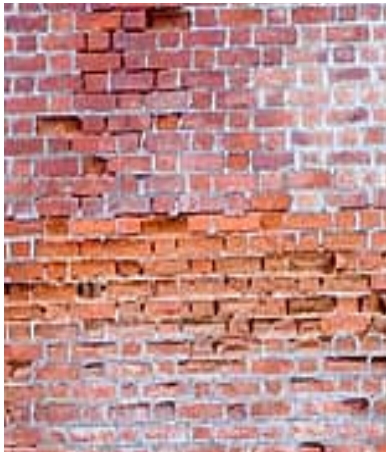
**Figure 1.** Protruding or loose brickwork index images (to be used in conjunction with Table 3)

**Figure 1.** Protruding or loose brickwork index images (to be used in conjunction with Table 3)

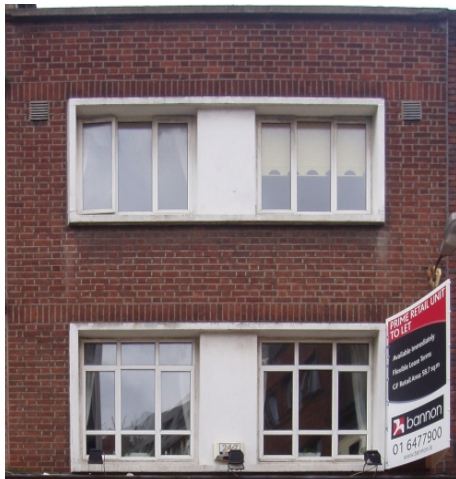
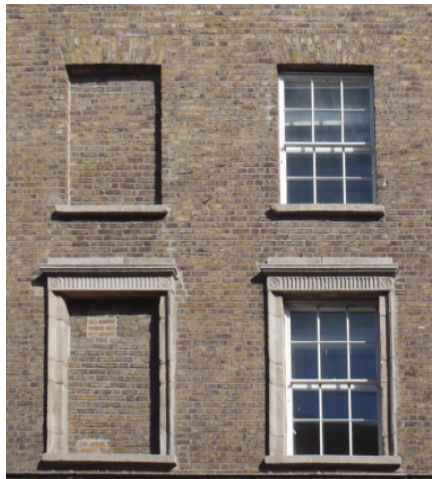
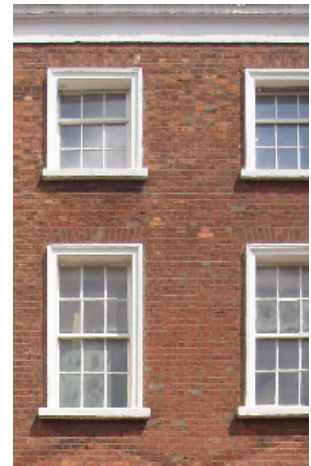
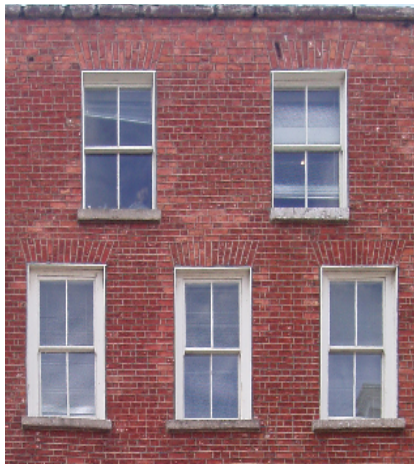
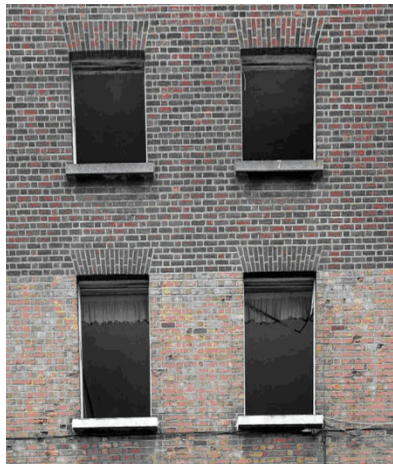
**Figure 2.** Replaced or repaired brickwork index images (to be used in conjunction with Table 4)

**Figure 2.** Replaced or repaired brickwork index images (to be used in conjunction with Table 4)

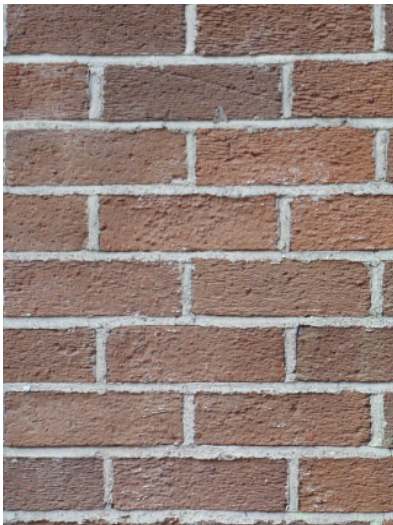
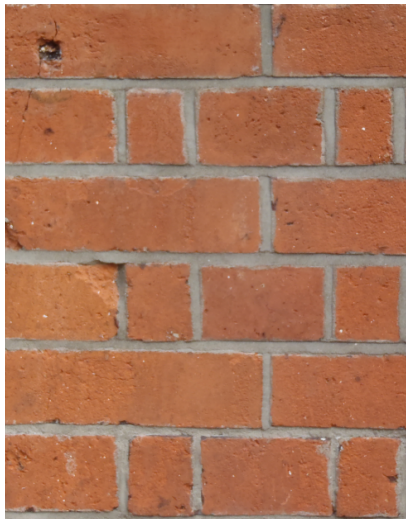
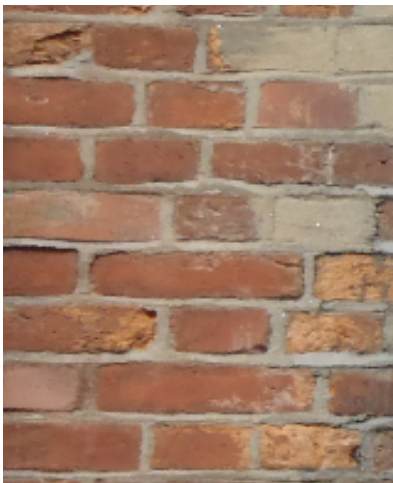
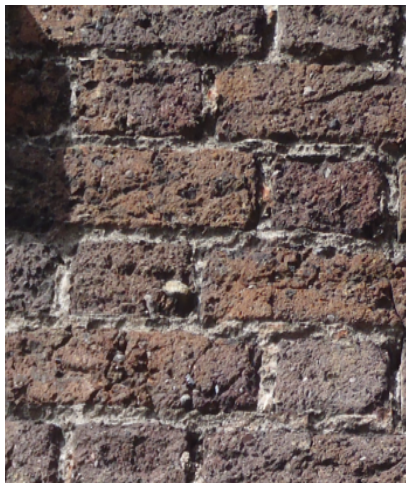
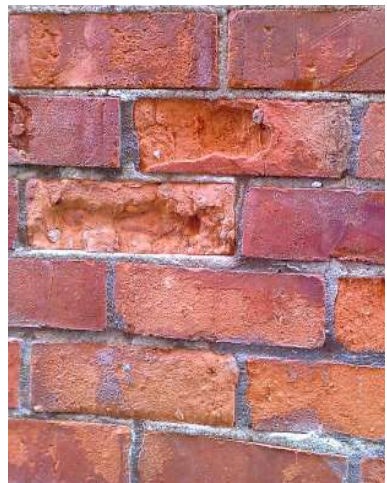
Figure 3. Damage due to exposure index images (to be used in conjunction with Table 5)

**Figure 3.** Damage due to exposure index images (to be used in conjunction with Table 5)

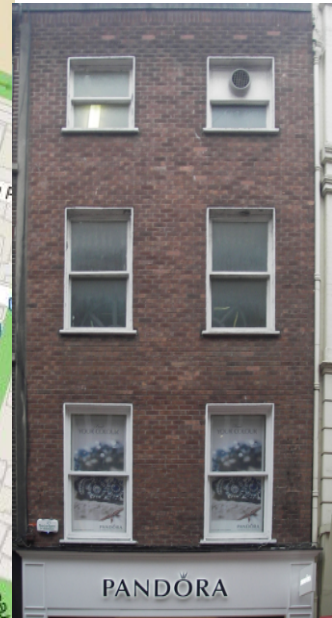
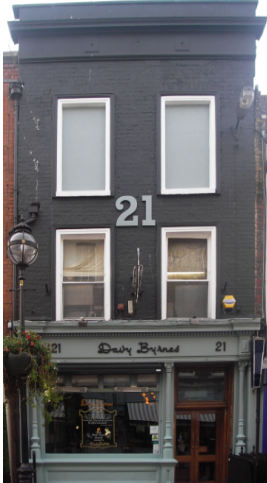
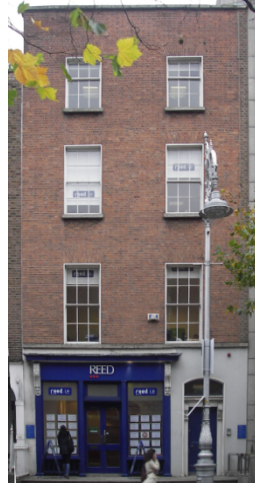
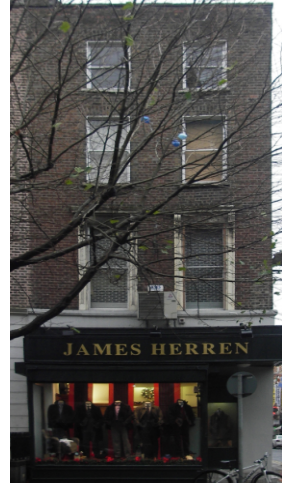
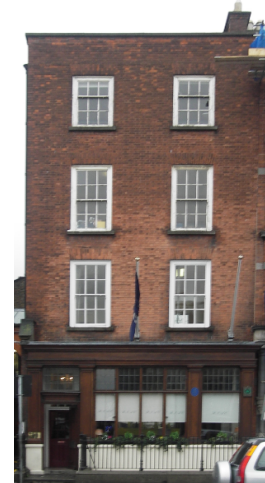
Figure 4. Selected buildings

obtained from only 5% of this dataset, resulting in access to only 6 buildings (Figure 4). Details of these six buildings are provided in Table 9.

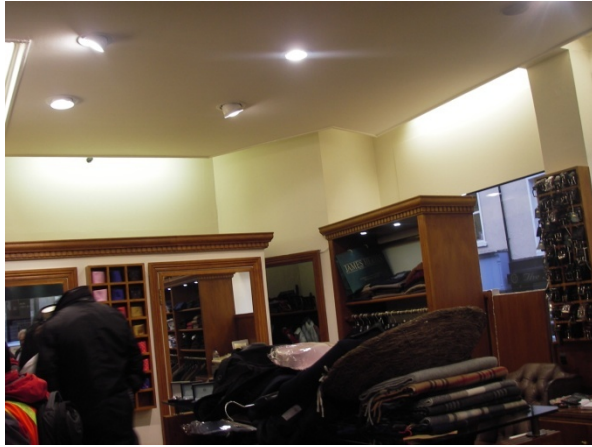
**Figure 5.** Type 1 (Building E) - interior views

**Figure 5.** Type 1 (Building E) – interior views

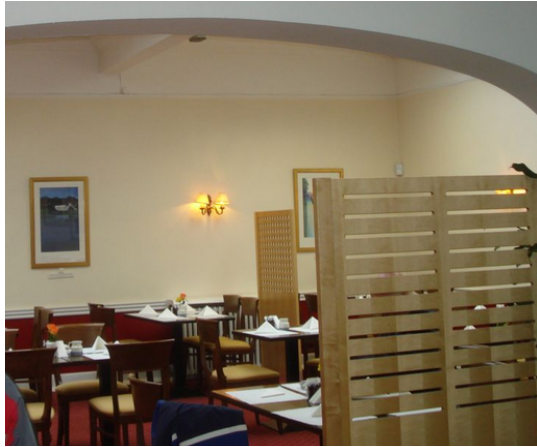
**Figure 6.** Type 2 (Building F) - interior views

Buildings D and F provided examples of Type 2, where the building consists of highly maintained commercial units on all floor levels, with public access at the ground level and private offices in the upper storeys. Visible defects were mainly aesthetic in nature and limited to cracked plasterwork. Figure 6 illustrates the state of Building F's interior.

**Figure 6.** Type 2 (Building F) – interior views

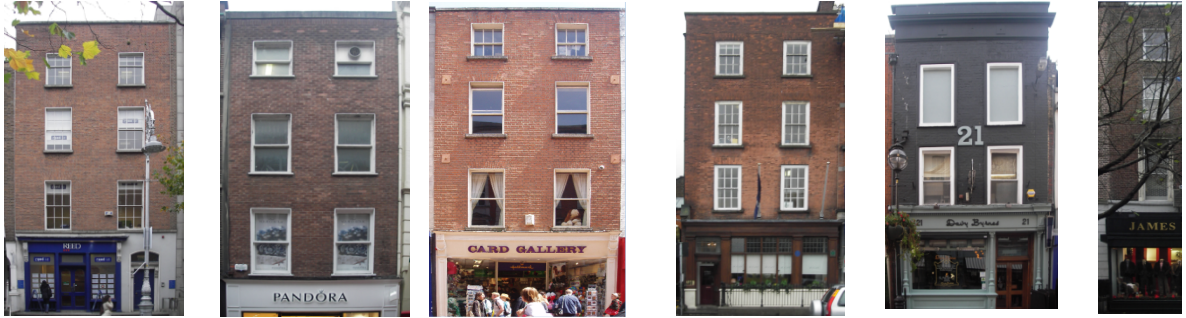
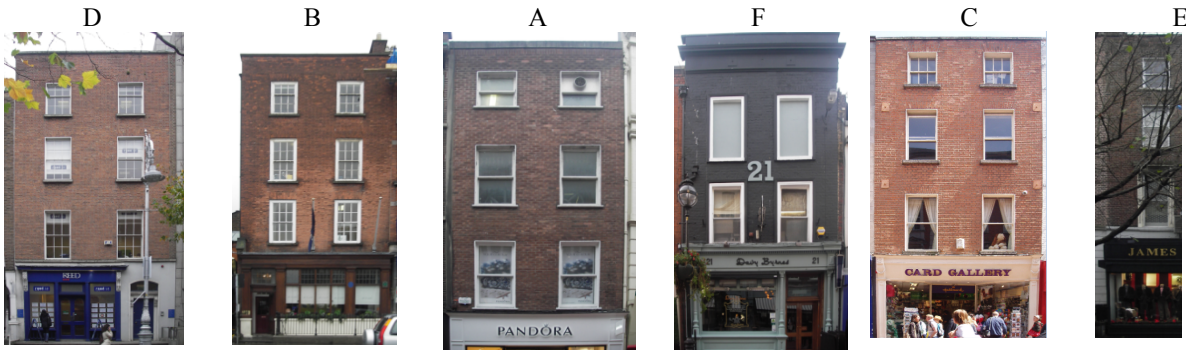
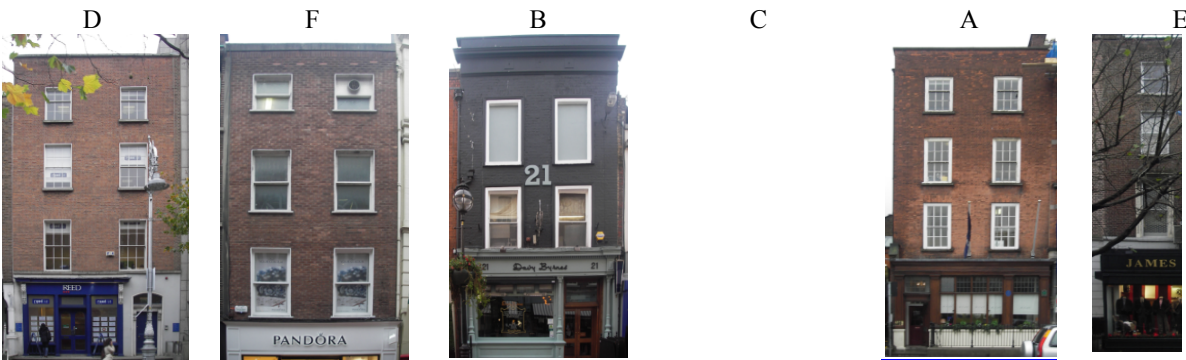
D	B	C	A	F	E
1	2	3	4	5	6
(Least damaged)					(Most damaged)

**Figure 9.** Damage ranking according to Inspector I

Figure 9 illustrates the damage ranking for the three methods according to Inspector I. All three methods assign Building D as the least dilapidated state and Building E as the most. However, differences are evident for the rankings in between. The detailed inspection considers Building C to be ranked fifth, i.e. second highest level of damage. However, the CEF System ranks this building fourth while the UCDIM places it third. The CEF System ranks Building A fifth, while the UCDIM ranks it fourth, and the detailed inspection ranks it third. Furthermore, the CEF System considers Building F as the second least damaged building, while the UCDIM lists it the second most damaged. Even though the UCDIM considers only the exterior façade, the findings reveal that for the majority of instances, this can provide a good estimation of the overall state of dilapidation for buildings in this region.
