Title	Hydrogeological and geophysical properties of the very-slow-moving Ripley Landslide, Thompson River valley, British Columbia
Authors(s)	Huntley, David, Holmes, Jessica, Bobrowsky, Peter, Donohue, Shane, et al.
Publication date	2020-08-20
Publication information	Huntley, David, Jessica Holmes, Peter Bobrowsky, Shane Donohue, and et al. "Hydrogeological and Geophysical Properties of the Very-Slow-Moving Ripley Landslide, Thompson River Valley, British Columbia." Canadian Science Publishing, August 20, 2020. https://doi.org/10.1139/cjes-2019-0187.
Publisher	Canadian Science Publishing
Item record/more information	http://hdl.handle.net/10197/12529
Publisher's version (DOI)	10.1139/cjes-2019-0187

1 Hydrogeological and geophysical properties of the very slow-moving Ripley Landslide,

2 Thompson River valley, British Columbia

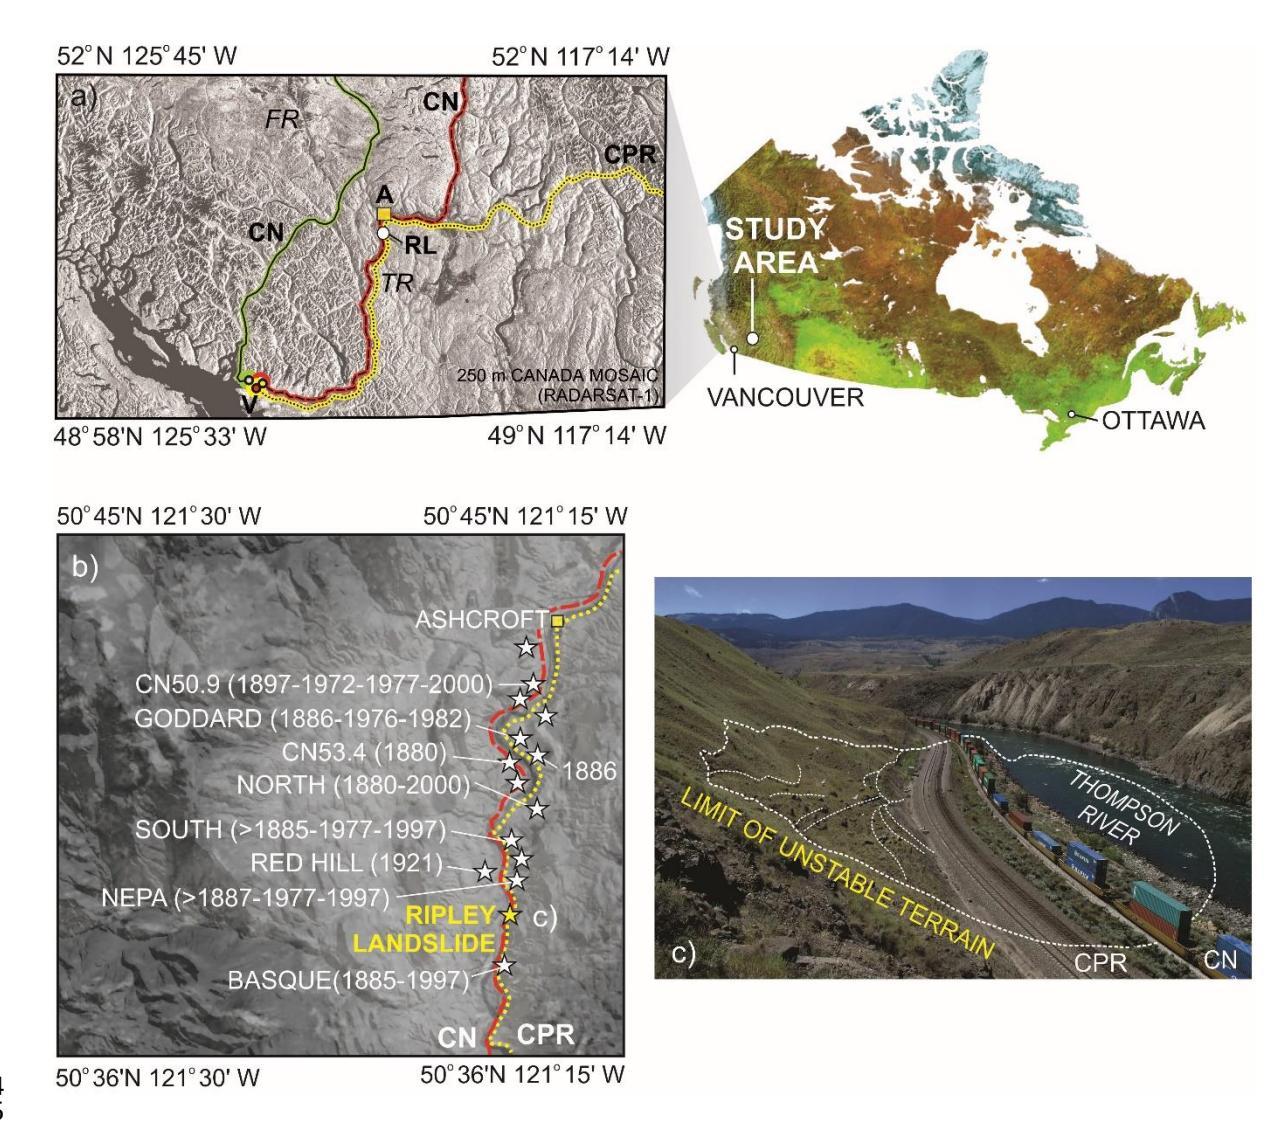
Fig. 1 The study area. a) Rail transportation corridors in southwestern British Columbia with location of the
Thompson River valley area of interest: A – Ashcroft; K – Kamloops; L – Lytton; S – Spences Bridge; V –
Vancouver; FR – Fraser River; TR - Thompson River. b) Landslides of the Thompson River valley, with location
of Ashcroft, the railway transportation corridor and Ripley Landslide test site. c) Overview of the test site
highlighting the approximate limit of unstable terrain and submerged slide toe.

The ten-kilometre stretch of Thompson River between Ashcroft and Basque Ranch, British 42 Columbia (BC) has experienced numerous landslides since the mid-1800s (Fig. 1). In light of 43 threats to trans-continental transportation, Stanton (1898) investigated the earliest of these 44 events in one of the first landslide studies in the Canadian Cordillera. Subsequent rapid failures 45 occurred during the twentieth century (Porter et al. 2002; Clague and Evans 2003) and 46 47 numerous landslides along this reach continue to creep (Eshraghian et al. 2008; Journault et al. 2018). Such instabilities have the potential to impact both of Canada's national railways, 48 49 portions of Trans-Canada Highway, arable land, fisheries, and the community of Ashcroft (Fig. 1 a). They also provide insight into landslide risk of several communities similarly situated 50 along the inner gorge of Thompson River such as Spences Bridge, and as far south as Lytton 51 52 at the confluence with Fraser River, where repeated failures have generated displacement waves or landslide dams (Drysdale 1914; Porter et al. 2002; Clague and Evans 2003). 53

Ripley Landslide is approximately 220 m wide (N-S) by 150 m long (E-W) with an estimated 171 volume of 400,000 m³ (Fig. 1 c). The landslide has been active since at least 1951, but 172 displacement across the slide body increased after 2005 when a rail siding was constructed 173 174 across its middle portion (Bunce and Chadwick 2012). During construction, embankments were extended upslope and a lock-block retaining wall, separating the Canadian National 175 Railway (CN) and Canadian Pacific Railway (CP) tracks, was installed (Fig. 1 d). Pronounced 176 sagging of the retaining wall and bulging of lock blocks has occurred since 2005 (Huntley et 177 al. 2016). To accommodate continual lateral and vertical displacement across the landslide, 178 both rail companies periodically add ballast, in addition to lifting and re-aligning their tracks. 179

Numerous conventional and experimental continuous monitoring technologies (Fig. 1 c, d) 182 provide insight on the activity, deformation mechanisms, and potential acceleration triggers of 183 Ripley Landslide. Each of these techniques record increased landslide activity in winter, when 184 river and groundwater levels are lowest (Macciotta et al. 2014; Hendry et al. 2015; Schafer et 185 al. 2015; Journault et al. 2018). Four permanent GNSS monuments installed across the 186 landslide in 2008 (Fig. 1 c) record cumulative annual displacement on the order of 100 mm/yr 187 to 200 mm/yr, which peaks from autumn to winter (Bunce and Chadwick 2012; Macciotta et 188 al. 2014; Hendry et al. 2015). InSAR results from 2013 to 2015 indicate similar magnitudes 189 and spatial-temporal patterns of displacement (Huntley et al. 2017b; Journault et al. 2018). 190

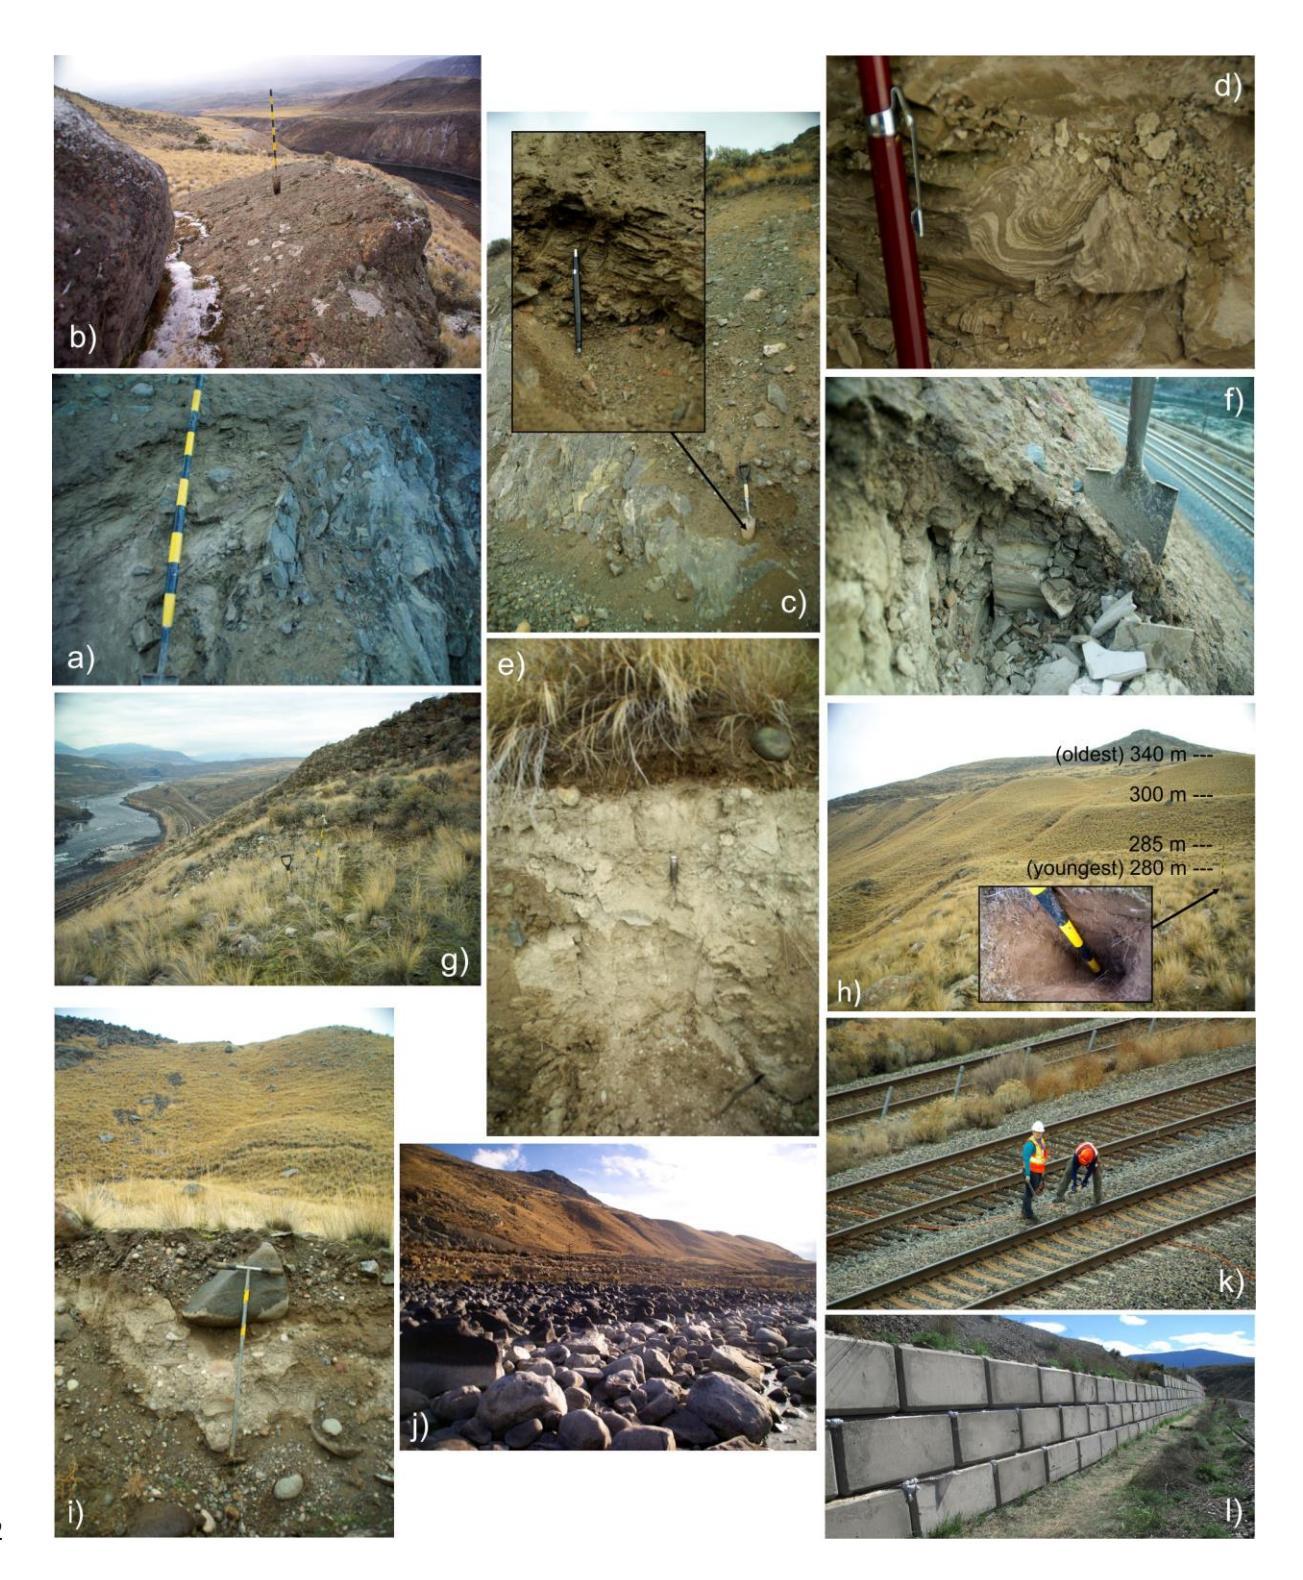
943 Fig. 2 Hydrogeological units of Ripley Landslide. a) Unit 1a- andesite: fine-grained crystalline igneous rock with 944 dominant fractures 040°/076°/E (278 m elevation), 074°/50°/NNW, 136°/78°/W, 178°/28°/E. b) Unit 1b - rhyolite 945 and pyroclastic volcanic rock: strike/dip/dip-direction 104º/18º/E (350 m elevation). c) Unit 2 - colluvial 946 sediments: interbedded clast-supported diamicton, sand and gravel overlying fractured bedrock (unit 1), ca. 276 m 947 elevation. d) Unit 3 - glaciolacustrine sediments: rhythmically interbedded clay, silt and sand with rare dropstones; 948 sub-till (unit 4) soft-sediment indicates glacial deformation, ca. 278 m elevation. e) Unit 4 - lodgement till: 949 massive, matrix-supported diamicton overlain by a veneer of hillslope colluvium (unit 8) exposed in headscarp; at 950 280 m elevation. f) Unit 5 - glaciolacustrine sediments: interbedded silt and clay overlying till (unit 4), silt-rich 951 beds appear lighter; bedding-parallel fissility and vertical slope relaxation fractures formed in exposed in railway 952 embankment. g) Unit 6 - glaciofluvial sediments: cobble gravel and sand; moderately steep slope (25 ° - 32°) is

953 gullied and drains a 340 m - 350 m elevation terrace abutting against bedrock (unit 1b). h) Unit 7 - alluvial fan 954 sediments: silt, sand and gravel deposited on outwash and till as terraced fans with slopes up to 12°; indicate falling 955 base-levels in the Thompson River valley during early Holocene. i) Unit 8 - colluvial sediments: erratic boulders, glaciofluvial cobbles and sand remobilized by debris fall, soil creep and surface runoff on slopes ranging from 25° 956 957 slope above the headscarp to 12° across the main slide body; on steeper portions of the slope (up to 32°), talus 958 blocks are derived from frost shattered rhyolite and volcaniclastic rock. j) Unit 9 - alluvial floodplain sediments: 959 boulders, cobbles and sand, sparse vegetation growth dominated by horsetails indicating zone of seepage across 960 the landslide toe. k) Unit 10 - anthropogenic features: boulder-rich track ballast overlying alluvial floodplain on 961 the landslide toe; CN (top left) and CPR tracks (centre); 1) Unit 10 - lock-block retaining wall separating CPR

962 (above left) and CN tracks (right).

Pleistocene and Holocene sediments unconformably overlie fine-grained, massive crystalline 254 255 andesite (unit 1a, **Fig. 2** a) and fine-grained, flow-banded crystalline rhyolite (unit 1b) with low or negligible intercrystalline porosity, and welded clast-supported agglomerates with a low 256 257 vugular porosity (Fig. 2 b; Tab. 1). The oldest Pleistocene deposits (unit 2) are up to 6 m thick 258 and include intercalated centimetre-thick beds of clay, silt, sand, gravel and diamicton (Fig. 3) with moderate intergranular porosity. This basal unit is disconformably overlain by up to 12 m 259 of silt-clay couplets (i.e., varves) with dropstones and stratified diamicton with low 260 261 intergranular porosities (Fig. 2 c, d). Units 2 and 3 are glaciolacustrine in origin and were deposited during the retreat phase of a penultimate glaciation and advance of the Late 262 Wisconsinan Cordilleran Ice Sheet, respectively. Glaciolacustrine units are over-consolidated, 263 deformed, eroded and overlain by unit 4, a massive, matrix-supported diamicton up to 5 m 264 thick composed of silt, clay, erratic boulders and ice-rafted blocks of locally derived bedrock, 265

interpreted as a (subglacial) lodgement till (Fig. 2 e). Consolidation of unit 3 causes silt and 266 clay particles to densely pack, resulting in an increase of effective stress, combined with a 267 decrease in void ratio, water content, and permeability (Le Meil 2017). The permeability of 268 glaciolacustrine units is anisotropic, with horizontal permeability (along the rhythmite beds) 269 an order of magnitude larger than the vertical permeability (across beds). Heterogeneities 270 caused by fissures and sand laminae intersecting the glaciolacustrine silt and clay significantly 271 272 enhance the bulk permeability of units 2 and 3. Till has a low vugular porosity due to the presence of isolated weathered igneous and sedimentary clasts and sand-filled voids within the 273 274 fine-grained matrix. Field observations, borehole logs and geophysical data all indicate that unit 4 till contains ice-rafted bedrock blocks. Silt-rich glaciolacustrine sediments (unit 5, Fig. 275 2 f), containing centimetre-thick sand beds with moderate intergranular porosity, conformably 276 277 overlies till. During summer months, salt crusts form where solute-rich groundwater seeps and evaporates from exposed sand-rich beds in units 3 and 5 along railway embankments and river 278 cutbanks. Above unit 5 lies >5 m of massive and crudely stratified beds of open framework, 279 clast-supported boulder and sand-rich gravel (unit 6, Fig. 2 g). This coarse-grained 280 glaciofluvial unit has a high intergranular porosity. 281

The oldest Holocene deposits, unit 7 (Fig. 2 h), consist of interbedded stratified diamicton and 283 open framework, clast-supported cobble-gravel incised into unit 6. This basal sequence fines 284 285 upward to massive centimetre-thick sand and silt beds with moderate intergranular porosity. Bedding lies sub-parallel to surface slopes ranging from $>3^{\circ}$ to $<8^{\circ}$ on alluvial fans, and $>8^{\circ}$ to 286 <12° on alluvial cones. Slopes >12° are covered in postglacial coarse-grained colluvium with 287 a high intergranular porosity (unit 8, **Fig. 2** i). Moderate slopes from $>12^{\circ}$ to $<26^{\circ}$ are covered 288 in a veneer of stratified diamicton and clast-supported cobbles, boulders with interstitial sand 289 and silt. Moderately steep bedrock slopes from $>26^{\circ}$ to $<35^{\circ}$ are covered in a veneer of clast-290

supported talus blocks. Modern alluvial floodplain sediments (unit 9, Fig. 2 j) are open 291 framework, clast-supported boulders and sand with a high intergranular porosity, confined to 292 elevations lower than 270 m. Surface water is quickly removed during heavy or prolonged 293 rainfall, and boulders and sand are permanently saturated by river water at shallow depth (<2 294 m) on the active flood plain. Bedrock, glacial and alluvial sediments (units 1-5 and 9), 295 excavated during track construction, are unconformably overlain by a linear deposit (<5 m 296 297 thick) of open framework, clast-supported cobble and boulder ballast and a lock-block retaining wall (unit 10) with high intergranular porosity (Fig. 2 k, l). 298

railway embankments are sub-vertical, penetrate deep into the slide body (greater than 2 m
depth) and cross-cut multiple units (Fig. 2 e, f). These penetrative structures impart a moderate
to high fracture porosity in till diamicton (unit 4), silt-rich glaciolacustrine beds (unit 5),
postglacial alluvium (unit 7), colluvial sediments (unit 8), and anthropogenic materials (unit
10). Coarse-grained glaciofluvial deposits (unit 6) and modern alluvial floodplain sediments
(unit 9) have no penetrative planar structures (Tab. 1).

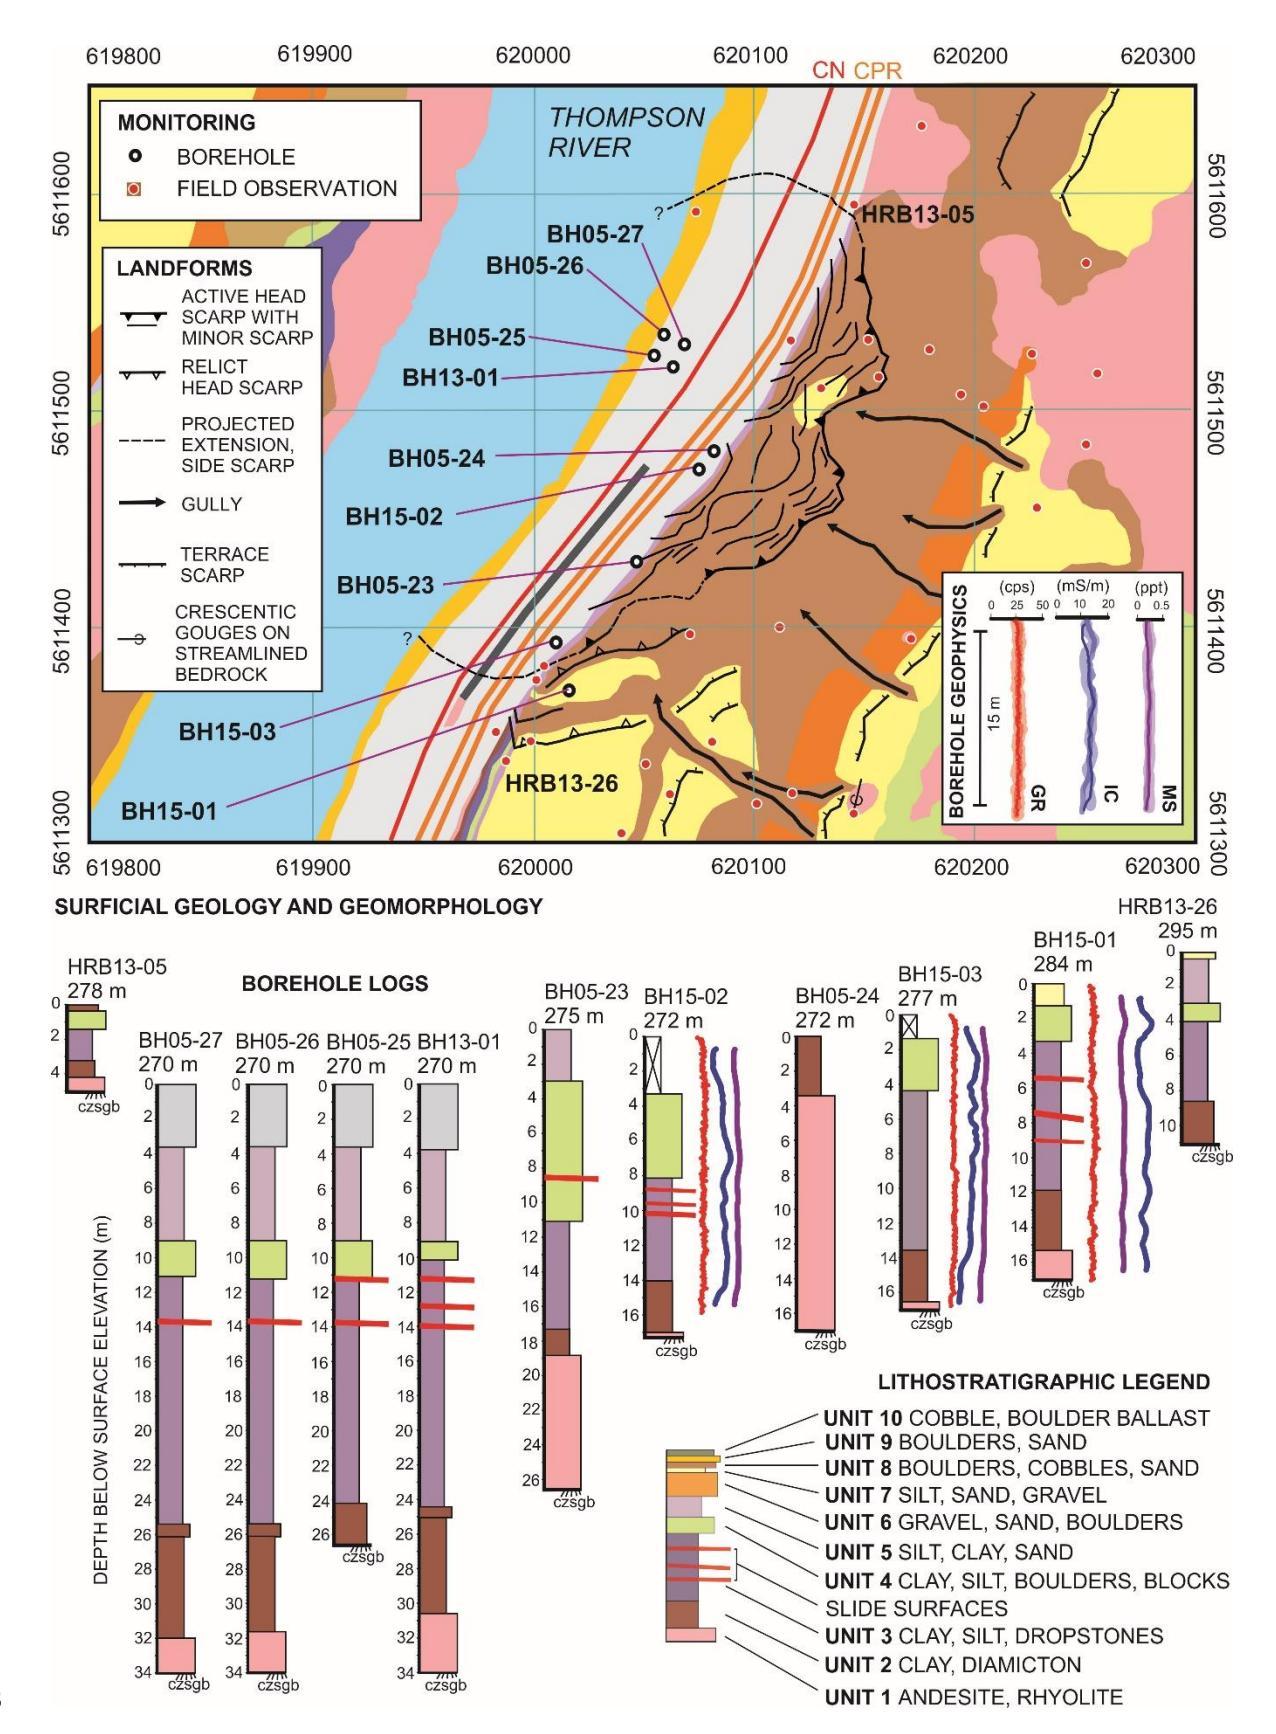
Fig. 3 Surficial hydrogeological units and landforms of Ripley Landslide and adjacent terrain, showing location
 of boreholes and field observations; lock-block retaining wall – grey line. Borehole geophysical logging and data
 processing by Frontier Geosciences Inc.

Downhole natural GR levels, IC and MS surveys of boreholes BH15-01, BH15-02 and BH15-425 426 03 (Fig. 3 and Fig. 5) provide further insight into the sub-surface thickness of earth materials, depth to bedrock, groundwater conditions and failure mechanisms of the landslide. East of the 427 CPR tracks, the Mount Sopris MGX logging tool encountered 15 m to 17 m of glacial deposits 428 overlying basal bedrock in the boreholes (Fig. 5). West of the CN tracks, boreholes show around 429 30 m of till and clay-rich glaciolacustrine sediments overlying bedrock (Fig. 3 and Fig. 5). 430 These observations corroborate the terrestrial and waterborne geophysics results indicating the 431 main landslide body is located over a >20 m deep bedrock basin underlying the modern 432 Thompson River. 433

More than 20 m of Pleistocene and Holocene sediment unconformably overlies unit 1 bedrock 496 497 (Fig. 3). Locally fractured and bedded sediments of unit 2 are imperfectly drained. Below 270 m elevation, coarser sediments remain saturated for much of year, especially during higher 498 river stages. Unit 3 is poorly drained in the sub-surface, with fine-grained sediments remaining 499 500 undersaturated for much of year. The exception would be during prolonged rainfall, snow melt, sustained confined groundwater flow and high river stage. Unit 4 diamicton and clay-rich 501 glaciolacustrine beds of unit 5 are imperfectly drained, with fractures allowing downward 502 infiltration of surface water and subsurface flow of groundwater. Both units become saturated 503 at depth during prolonged rainfall, snow melt and at high river stage (Tab. 1). At depth, vertical 504 fractures and sub-horizontal planes become saturated during prolonged rainfall or snow melt. 505

slowly (cumulatively <55 mm/yr) on gentle (<2°) channel-sloping failure planes developed in 589 weak, highly plastic layers of fine-grained glaciolacustrine silt and clay (Fig. 3). Failure of units 590 2 to 5 occurs as shear strength is reduced in response to periods of saturation when the residual 591 friction angle of clay layers falls below the angle of slope (generally $<25^{\circ}$). The ERT data show 592 that these failing sediments are conductive ($< 80 \Omega m$), potentially saturated with groundwater, 593 and extend under the river (Fig. 6). Sediments of units 2 to 5 readily move, even on gentle 594 595 slopes, due to a reduction in shear strength with increasing saturation of sediments and penetrative structures. All other surficial units contain little clay, are non-plastic and permeable 596 597 to some degree. The presence of penetrative structures (e.g., tension cracks and slide surfaces), bedding thickness and porewater pressure in sand and gravel beds within glaciolacustrine units 598 influence the effective stress condition of the slope (cf. Clague and Evans 2003; Bishop et al. 599 600 2008). The residual friction angle of clay beds in glaciolacustrine units is stress dependant: high normal stresses promote alignment of clay particles during shear (Schafer et al. 2015; Le Meil 601 2017). Greater normal stresses beneath the main body of the landslide are expected where 602 InSAR and GNSS measurements show rates of movement are highest, and where geophysical 603 data indicate surficial deposits are >20 m thick. While the rate of movement is very slow, rapid 604 failure is possible under certain conditions. For example, when surface tension cracks fill with 605 infiltrating water (or snow) and landslide debris becomes saturated by rising river and 606 groundwater levels. 607

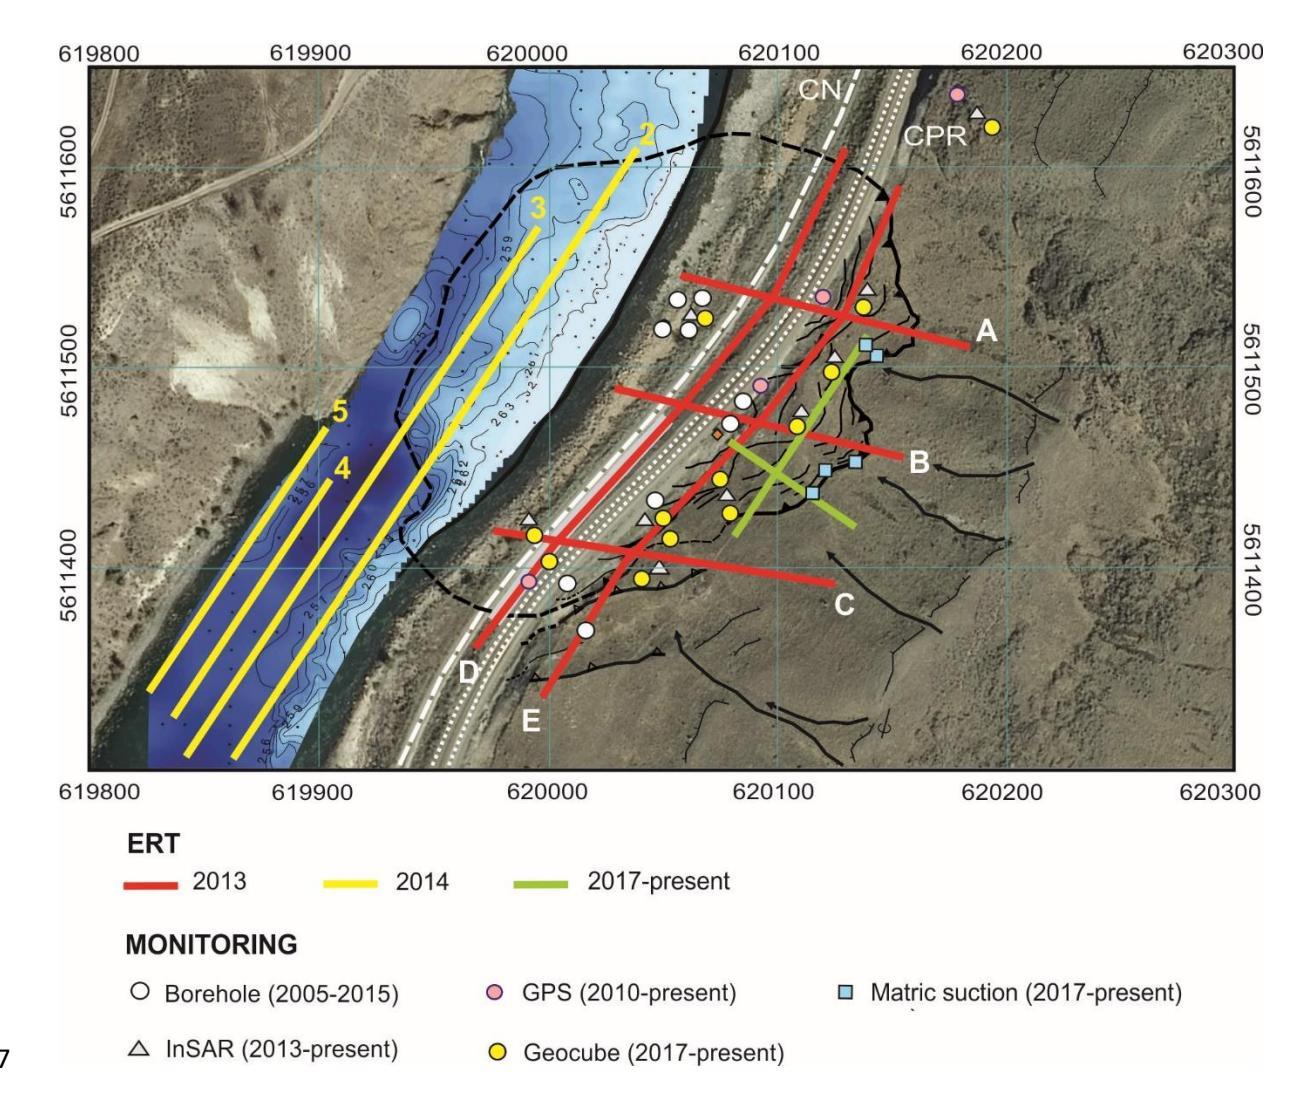
Fig. 4 Geophysical transects for November 2013 (red lines), November 2014 (yellow lines), and PRIME
 installation, beginning in November 2017 (green lines); other monitoring components shown include positions of
 logged boreholes (2005-2015), InSAR corner reflectors (2013 - present) and permanent GNSS stations (2010 -

971 present).

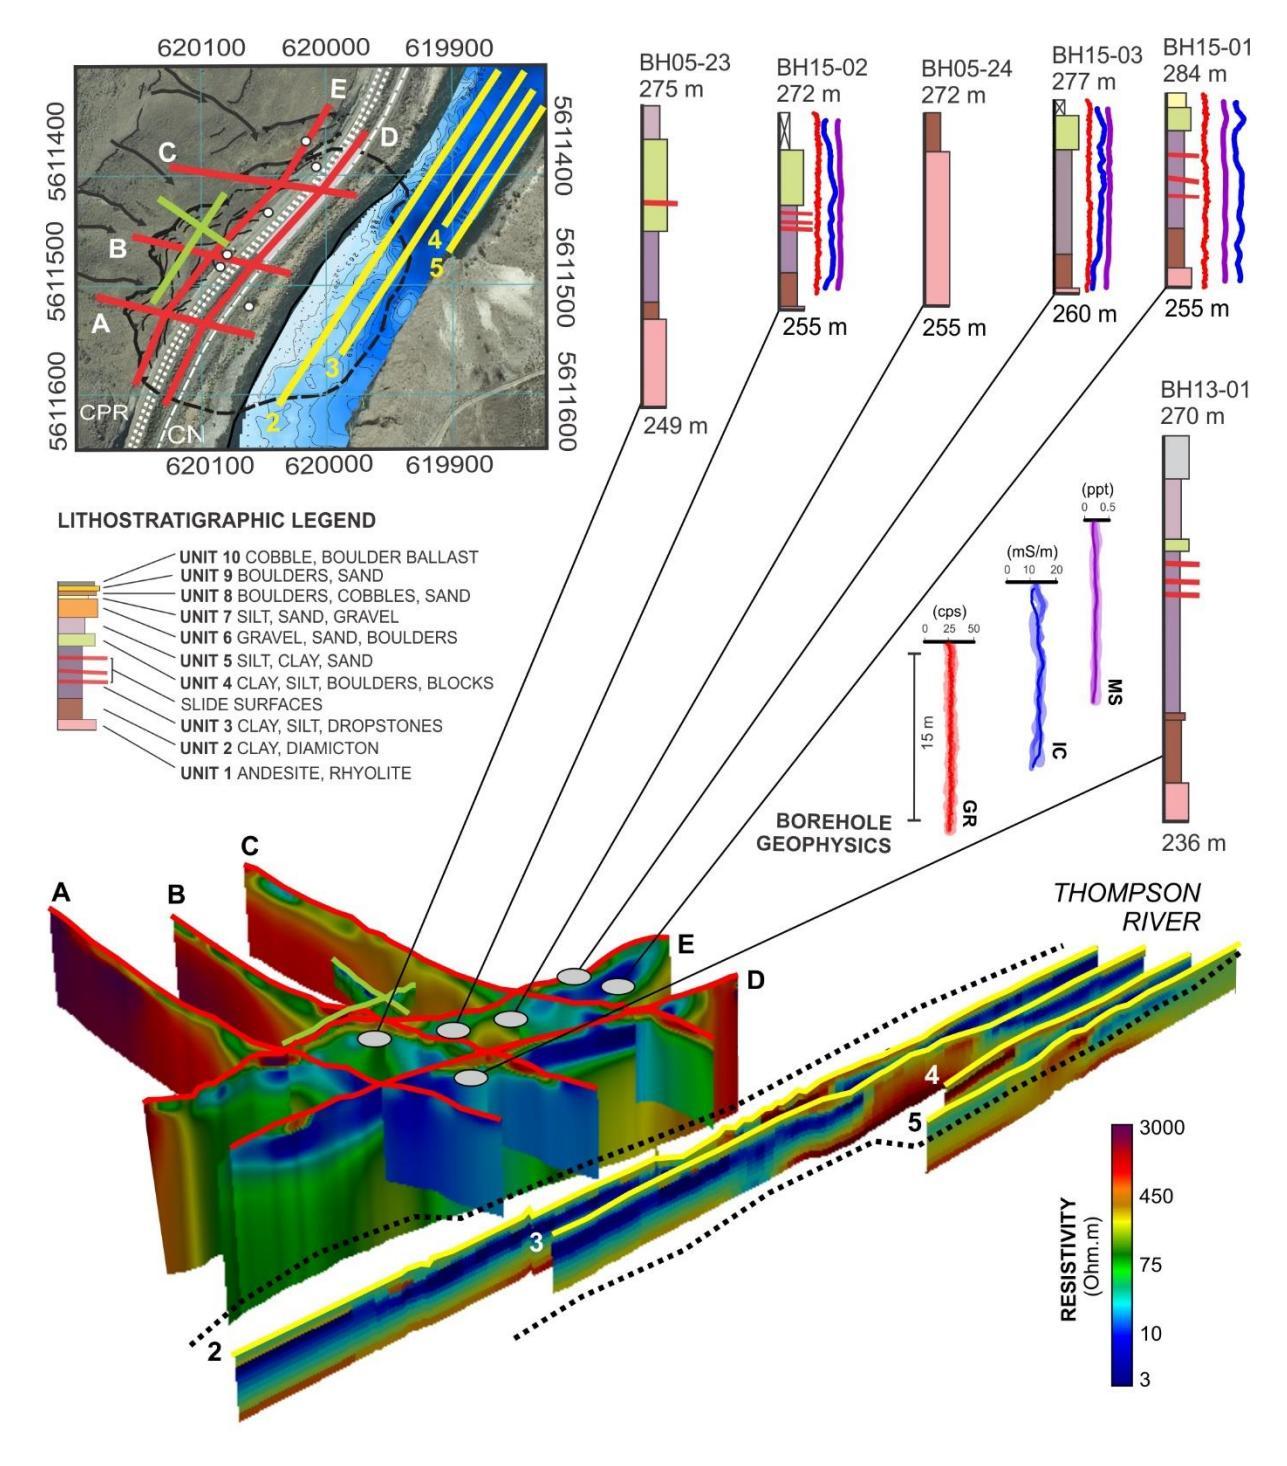
Fig. 5 Terrestrial ERT pseudosections (red transect lines A, B, C), waterborne ERT pseudosections (yellow transect lines 2, 3, 4, 5) and PRIME installation (green transect lines). Location of boreholes shown in relation to transect lines. Gamma radiation measured in counts per second (cps), induced conductivity measured in milliSiemens/m (mS/m) and magnetic susceptibility in parts per thousand (ppt). Also shown, location of elevated terrain conductivity readings located on submerged slide toe. Landslide extent (approximate) shown as dashed black lines on inset map.

The terrestrial-based ERT survey undertaken in November 2013 and waterbourne ERT survey 377 completed in November 2014 are presented with PRIME data from November 2018 in a fence 378 diagram showing the range of electrical properties of the landslide (Fig. 5). Since the surveys 379 were completed at the same time of year, differences arising due to the influence of seasonal 380 changes in weather conditions on the electrical properties were minimised by selecting 381 November as the month of observation, and ensures that the electrical properties are 382 comparable, although completed in different years. Data from the terrestrial-based ERT lines 383 were inverted in 3D using Res3DInv (geotomosoft.com 2017), taking account of the offline 384 385 variation in topography in the topographically complex area of the slide. This improved the correlation between each of the lines, reducing the mismatch in resistivity values at depth. The 386 waterbourne survey data were inverted in 2D using Res2DInv (geotomosoft.com 2017). The 387 lines are displayed in ParaView® alongside the PRIME ERT lines (Fig. 5). 388

Pseudo-3D models capture resistivity, soil moisture and groundwater conditions in surficial 519 520 deposits and bedrock for the fall seasons of 2013 and 2014 (Fig. 5 and Fig. 6). This representation is interpretation-oriented, with the selection of resistivity thresholds at 80 Ω m 521 522 and 110 Ω m determined by observations of earth materials, and their hydrogeological properties at surface and in logged boreholes (Fig. 2 and Fig. 3). Electrically resistive earth materials 523 $(>110 \Omega m, red on Fig. 6)$ include undersaturated (dry) sand and gravel (unit 6), till diamicton 524 (unit 4) and competent bedrock (unit 1). Bedrock, clay, till and gravel saturated with 525 groundwater are all conductive bodies (<80 Ω m, blue on **Fig. 6**). Along the north and south 526 boundaries, a transition from bedrock to saturated clay-rich glacial sediments beneath the river 527 is recorded between 220 m and 240 m elevation by a drop in resistivity values to below 80 Ω m. 528 From 240 m to 270 m elevation, conductive earth materials (<80 Ω m) are bounded by resistive 529 zones (>110 Ω m) beneath the river and east valley slope (**Fig. 6**). This pattern is interpreted to 530 represent a north-south oriented bedrock palaeochannel fragment infilled with remobilized 531 glacial deposits (units 2 and 3). The 2D waterborne ERT dataset (Huntley et al. 2017a; Huntley 532 et al. 2019a) and pseudo-3D model (Fig. 6) show a significant portion of the landslide lying 533 below river level from approximately 270 m to 230 m elevation. The main slide body is 534 represented as an ovate conductive zone (<80 Ωm) containing inliers of resistive material (>110 535 Ω m) along the northern, eastern and southern flanks (Fig. 6). These latter features are 536 interpreted as locally derived bedrock blocks remobilized during glaciation. 537

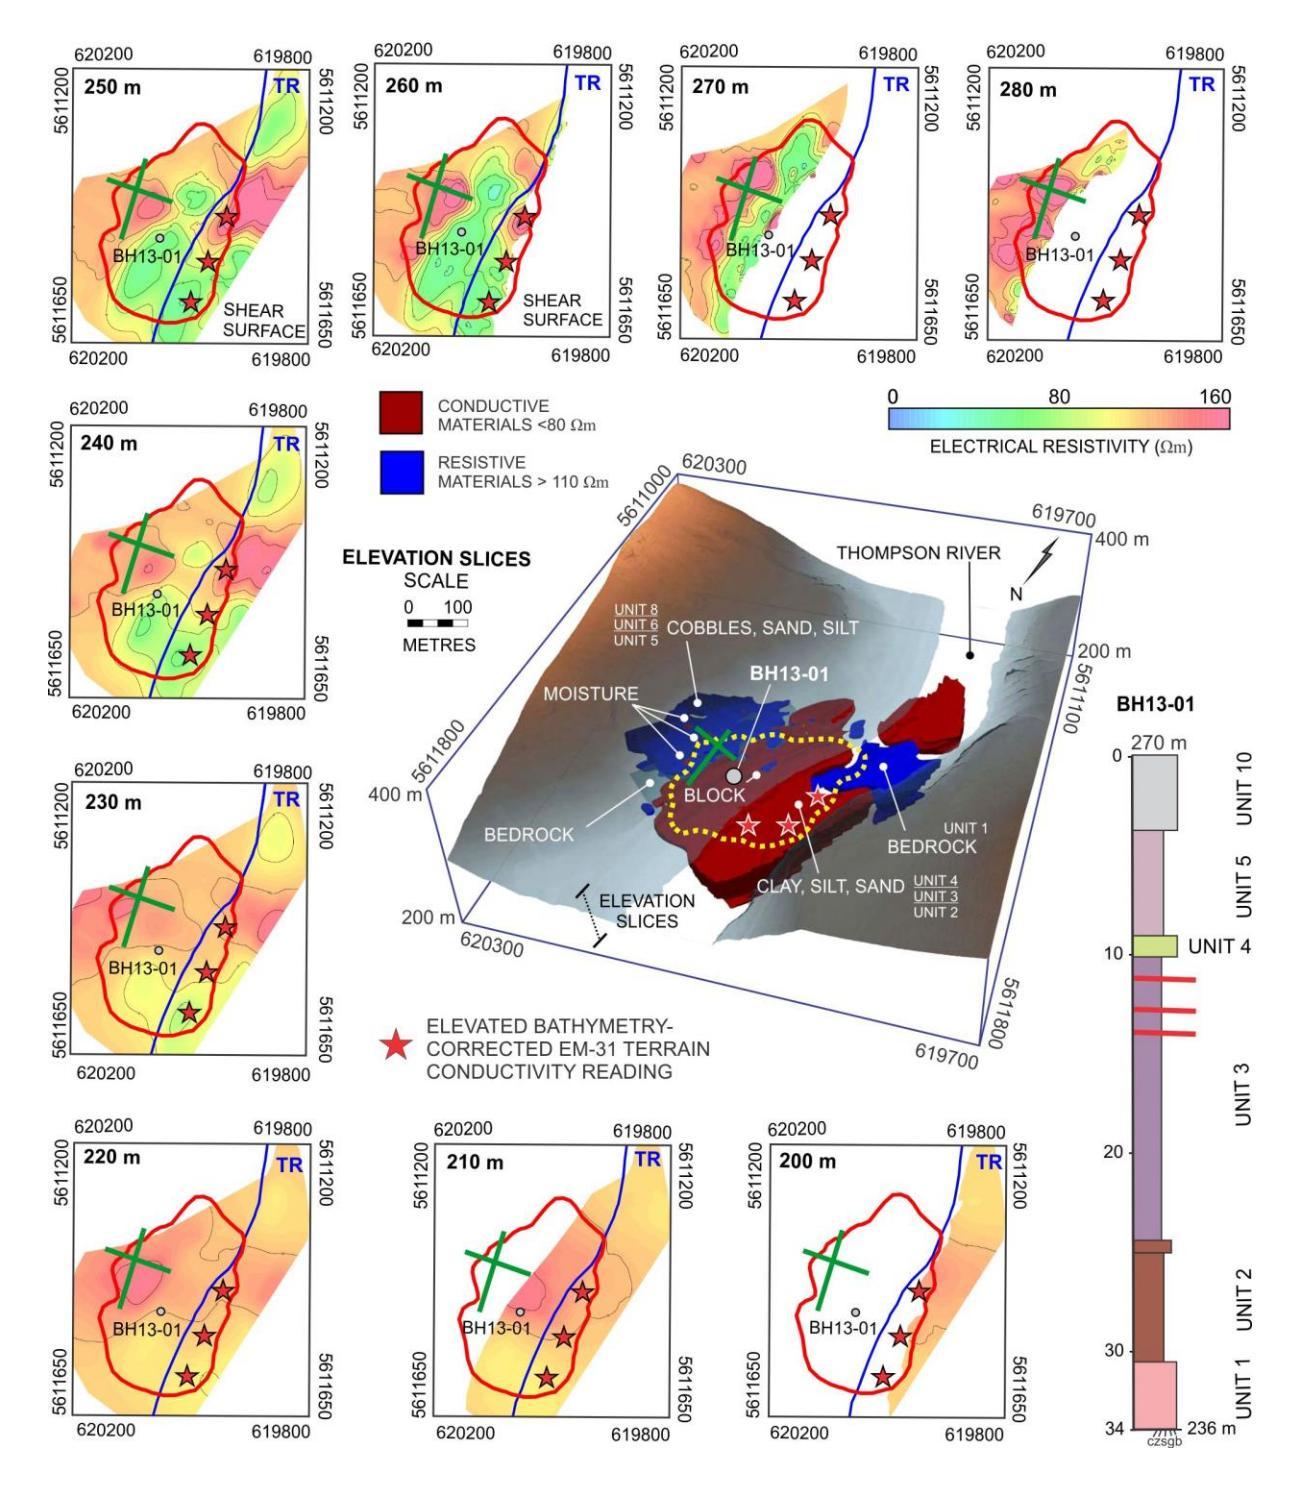
Fig. 6 Electrical resistivity tomographic depth slices of Ripley Landslide. Location of BH13-01 shown; graphic
 log captures changes in hydrogeological units at depth near the centre of the slide body. Solid blue line – east bank
 of Thompson River (TR). Solid green line - PRIME array. Red stars indicate elevated bathymetry-corrected EM
 terrain conductivity interpreted as artesian groundwater discharge zones exposed by river erosion. Data processing
 by Frontier Geosciences Inc.

Elsewhere in the Thompson River valley, failing glaciolacustrine beds are highly plastic, with 575 plastic/liquid limits ranging from 45% to 90% and residual friction angles of 10° to 15° (Schafer 576 et sl. 2015; Le Meil 2017). Silt beds in units 2, 3 and 5 have higher overall residual shear 577 strength compared to clay beds, with values ranging from $>26^{\circ}$ to $<35^{\circ}$ (cf. glacial pond to 578 steep-dipping silt-rich debris flow diamictons draped over bedrock in Fig. 2 c). At Ripley 579 Landslide, field observations and borehole logs show that deformation and erosion by glaciers 580 or pre-historic slope movement have created pre-sheared discontinuities in units 2, 3 and 4 (Fig. 581 2 d) at a residual strength that predispose these sediments to failure (cf. Clague and Evans 2003; 582 583 Eshraghian et al. 2007; 2008). Fine-grained glacial sediments (units 2 to 4) have low permeability (**Tab. 1**) and exhibit subtle resistivity changes reflecting variations in total clay 584 and groundwater content across the slide body (Fig. 6). 585

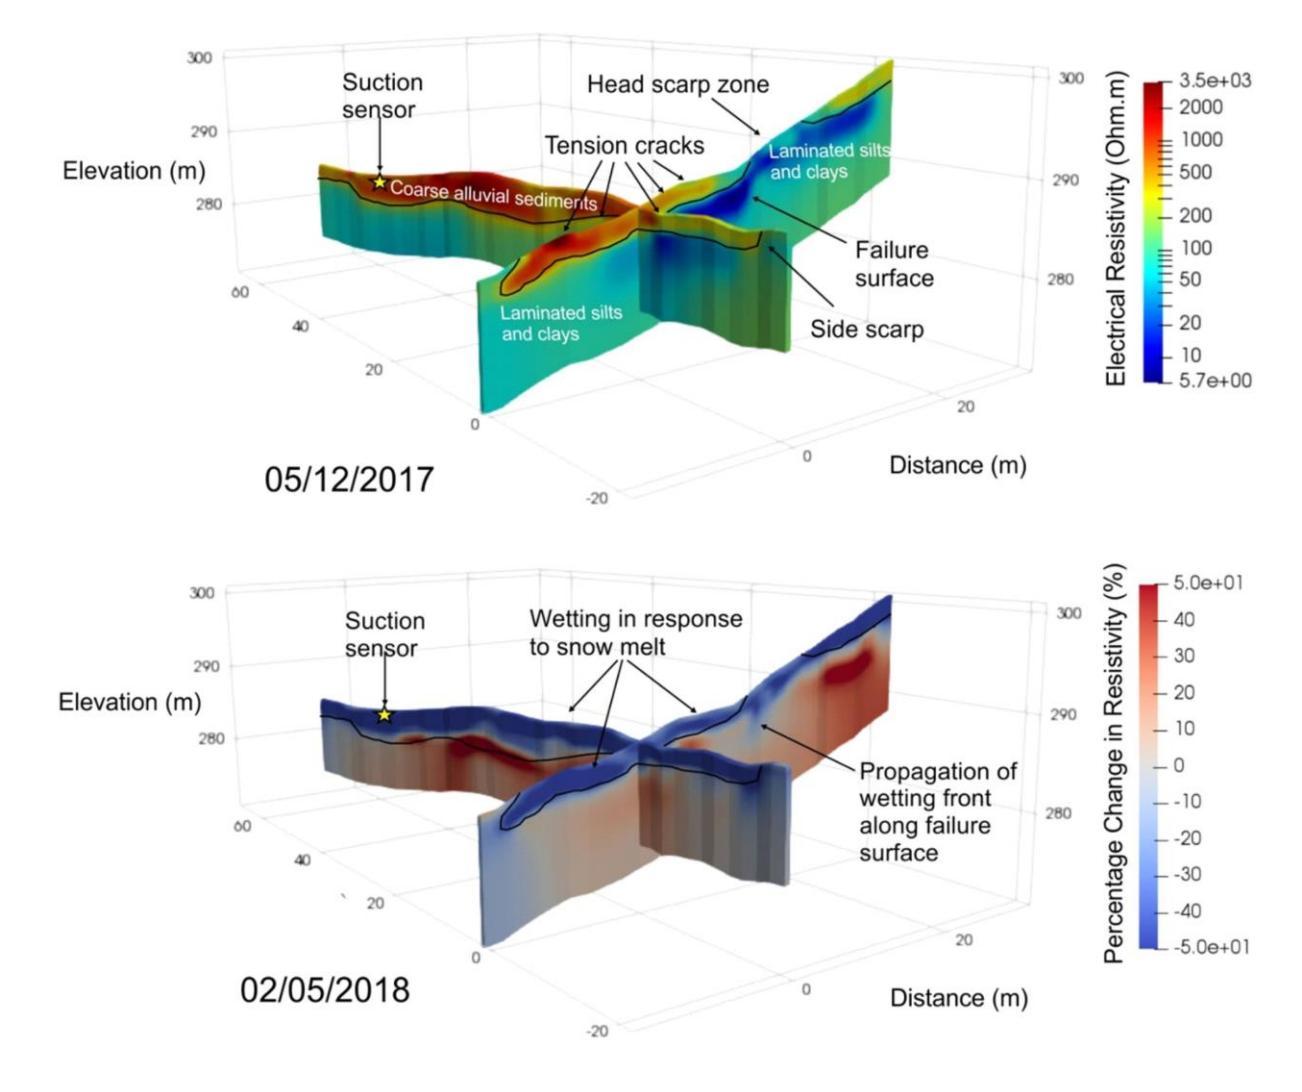
Fig. 7 Electrical resistivity tomography images generated from the PRIME data collected on the Ripley landslide.
The baseline image (December 05, 2017) highlights the lithological units present on site and shows key geomorphological features including failure surfaces and tension cracks. The image from May 02, 2018 shows the percentage change in resistivity from the baseline image, highlighting changes which took place following the onset of snowmelt on the site. Suction sensor locations are marked by the yellow stars. The suction sensors (yellow star) are located at 0.3 m, 0.6 m, 0.9 m, 1.2 m and 2 m below the surface.

The PRIME system has provided new insight into the hydrogeological structure of the slope 405 (Fig. 7). The ERT models reveal a complex stratigraphy of coarse colluvial sediments (unit 8) 406 overlying massive silt-rich diamicton (unit 4) with tension cracks over 0.5 m wide and 1 m 407 deep, and highly fissured laminated silts and clays (unit 3) in which the landslide failure plane 408 409 lies. Large decreases in surface resistivity (>50%) by through (March to May) are due to an increase in moisture content are due to snowmelt and intense, short-duration precipitation 410 events. Temperatures are consistently above 0°C by this time, and despite a negative weekly 411 effective rainfall during this season, the additional moisture resulting from snowmelt is 412 sufficient to increase the moisture content of the slope. This demonstrates the need for 413 subsurface imaging in such locations where both temperature and precipitation control 414

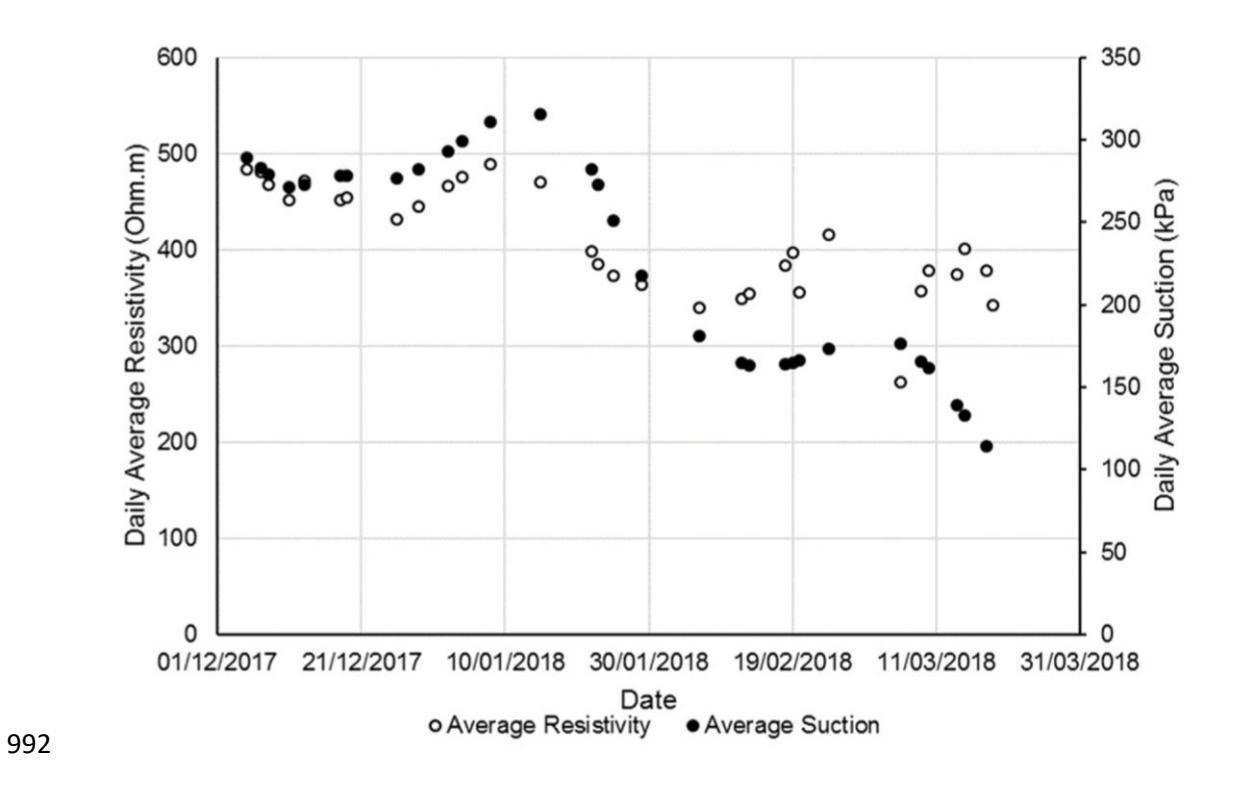
Fig. 8 Relationship between resistivity and suction for the Ripley landslide head scarp. The average daily
resistivity is the average resistivity of cells of the PRIME model (Fig. 7) proximal to the suction sensors (within
1 m distance). The suction sensors are located at 2, 3, 4, and 6.5 ft depth from the surface, and their location
relative to the PRIME ERT lines is shown in Fig. 7.
