THE CONSERVATION OF A 19TH CENTURY GIANT DEER DISPLAY SKELETON FOR PUBLIC EXHIBITION

by Kate Aughey¹, Ruth F. Carden² and Sven Habermann¹

Aughey, K., Carden, R.F. and Habermann, S. 2016. The conservation of a 19th Century giant deer display skeleton for public exhibition. *The Geological Curator* 10 (5): 221 - 232.

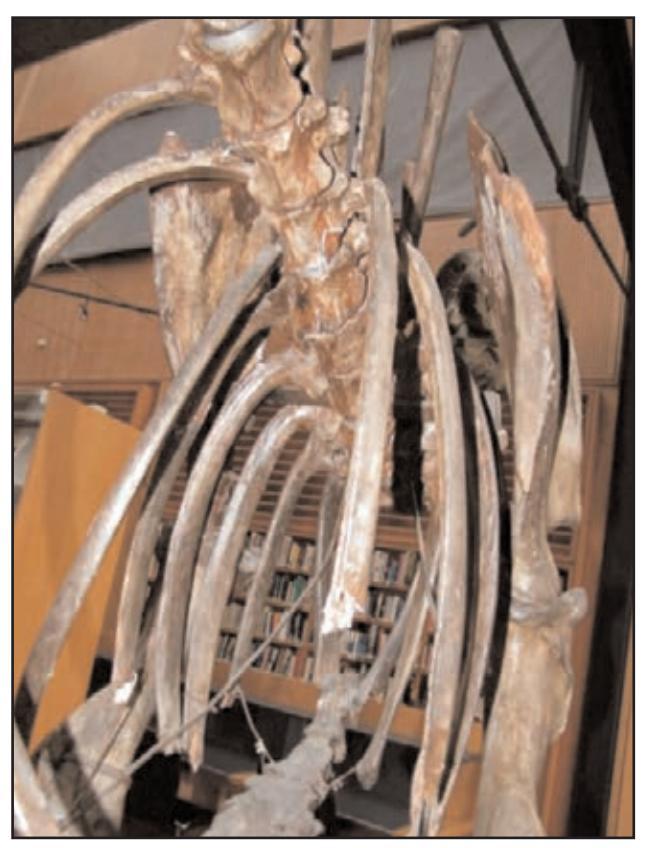
Figure 1. The pre-conservation condition of the giant deer specimen ribcage whilst still in situ. The light brown painted surface of the old repair works is clearly visible against the real bone.

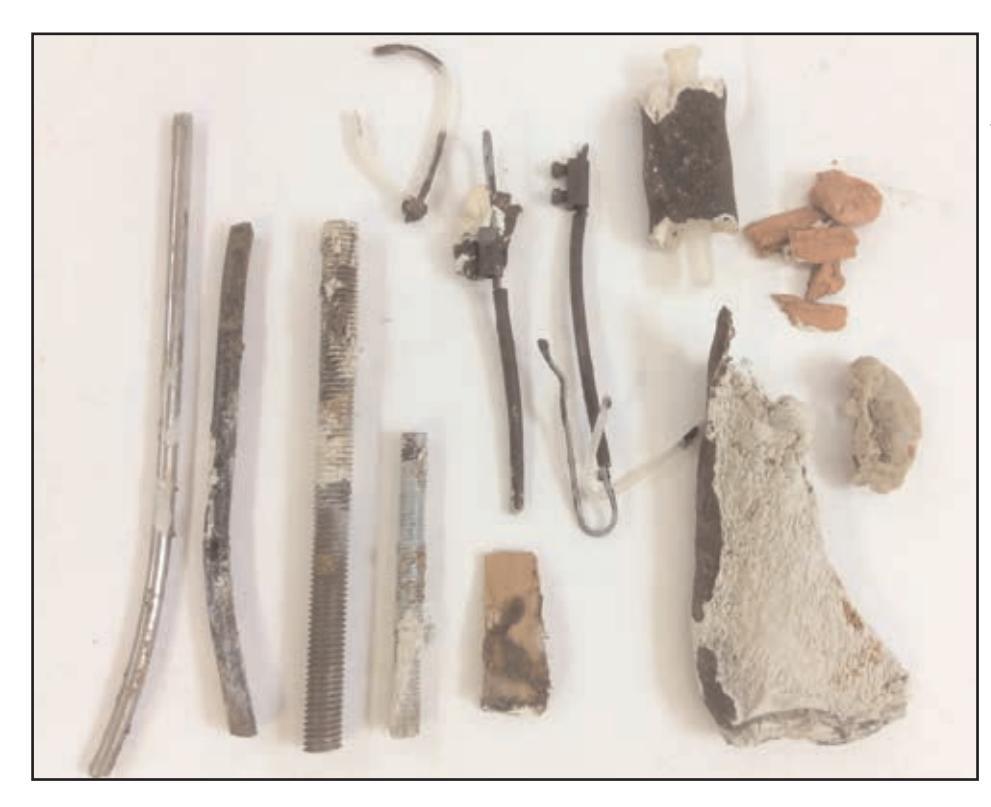
Initial condition assessments of the whole specimen revealed that extensive restoration had occurred in the past as well as a number of *ad-hoc* repairs. The plaster-based fillers used for both gap-filling and the larger areas of re-modelling were crumbling and a very dark brown paint-layer on the bone surfaces further emphasised this state of disrepair (Figure 1). Other fillers and stabilising materials included wood, various metal rods and nails, cable ties and even a plastic syringe cap used to dowel two sections of rib together (Figure 2).

Figure 2. A selection of materials applied during previous restoration treatments found and removed from the specimen.

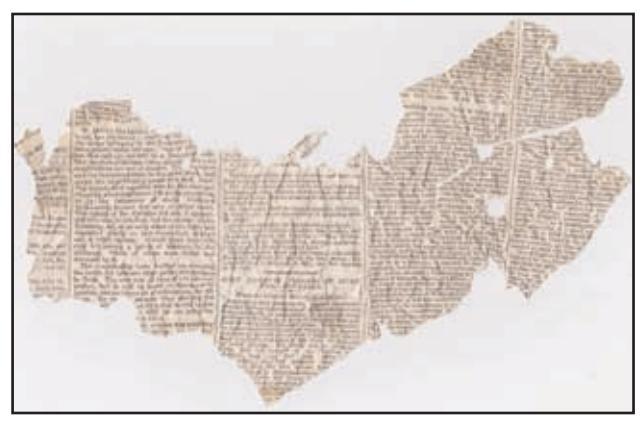
In order to limit the movement of the bones once they were mounted, cavities around the iron rods were routinely filled with plaster or linseed putty and packed with soft materials such as newspaper (Buttler 1994; Andrew 2009). In the case of this specimen, a fracture to the left distal femoral condyle region revealed the plaster-fill along with a tantalising scrap of newspaper containing articles which could be dated to 1864, giving an approximate date for the original mounting (Figure 3).

Figure 3. Newspaper fragment found within the left femur dated to 1864.

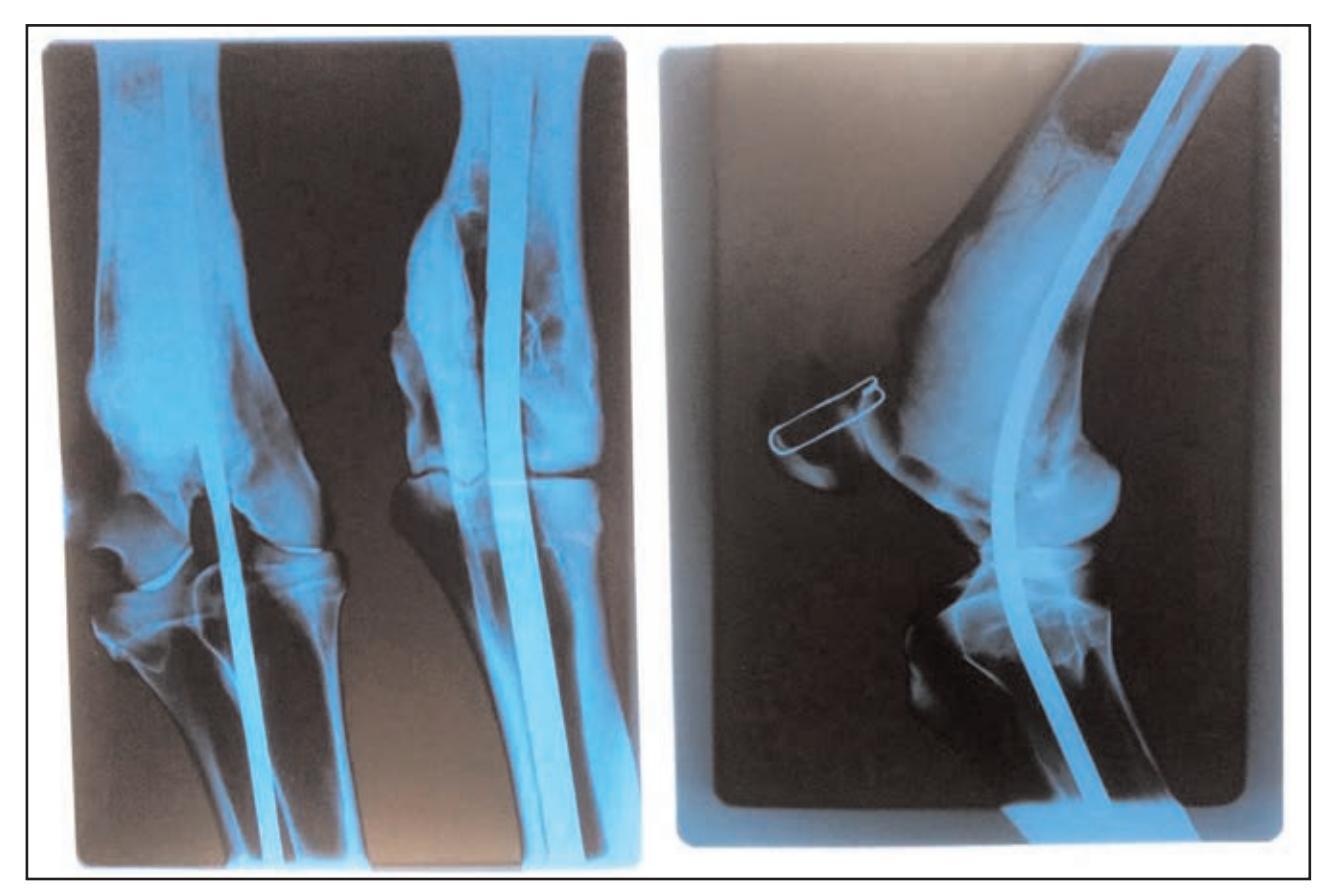
The X-rays revealed that the iron rods did indeed run continuously through each leg (Figure 4) and that rather than being stress fractures caused by compression, the longitudinal splits were likely the result of the expansion and contraction of the bones during environmental fluctuation.

Figure 4. Radiological (X-ray) imagery of the (A) right femur-tibia junction anterior, (B) right humerusradius/ulna junction posterior aspect and (C) right humerus-radius/ulna junction, medial aspect. X-ray images courtesy of Jens Werner MRCVS of Western Veterinary Surgery, Clifden, Co. Galway, Ireland.

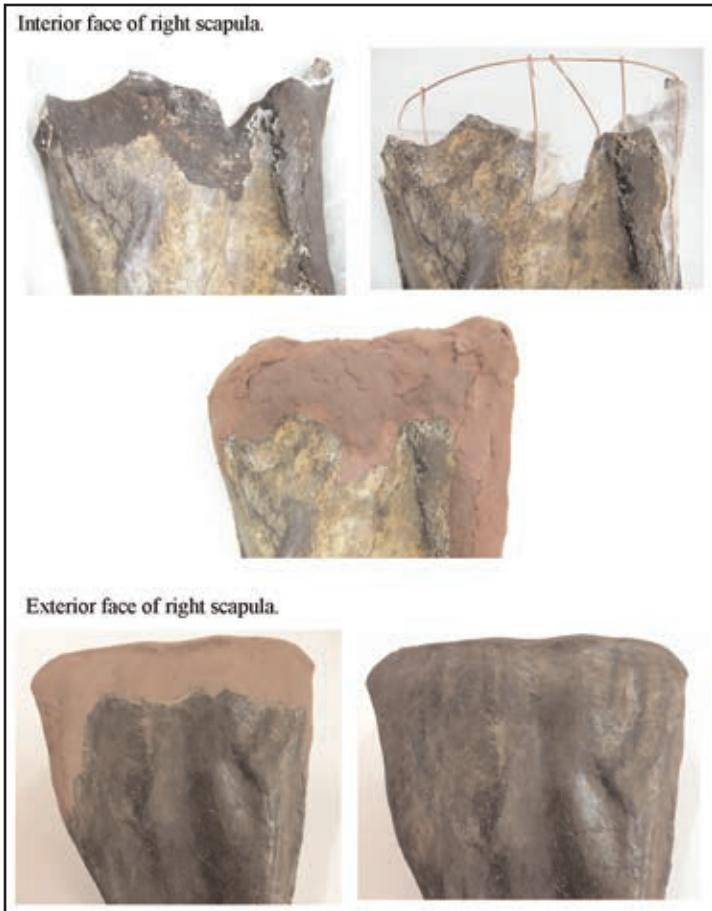
Figure 5. Stages in the modelling of damaged skeletal components (see text for stage explanations).

Larger areas, for example the scapula, required remodelling and 1.5mm copper plated mild steel welding rods were used to provide an internal armature (Figure 5). The welding rods were chosen as they offered a high degree of stiffness and

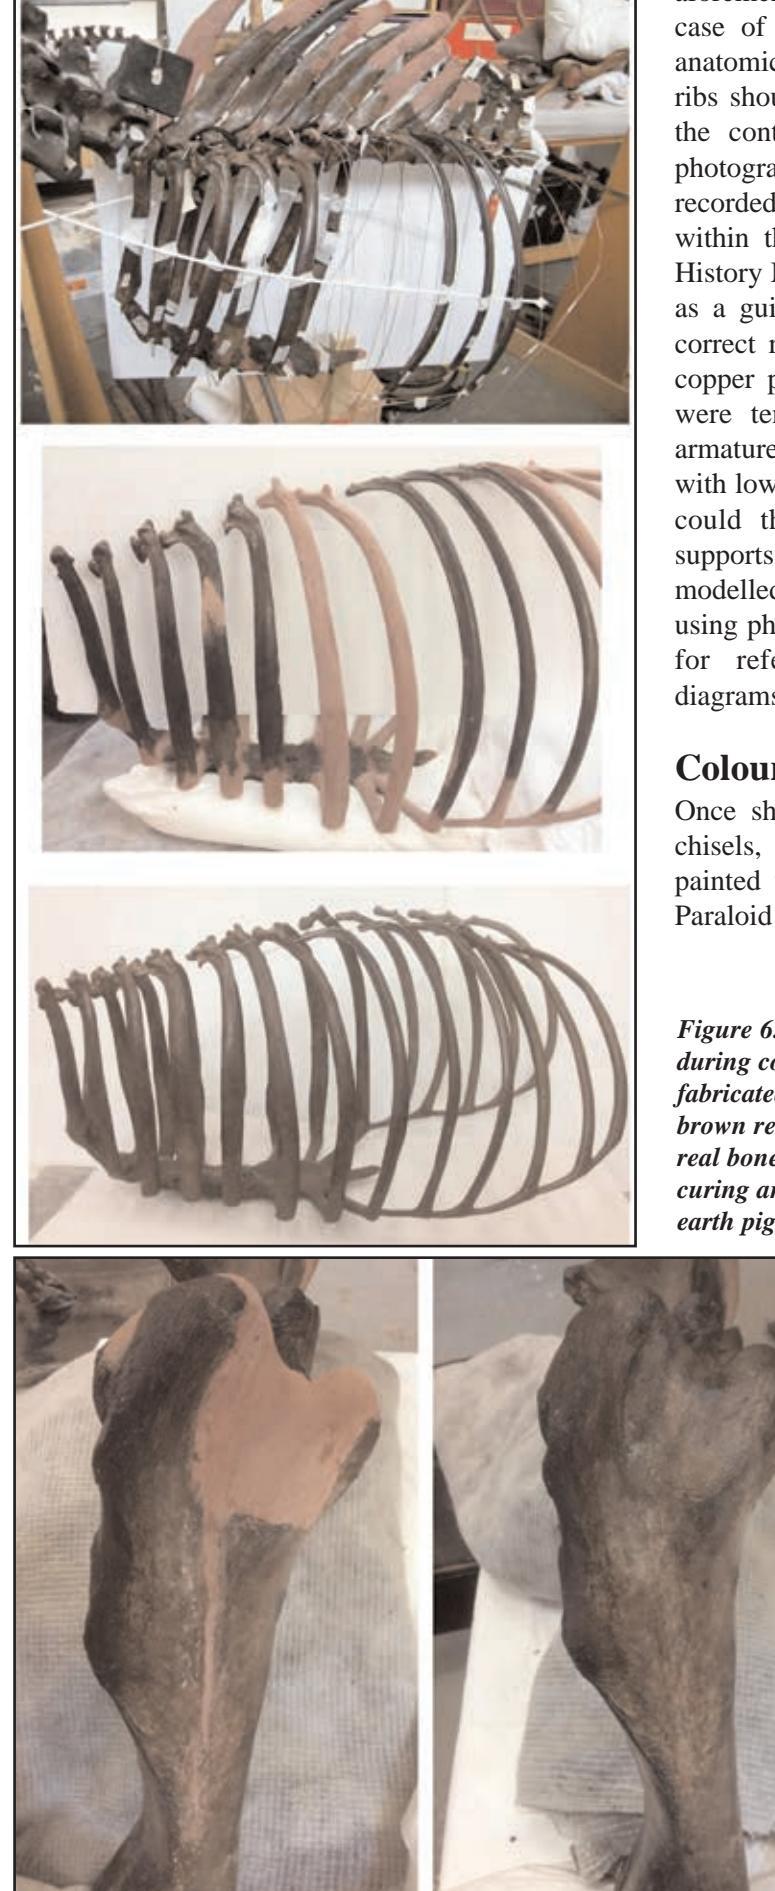
Figure 6. (Top) The ribcage of the giant deer specimen during construction. (Middle) The remodelling and fabricated ribs are those areas that display a lighter brown relative to the remaining darker brown coloured real bone. (Bottom) The fabricated ribs post 24-hour curing and shaping, and subsequently in-painted with earth pigmentation.

Figure 7. The giant deer (right) humerus bone before and after colouring with earth pigmentation.

aforementioned missing localised larger areas. In the case of the ribcage, the vertebrae and ribs were anatomically arranged to establish where the new ribs should be located and to ensure they followed the contour of those already present. Reference photographs and an average set of dimensions were recorded from three similarly mounted specimens within the National Museum of Ireland - Natural History Museum and these measurements were used as a guideline for approximating the anatomically correct rib lengths and shapes. A series of 1.5mm copper plated steel welding rods and existing ribs were temporarily secured to a flexible external armature made from 5mm diameter fiberglass rods with low tack masking tape. The bulked epoxy filler could then be shaped around the welding rod supports and refined once cured (Figure 6). All modelled components were constructed in this way using photographs of mounted giant deer specimens for reference in-conjunction with anatomical diagrams of morphologically similar deer species.

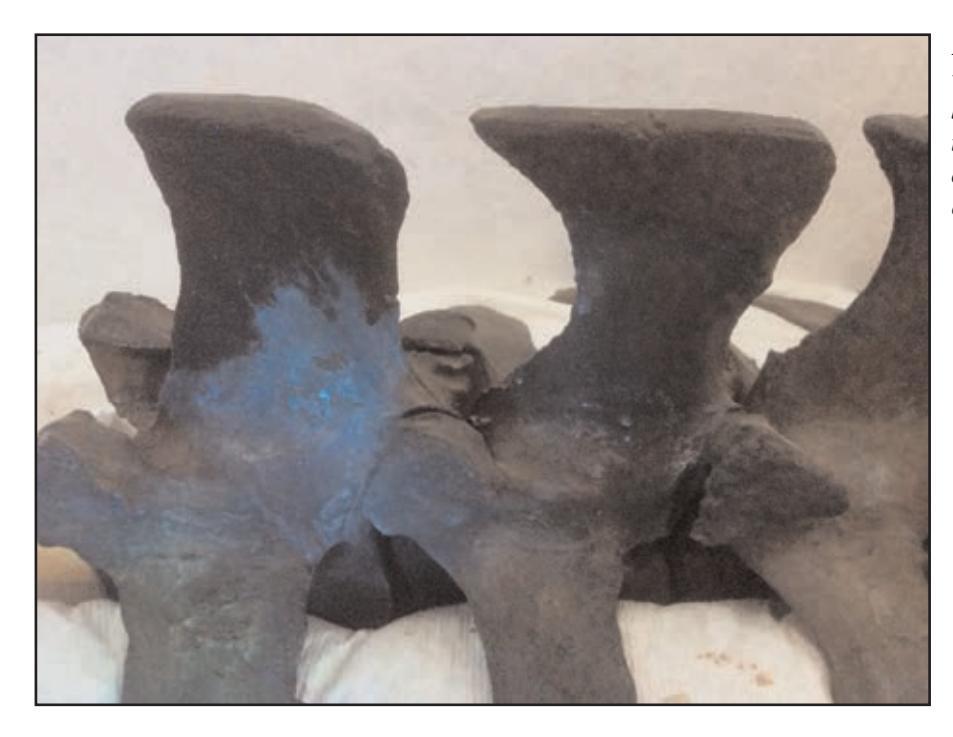
Figure 8. Giant deer lumbar vertebrae with newly remodelled bone infilled areas clearly visible in ultraviolet light (bluish colour), after in-painting with earth pigments.

pigments had the advantage of closely matching the brown earth tones of the specimen, providing a convincing aesthetic match and could be easily and quickly removed if swabbed with acetone. The reddish brown hue of the phenolic microballoons was also advantageous in achieving a close match (Figure 7). As a binding agent, the Paraloid B72 added a slight sheen that accurately represented the sheen of the shellac-covered bones. An additional benefit to this system is that the in-painted areas can be quickly identified as matt dark areas in contrast to the shellac coated bone surfaces when exposed to ultraviolet light (Figure 8).

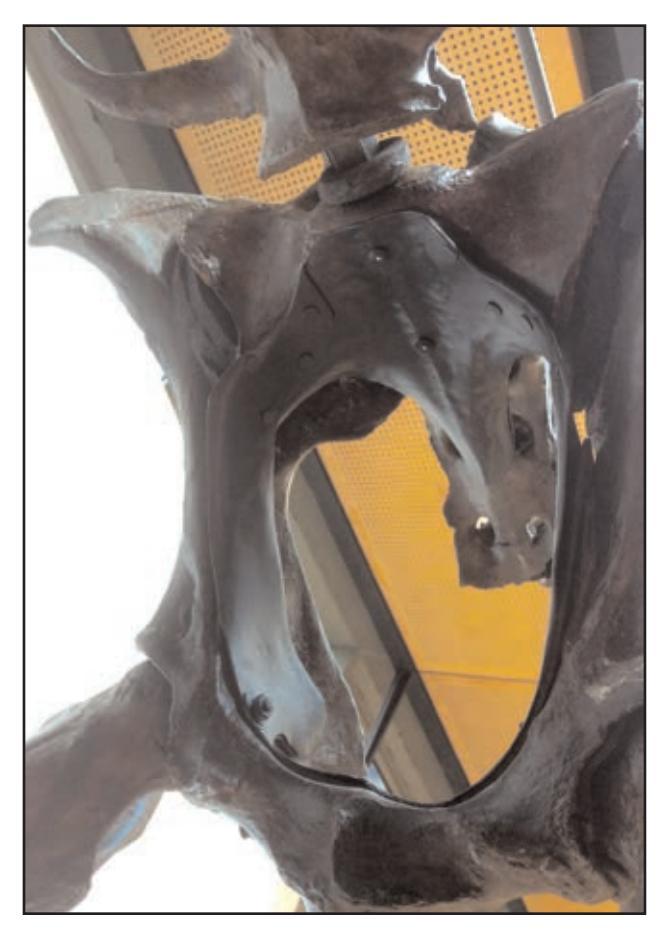
Figure 9. The pelvic bracket in situ after the completion of the treatment.

As well as the intrinsic structural mounting rods, a number of metal brackets, nails and metal bars had been used externally to secure weakened components. One such example was the pelvis, which bore a high degree of structural stress and strain as the only point of contact between the rods protruding from the proximal areas of the hind limbs, and the rod supporting the spinal column. A large internal section had been historically incised from the sacrum to allow it to be threaded onto the end of the spinal column and this was then adhered to the pelvis with an animal glue and cotton filler. Subsequently, the pelvis was attached to the femoral articular heads with M6 mild steel threaded bars, screwed into a tapped hole in the top of the leg rod, which protruded through holes drilled in the both of the femoral articular heads and passed on through the centre of the acetabular fossa of the pelvis (acetabular-femoral articular head joints) where they were secured with nuts and washers. The holes in the articular heads of each femur had become enlarged through wear and allowed the threaded rods to be upgraded to heavier duty M8 stainless steel replacements. It was clear that the stress placed on the pelvis in this way must be transferred to a supportive bracket and so a new stainless steel bracket was designed and cold forged in 1.2mm stainless steel sheet to run in a continuous loop, conforming to the interior facets of the pelvis and sacrum with 2mm Plastazote® providing a cushion between bone and bracket (Figure 9). The original holes securing the leg rods to the pelvis were then reused with new stainless steel rods, nuts and Plastazote® washers.

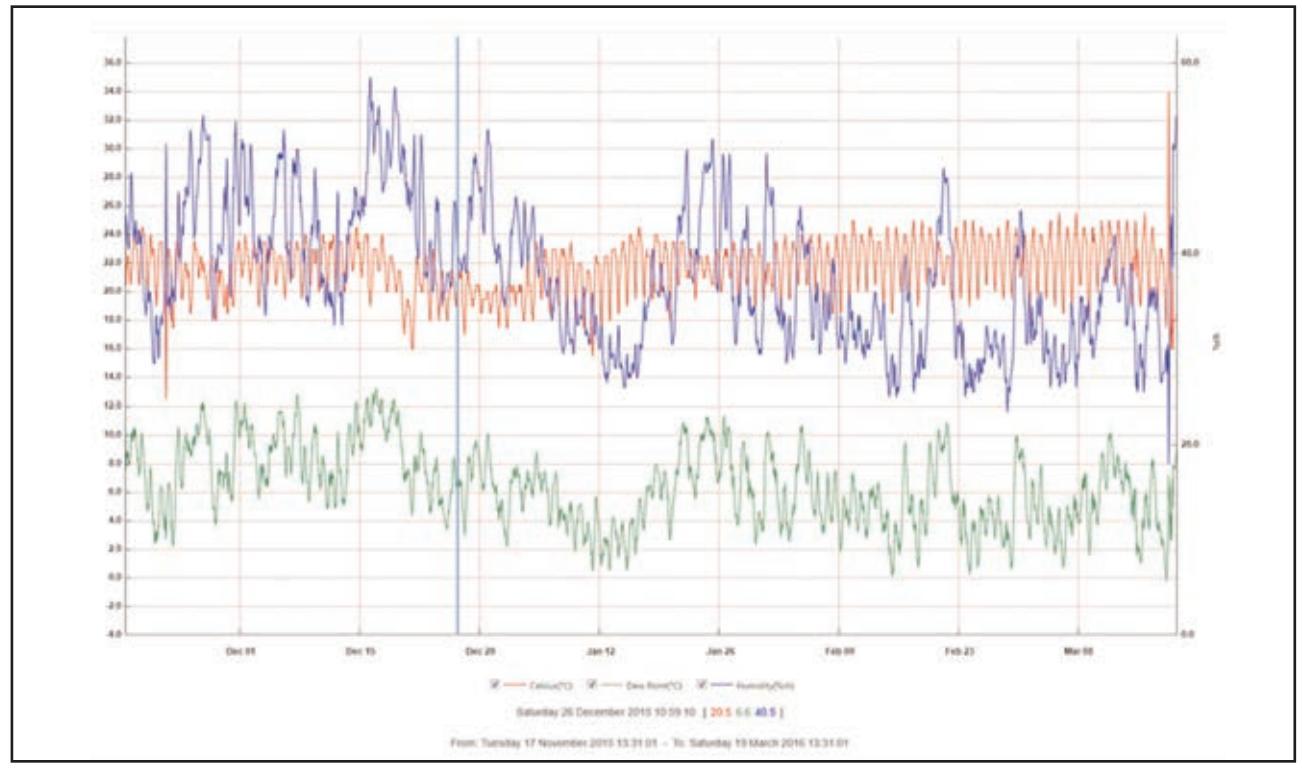
The readings obtained from the data logger (Figure 10), taking hourly readings across a four-month

period, recorded a minimum temperature of 12.5°C with the highest temperatures reaching 34°C. The average relative humidity recorded across this span was 37.7% but alarmingly, on particularly unstable days the specimen was subject to diurnal relative humidity fluctuations of around 20%. These values fall well outside of recommended levels and so a maximum exhibition period of six months was advised for this specific location with regular monitoring in place to flag up potential issues before they became damaging to the conserved skeleton. Presently, the specimen has been removed to a climatically stable storage location while research is underway to source a suitable display case with incorporated climate control.

Figure 10. Data logger hourly readings across a four-month period, illustrating fluctuations in recorded minimum temperatures (red), average relative humidity (blue) and the dew point (green).

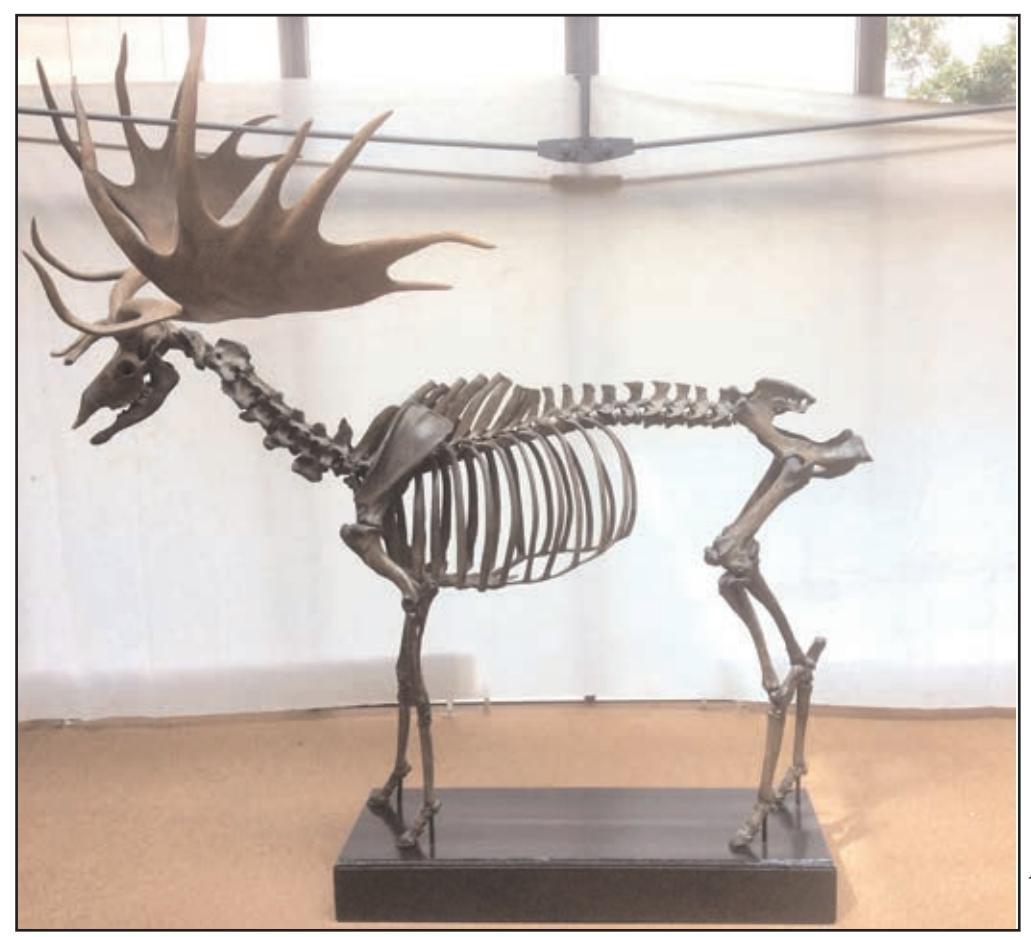
Figure 11. The mounted giant deer post conservation treatment.

and aimed to improve the viewers understanding of the scale and shape of the specimen by reinstating missing or broken skeletal components. The use of an epoxy resin bulked with phenolic microballons for modeling purposes was largely informed by the sucessful use of such materials in the conservation of degraded wood. A comparison of the compressive and tensile strengths of this material with subfossil bone is an area for future research. Due to fluctuating environmental factors occurring within the display area, a maximum exhibition period of six months was recommended with an ongoing monitoring programme in place to safeguard the future of the specimen. A climate controlled display case and alternative future display location are currently being investigated (Figure 11).
