# **Title of paper:** Analysis of the peat slide at Pollatomish, County Mayo, Ireland

Names of authors: Michael Long and Paul Jennings

**Abstract:** A major landslide event occurred at Pollatomish, County Mayo, Ireland in September 2003, during a period of intense rainfall. It comprised about 30 significant individual longitudinal planar type slides of peat and weathered rock. Relatively simple limit state stability analyses, using the method of slices and an infinite slope analysis, were used to model the slide and it was found that the features observed on site could easily be reproduced. These included confirmation that thin layers of peat could be stable on steep slopes but the margin of safety reduces rapidly under elevated pore pressure conditions. As was observed in the field, the analyses suggested the most vulnerable zone was the upper layer of weathered rock but that slides could occur in the peat if its thickness was appreciable. Careful site characterization is vital in such studies. Here efforts have been made to understand the effect of fibres on the peat strength and some sensitivity analyes have been performed to assess the critical engineering parameters of the p

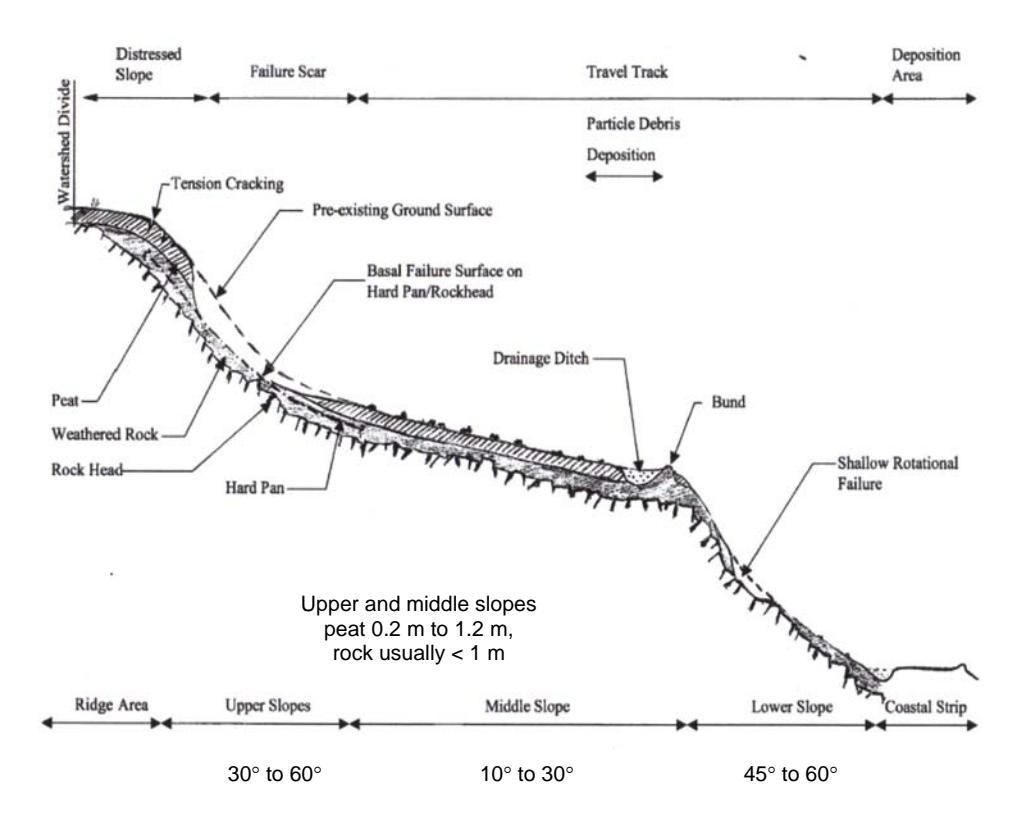
Figure 2. Schematic section through slope (adapted from Tobin 2003)

The slope profile (applies generally but particularly to the north and east facing hills) comprises some or all of the following elements, as shown on Figure 2:

- Ridge line.
- Upper slope. This is the zone generally above the 150 m contour and comprises a steep upper slope with inclination 30° to 60°. It may represent an old corrie back-wall where there has been accentuated erosion by ice during the last Ice Age.
- Middle slope. Relatively smooth slope of 10° to 30° between the 50 m and 150 m contours.
- Lower slope. Towards the coastal lowlands the slope increases to approximately 45° to 60°. It has a benched rather than smooth appearance
- Coastal strip. This consists of a narrow strip of moderately sloping ground varying from 10° to 30°.

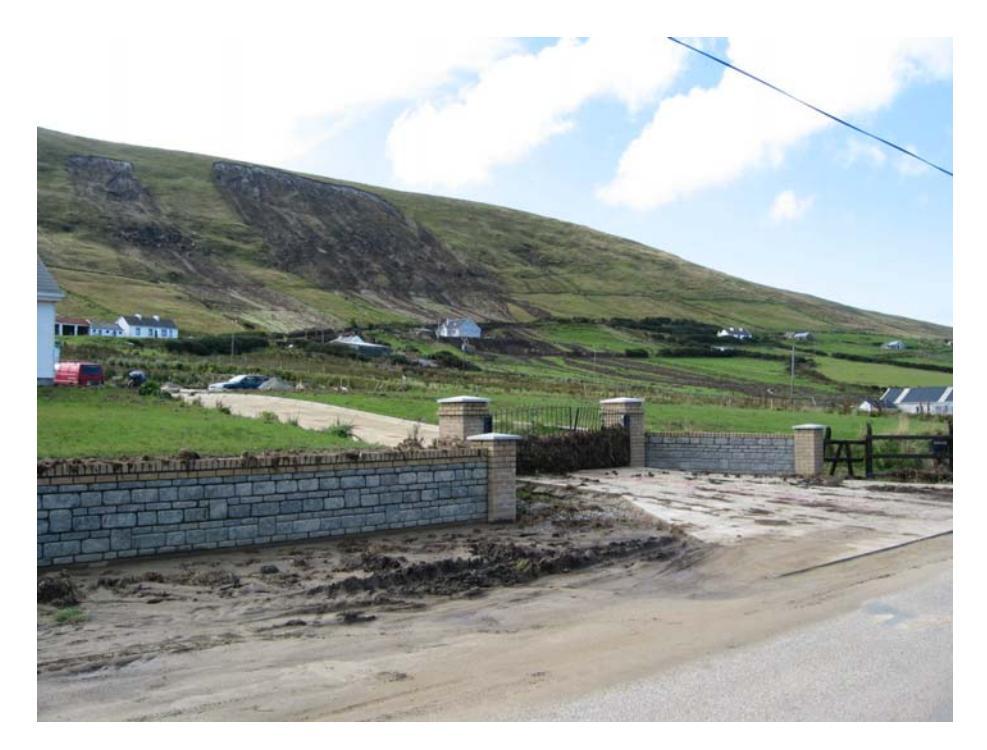
**Figure 3.** General view of slips on north side of Dooncarton Mountain facing towards the west. Type A failures mostly in upper slopes. Type B failure near middle house. Note movement arrested by drainage ditch at base of middle slope. Debris flow into lower slope cause by water flow.

Type A failures are located on the upper slope and are the dominant failure type (Figures 3 and 4). Apparent failure scars on the lower slopes, for example behind the cemetery at Pollatomish, are primarily as a result of landslide debris passing over the existing ground surface. The ground in these areas did not fail, though it was scoured by the passage of debris and subsequent erosion by surface water. Once mobile the soil material mixed with rain and groundwater and behaved as a fluid. Down slope flow was mainly via the existing drainage channel and small topographical features.

The authors have identified about 50 distinct failure zones, about 30 of which are of significant (of more than a few metres width) size. Some of these coalesce to form larger failure masses. Some typical failures are shown on Figure 3. Note that the transverse drainage ditch absorbed a significant fraction of the slide energy and protected the privately owned land down slope. Figure 4 shows a detail of a failure on the upper and middle slopes. Scar widths varied between a few metes to in excess of 150 m and involved volumes of material up to 20000 m<sup>3</sup>. The total volume of material involved is estimated to be in the region of 200,000 m<sup>3</sup>.

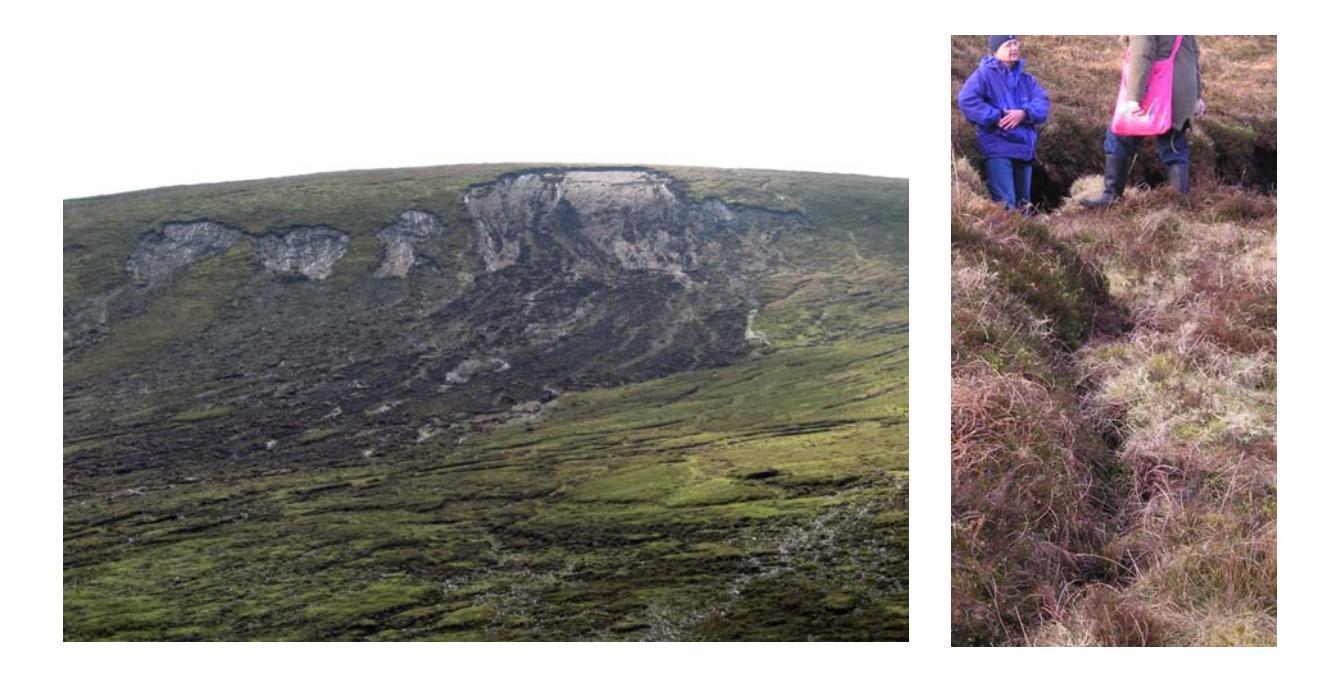
**Figure 4**. (a) Detail of failures on upper and middle slopes exposing smooth weathered rock surface; (b) detail of shrinkage crack in peat surface in undisturbed area adjacent to slide.

The dry conditions in the summer prior to the slide would have resulted in drying and shrinkage of the blanket peat (Figure 4b). This caused new cracking, reactivation of old cracks and opening of peat fuel cuttings. These cracks were observed by local people in the area before the event and in undisturbed areas adjacent to the slides afterwards. Any increase in stability due to lowering of the water table is likely to have been offset by the reduction in unit weight of the peat by drying. This matter will be addressed in the stability analyses below.

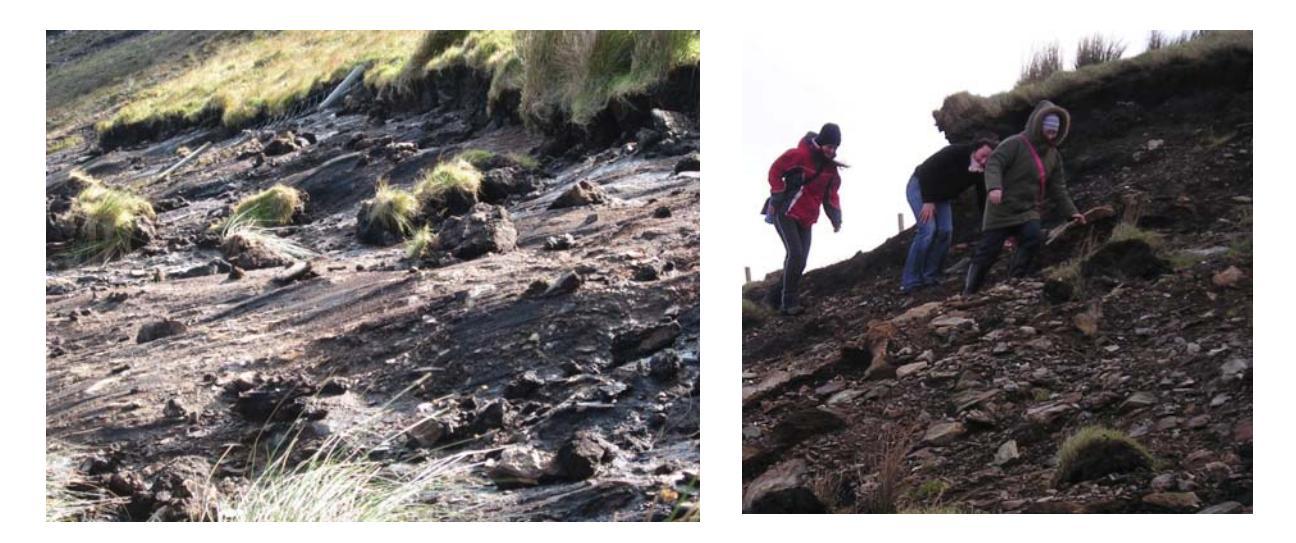
**Figure 5.** Type A slide slip surface (a) just after slide showing smooth surface in weathered rock and downslope striations and (b) approximately 18 months later where water flow has cleaned surface and locally exposed intact bedrock

The majority of the failures were of Type A and, from observations of the head and side scars were located in the mineral soil above the "hard pan", see Figure 5(a). This surface was extremely smooth and difficult to walk on. It exhibited striations or scratches in the down slope direction. Some orange colour staining of poorly developed "hard pan" can be observed below the failure surface. Within the weathered rock the failure surface was typically at about 200 mm depth and resembled weathered joints or discontinuities in a rock mass due to its "rusty" appearance and the presence of a seepage zone. Subsequent water flow may have locally exposed the surface of the intact bedrock, Figure 5(b).

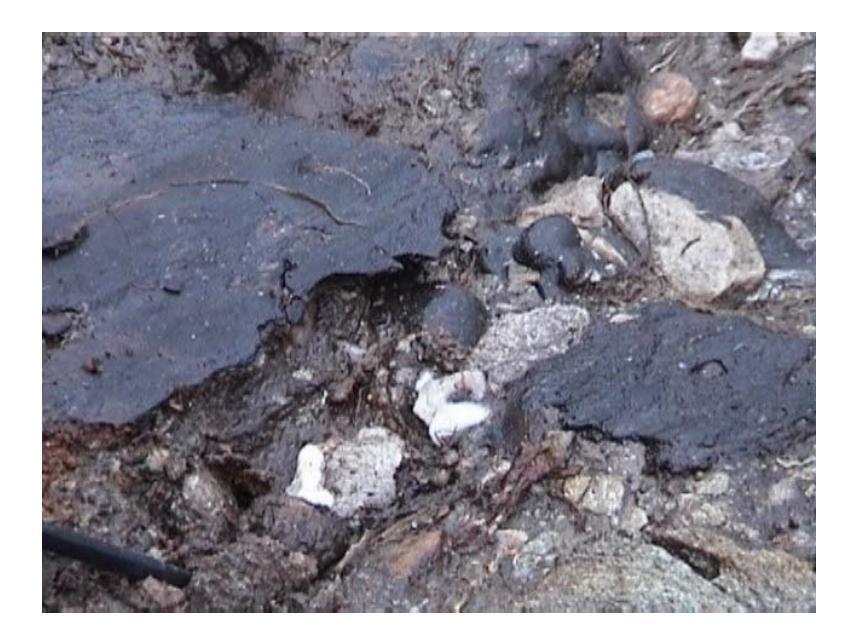
**Figure 6.** Slip surface in Type B slides: failure plane comprises a thin polished layer (typically 3 to 5 mm) of stiff black to dark brown amorphous silt/clay located near the base of the peat. This layer overlies weathered rock with local nodular "hard pan".

(somewhat to moderately humified) according to the Von Post scale (Hobbs, 1986) Fibres are readily identifiable, are a mixture of coarse and fine, and occur at random orientation. Close to the peat / weathered rock interface, and generally located 200 mm to 300 mm below the top of the weathered rock, there is a layer of "hard pan". As will be described below, this layer was observed just below some of the failures. This is considered to be a precipitated layer, of iron mainly, but also of manganese minerals, leached from the overlying deposits. Its thickness ranges from a few millimetres to 100 mm and comprises nodular black amorphous silt / clay which is cemented to angular gravel or cobble sized fragments, see Figure 6. Its state was not always as well developed as shown on Figure 6 and sometimes only an orange colour staining was visible in the weathered rock. An important characteristic of this layer is its low permeability and its resistance to root growth. Above the hard pan is a layer of irregular thickness typically 50 to +100mm, but can be absent, of soft to very soft brown to dark brown slightly sandy silt/clay. The top of the zone comprises a thin layer (typically 3 to 5 mm) of stiff black to dark brown amorphous silt/clay (referred to as dopplerite by Feehan and O'Donovan, 1996). The thin layer is polished on the upper surface, which may represent slickensides, see Figure 6.

Of the 50 individual failures, it is estimated that in about 11 of these the failure surface was located in the peat. These failures were of Type B, i.e. shallow rotational slides triggered by mobile sliding material. The failure plane comprises a thin polished layer (typically 3 to 5 mm) of stiff black to dark brown amorphous silt/clay located near the base of the peat, see Figure 6.

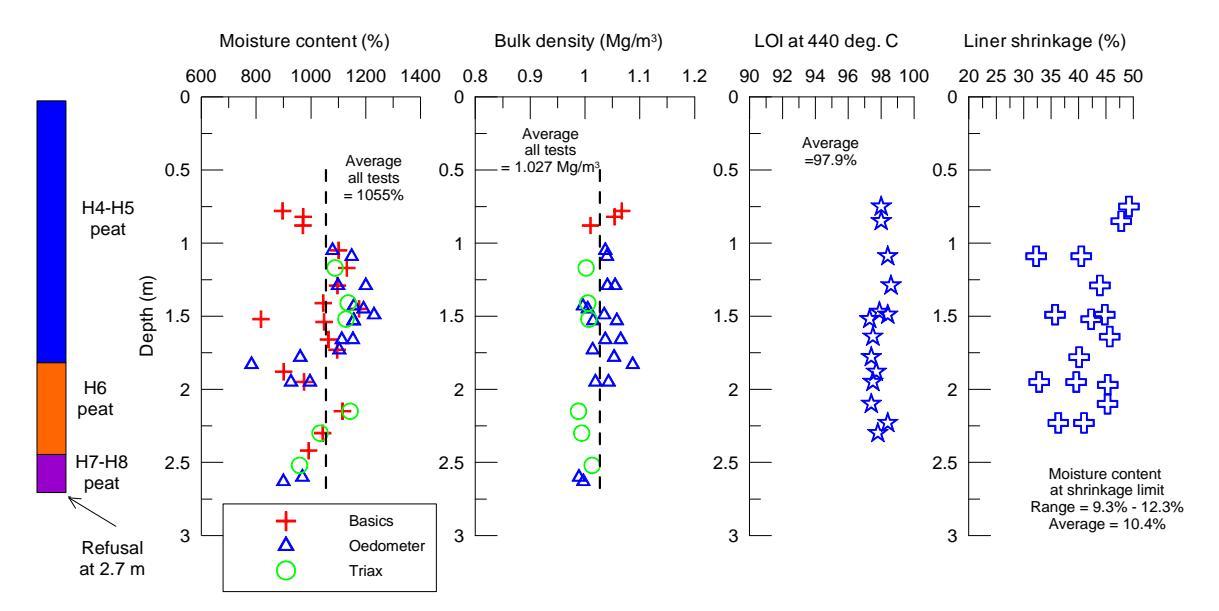
Figure 8. Index properties and classification of peat

Basic index properties of the peat and a description based on the von Post scale are given on Figure 8. The studied site was underlain by about 1.8 m of H4 to H5 (somewhat to moderately humified) peat, over about 0.6 m of H6 (moderately humified) peat, which in turn overlies a thin 0.2 m layer of H7 to H8 (fairly well to well humified) material. Fibres and roots are still easily identifiable. They comprise a mixture of coarse and fine elements and are orientated and spaced randomly. The material shows little evidence of plasticity. Weathered rock was encountered at 2.7 m. Peat is notoriously heterogenous. However in this case it can be seen that the properties are relatively uniform, with its moisture content varying between 800% and 1200% (average 1055%) and with an average bulk density of 1.03 Mg/m<sup>3</sup>, i.e. slightly denser than water. Based on the LOI values the material is almost completely organic with an average organic content of 97.9%. Linear shrinkage values reduce from close to 50% at 0.75 m to about 40% at 2 m depth, possibly reflecting the reduction in fibre content with depth. Moisture content at the shrinkage limit is about 10% confirming the large potential for shrinkage in the material.

No specific measurements of the unit weight of dried peat have been carried out for Pollatomish. Data for the nearby peat sampling site, shown on Figure 8, which was obtained close to the time of the failure at Pollatomish suggests very little influence of drying on the bulk density. Van Baars (2005) has determined an average bulk unit weight of 5 kN/m<sup>3</sup> for the unsaturated peat at the Wilnis embankment and this value is used here for illustration purposes. Taking the case of the 40° slope with peat thickness 1.2 m, as shown on Figure 19, FoS can be seen to be extremely sensitive to this parameter for all cases except the dry slope. By comparing the slope of the plots, it seems the influence of the decrease in effective stress caused by the reduction in peat unit weight is not counterbalanced by the corresponding reduction in water pressure.

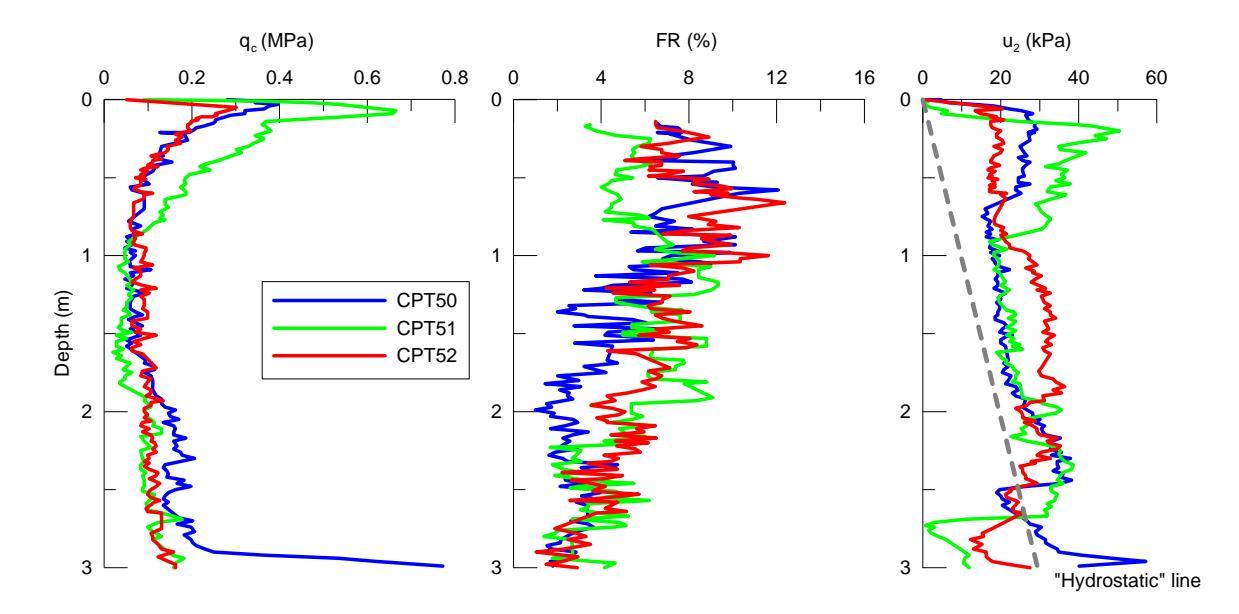
Figure 9. CPTU test results

The nature of the peat and the contrast between the peat and the underlying weathered rock can be seen clearly in the plot of the CPTU data on Figure 9. Initially the CPTU end resistance ( $q_c$ ) is relatively high due to the fibrous nature of the upper peat layers. It then gradually reduces to a minimum at about 1.5 m, before increasing slightly again. The interface with the underlying weathered rock can be clearly seen in the  $q_c$  response. CPTU friction ratio (FR) decreases reasonably uniformly with depth in the peat reflecting the reducing fibre content (increasing H number). The generated pore pressure ( $u_2$ ) is sensitive to the rate of cone penetration. Here the standard rate of 2 cm / s was used and  $u_2$  generally greater than hydrostatic, particularly in the upper more fibrous material, until close to the weathered rock surface.

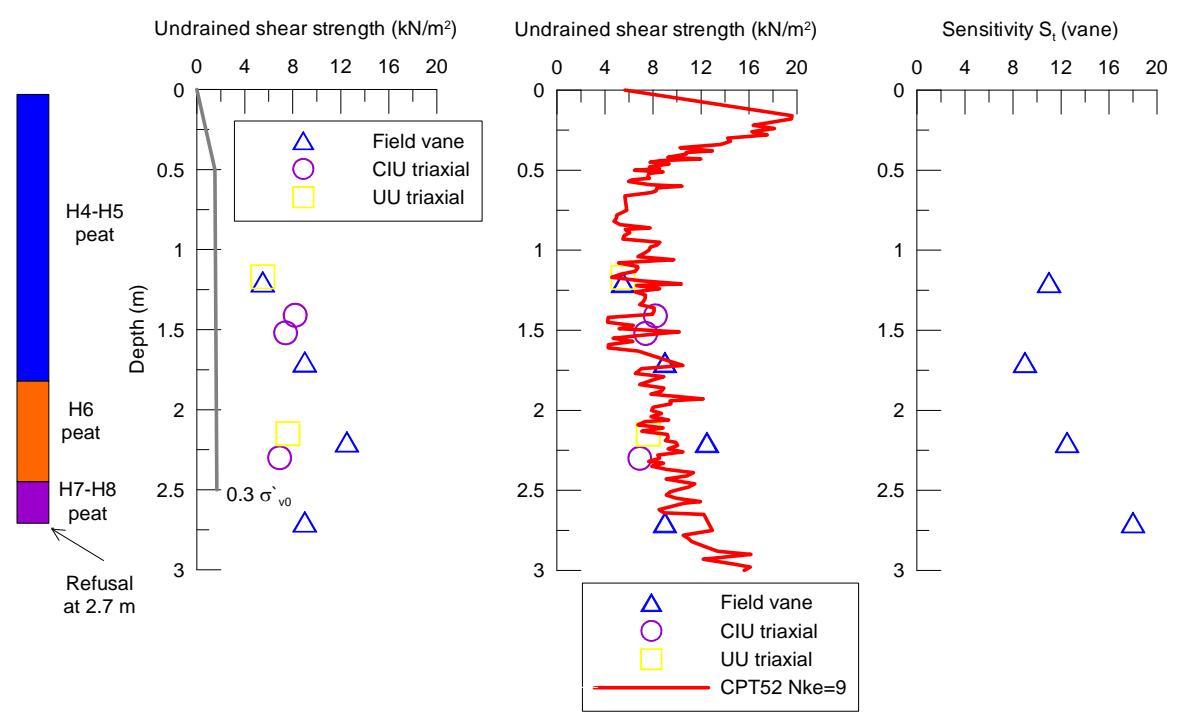
Figure 10. Undrained shear strength

Although the fibres will influence the shearing action in different ways for the vane and triaxial tests, there is very good agreement between the values from the 3 sets of tests, as can be seen on Figure 10, with  $s_u$  increasing from about 5 kPa at 1.0 m depth to 8 kPa near the base of the stratum. Undrained shear strength can also be determined from CPTU tests. Rodgers (1992) found that there was good correlation between effective cone resistance  $q_t - u_2$  ( $q_t$  is cone resistance  $q_c$  corrected for pore pressure effects after Lunne et al. 1997) and vane shear strength for various (including organic) soils. Using the expression  $s_u = q_t - u_2 / N_{ke}$ ) and assuming  $N_{ke} = 9$ , it can be seen that  $s_u$  derived from the CPTU compares very well with those values obtained from the other techniques.

Field vane sensitivity  $(S_t)$  values for the peat are also shown on Figure 10 and it can be seen that  $S_t$  increase from about 8 to 18 with depth. These are relatively high values and are consistent with the near liquid state of the peat following remoulding in particular during the Type B slides.

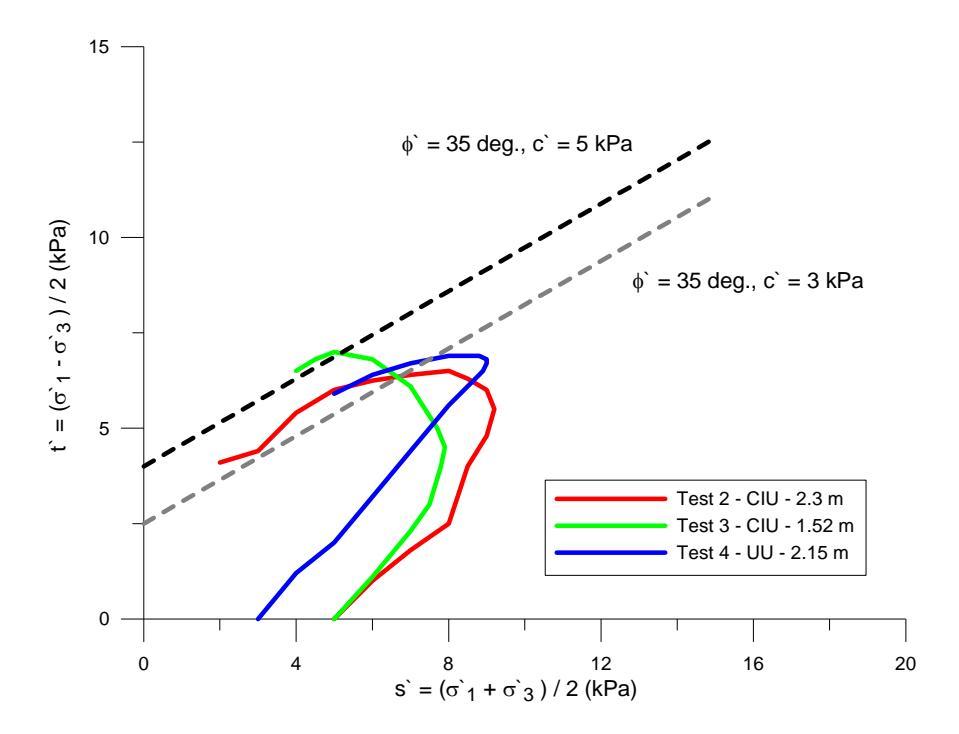
Figure 11. Effective stress strength parameters / stress paths

Stress paths (in s` =  $\sigma'_1 + \sigma'_3 / 2$ , t` =  $\sigma'_1 - \sigma'_3 / 2$  space) for three of the tests are shown on Figure 11. It can be seen that the behaviour of the peat resembles that of a normally consolidated clay and that its parameters can be defined as being in the range c' = 3 kPa and  $\phi' = 35^\circ$  to c' = 5 kPa and  $\phi' = 35^\circ$ .

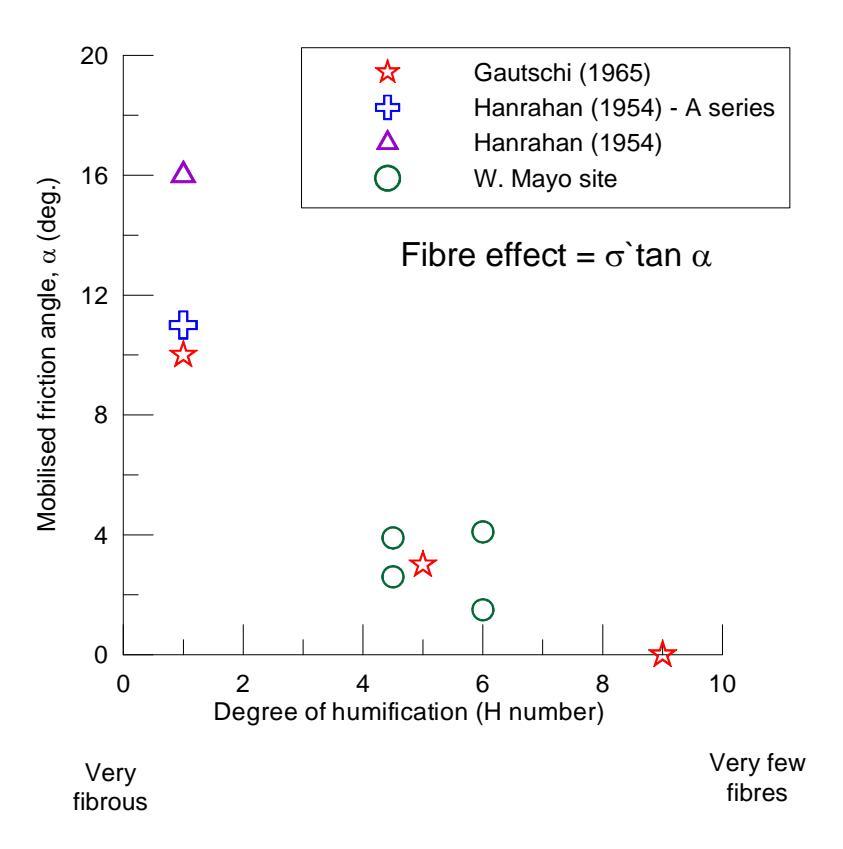
Figure 12. Effect of fibres on effective strength parameters

The effect of the fibres can then be expressed as  $\sigma'$  tan  $\alpha$  and as can be seen on Figure 12, this effect is consistent being highest for H1 peat and more or less zero for H9 peat. The data from this site is consistent with the older results and there would seem to be considerable promise in using this scheme. From this approach then the fibres account for approximately 4° of the frictional resistance of the material and combined with Landva and Rochelle's ring shear data gives an overall strength of c' = 3 kPa and  $\phi'$  = 35°, which is consistent with the data from the stress path plots on Figure 11. It is recognised that

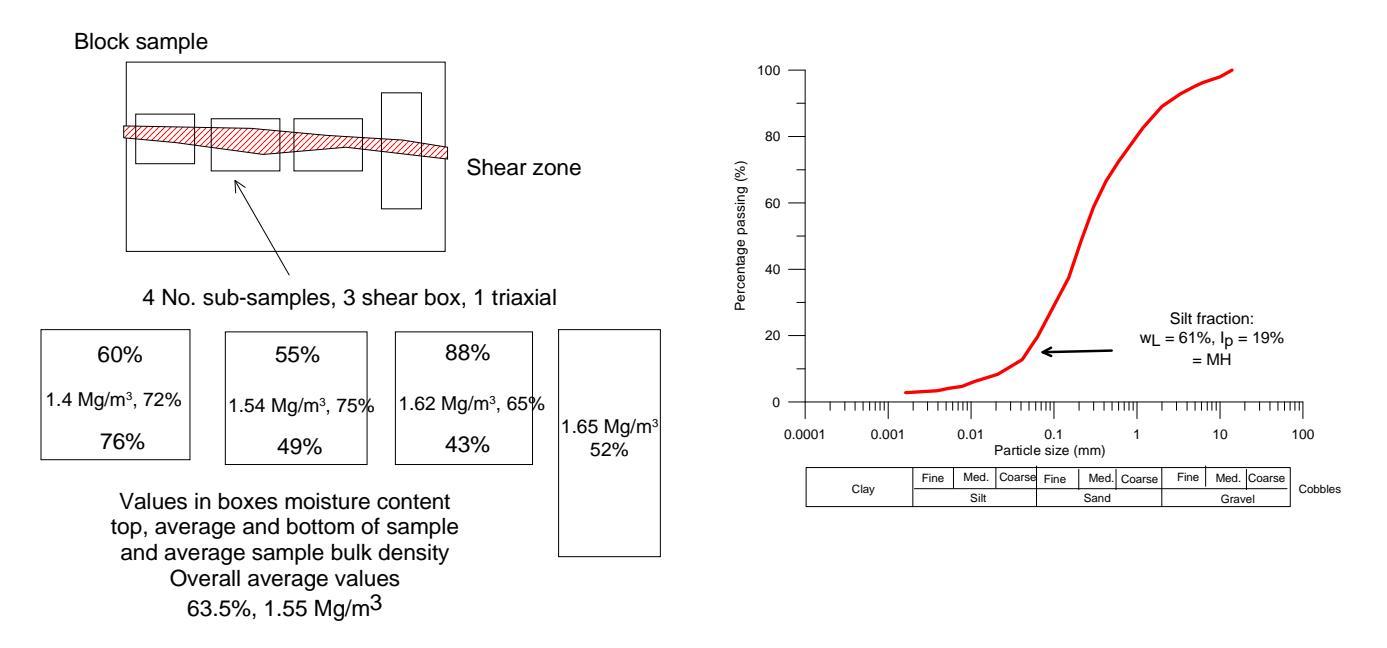
Figure 13. Basic index properties of weathered rock in failure zone.

A block sample of the weathered rock, from the failure zone of a typical Type A slide on Dooncarton Mountain, was sub-divided into four portions for shear box and triaxial testing as shown on Figure 13. A grading curve for the material is also shown in Figure 13. In engineering terms the material can be described as medium dense dark brown peaty sand. Basic index properties are very variable with no obvious correlation to the zone of most intense shearing. Moisture content varies between 43% and 88% with an average of 63.5%. Similarly bulk density varies between 1.4 Mg/m<sup>3</sup> and 1.65 Mg/m<sup>3</sup>.

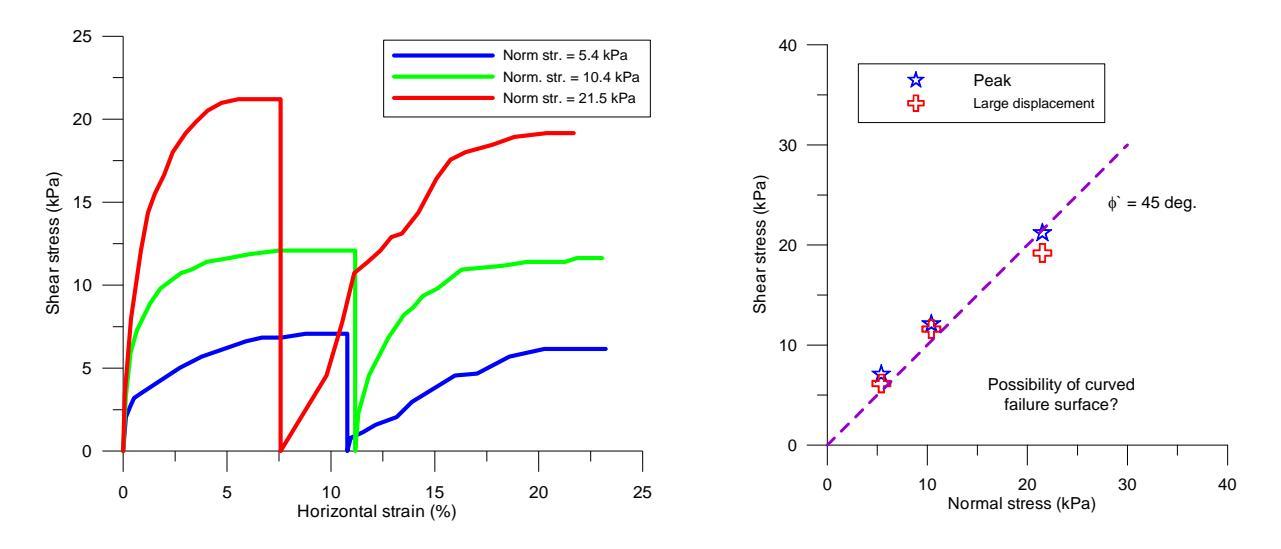
Figure 14. Shear box tests in weathered rock

Results of the small shear box tests for the weathered rock are shown on Figure 14. Normal stresses were 5.4 kPa, 10.4 kPa and 21.5 kPa, these values being as close as were possible to the in situ stress conditions. Following initial shearing the box was reversed and the sample was re-sheared in order to observe the large displacement shear strength. From the plots it can be seen that:

Vertical movement of the shear box was also measured during the tests and only very small movements were detected indicating the state of the material was close to the critical void ratio. The ductility of the material is an important factor as far as sliding is concerned as it indicates that rapid sudden failure without warning is unlikely.

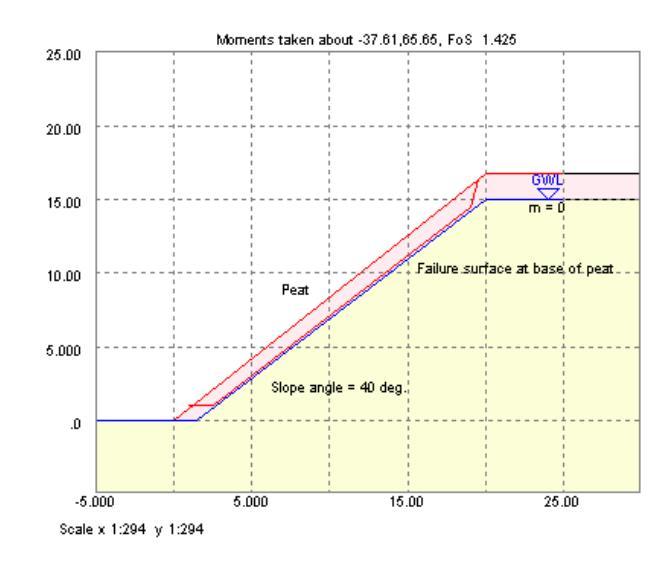
**Figure 16.** Output from OASYS-SLOPE. (Slope angle 40°, peat thickness 1.2 m, water at base of peat, failure surface near base of peat)

In order to calibrate the relatively simple infinite slope analysis, some calculations were carried out using the method of slices by means of the software OASYS SLOPE, see Figure 16. The example shown is for a 40° slope with 1.2 m thickness of peat and with the failure surface located within the base of the peat. For this example groundwater is assumed to be at the base of the peat. As can be seen the failed mass was subdivided into 10 slices and the factor of safety was calculated using Janbu's method of variably inclined inter-slice forces (Janbu 1957). A factor of safety (FoS) of 1.43 was calculated. For the same conditions, except with a failure surface located in the weathered rock, the factor of safety was calculated to be 0.87, i.e. tendency is for failure to occur in weathered rock on steep slopes, as was observed in practice.

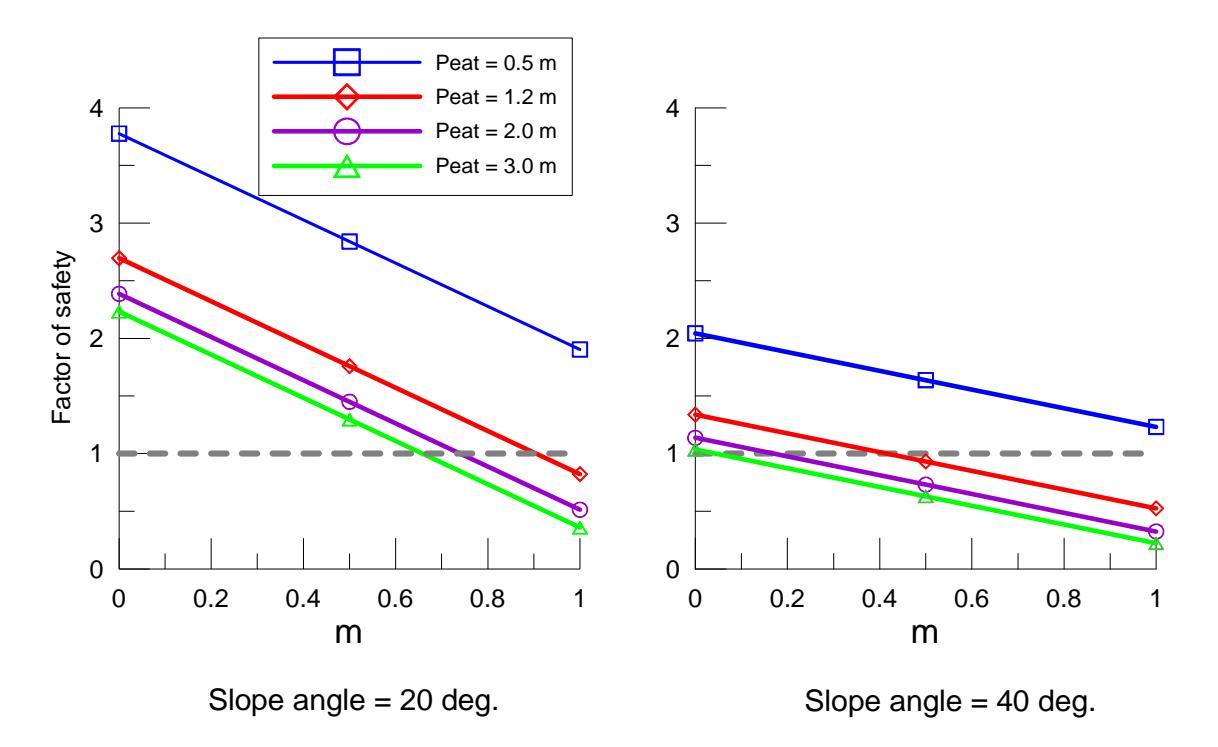
**Figure 17.** Infinite slope analysis – failure in peat. m is depth of water measured upwards from failure surface

Some output for infinite slope analyses with various peat thickness and depth to the water table and with the failure surface located in the peat are shown on Figures 17. Water pressures in the weathered rock correspond to those at the base of the peat. Slope angles were assumed to equal  $20^{\circ}$  and  $40^{\circ}$ , which were in the range of those typically observed in the field. It can be seen that:

- Thin layers of peat can be stable on steep slopes.
- For peat thickness of 1.2 m or greater and high m values, the slope becomes unstable.
- FoS decreases with increasing layer thickness.
- FoS decreases with increasing slope angle.
- Increasing water pressure (m) causes significant reduction in FoS.
- For m = 0, peat thickness = 1.2 m and slope angle = 40°, FoS = 1.34. This compares to 1.43 from the more sophisticated method of slices.

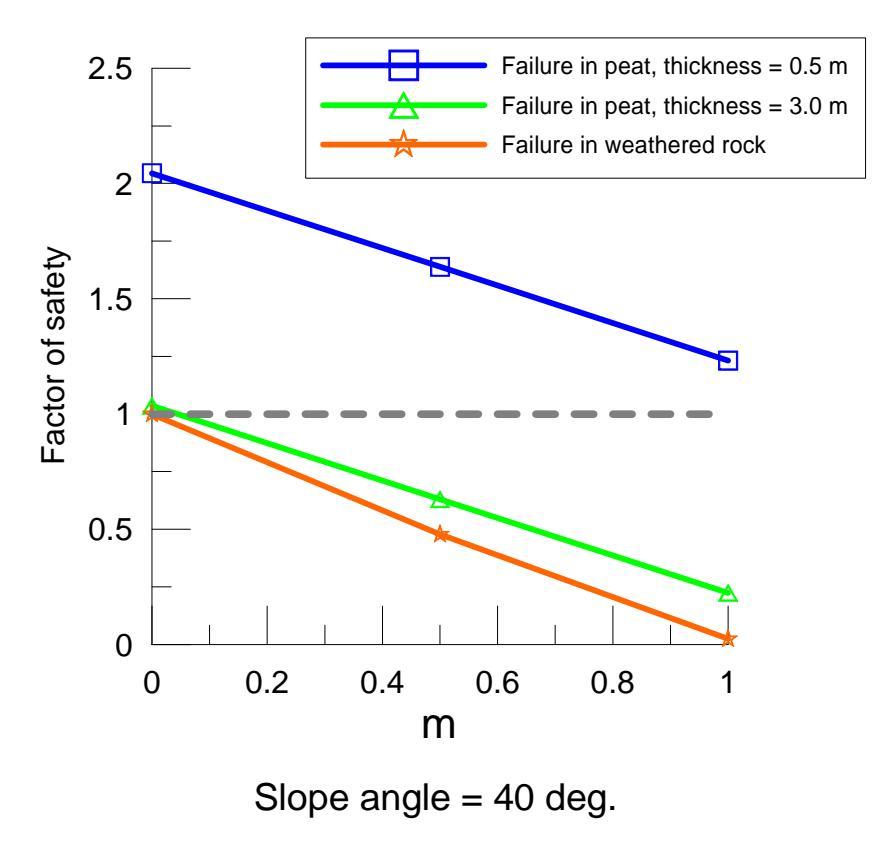
Figure 18. Infinite slope analysis – comparison of failure in peat and weathered rock

Similar output is shown on Figure 18, except in this case a comparison is made between failure in the weathered rock and in the peat for the case of a  $40^{\circ}$  slope. In this case it can be seen that:

• There is a greater potential for failure in the weathered rock except where the peat becomes thick.

• For m = 0, and failure in weathered rock, FoS = 1.00. This compares to 0.87 from the more sophisticated method of slices.
